# Vision Zero

# Vision Zero Corridor Studies

CR 579/Mango Road

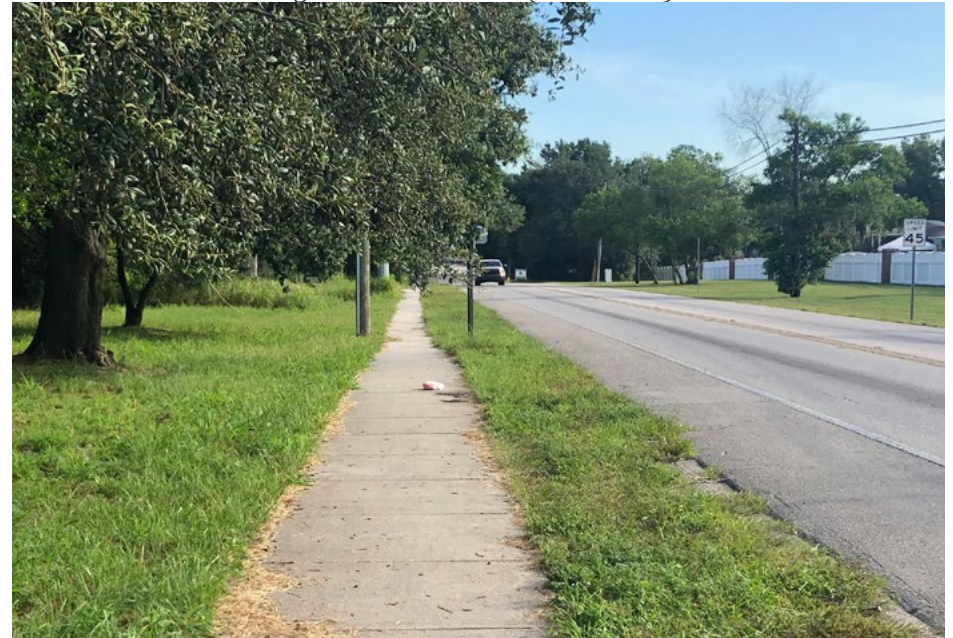
Figure 2 - Sidewalk (West Side)

Along Mango Road there is continuous 5-foot sidewalk on the west side of the roadway (**Figure 2**). Fragmented sidewalk ranging from five to six wide is present on the east side (**Figure 3**). Gaps in the sidewalk on the east side are located between north of the Walmart driveway to Clay Pit Road (approximately 1,400 feet) and between north of Mango Groves Boulevard to Sunlight Lane (approximately 2,550 feet) (**Figure 4**). Paved shoulder is present along the roadway but dedicated bicycle facilities are not provided along the corridor.

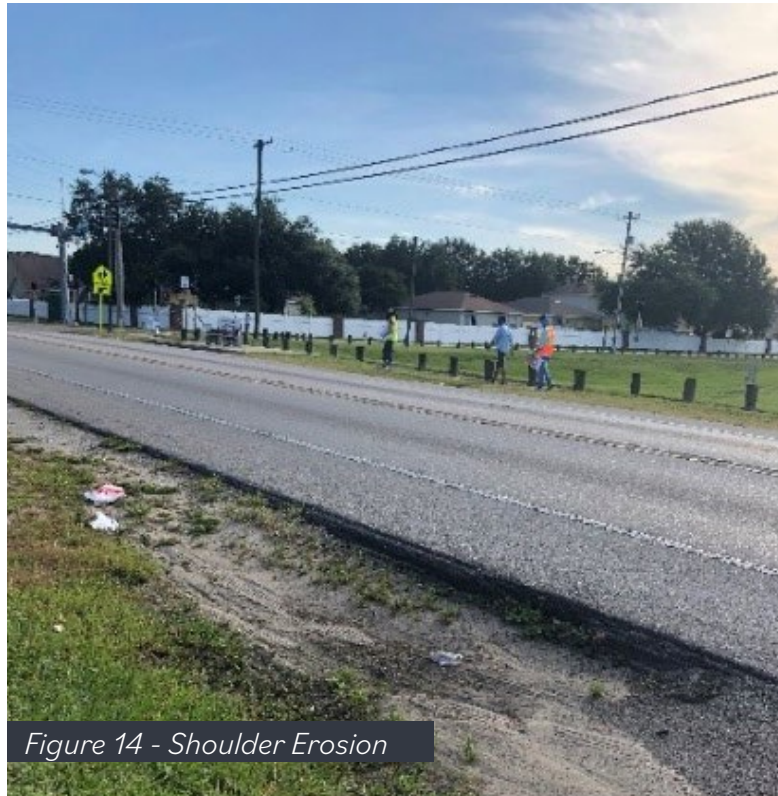
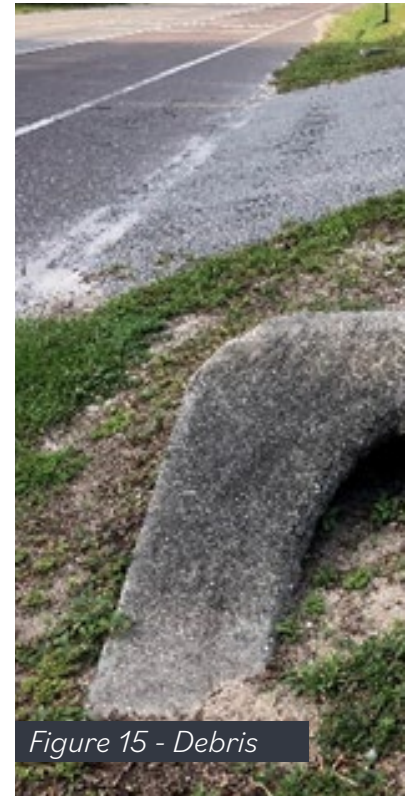
Figure 14 - Shoulder Erosion

A road safety audit and field review of existing conditions on Mango Road was conducted on June 23, 2020 by the consultant team and representatives from Hillsborough County and the MPO. While traffic conditions were observed, these conditions may not be representative of typical conditions as the due to the impact of COVID-19. During the safety audit the conditions along the corridor were reviewed with a focus on the existing maintenance, safety, and connectivity provided for pedestrians, cyclists, and vehicles. The findings from the audit include the need for maintenance along the corridor to address obstacles blocking the sidewalk and shoulder erosion (**Figure 14**), the removal of debris from drainage structures (**Figure 15**), restriping of degraded pavement markings (**Figure 16**), and the replacement of cracked sidewalk (**Figure 17**). The detailed audit for Mango Road can be found in **Appendix B**.

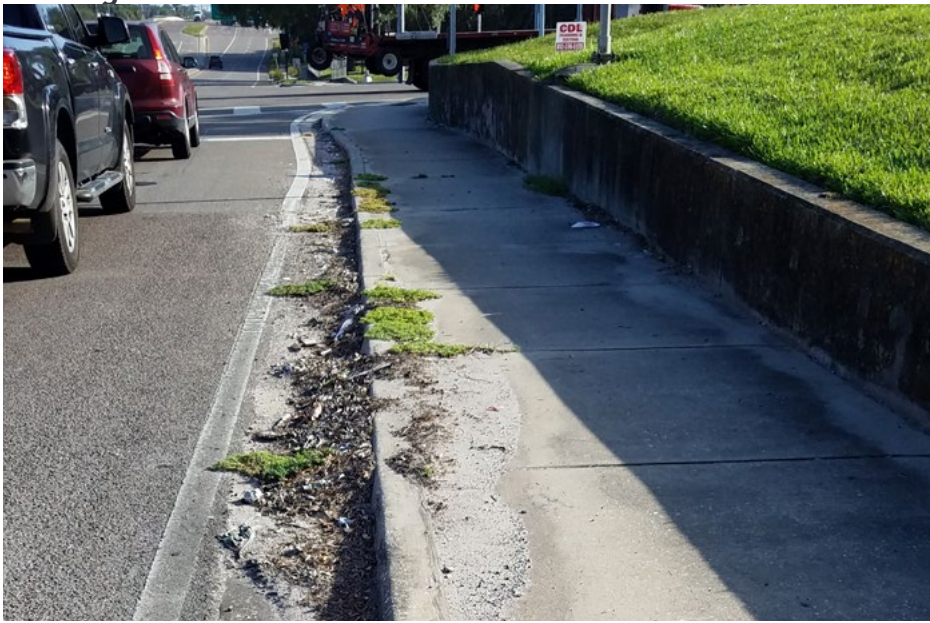
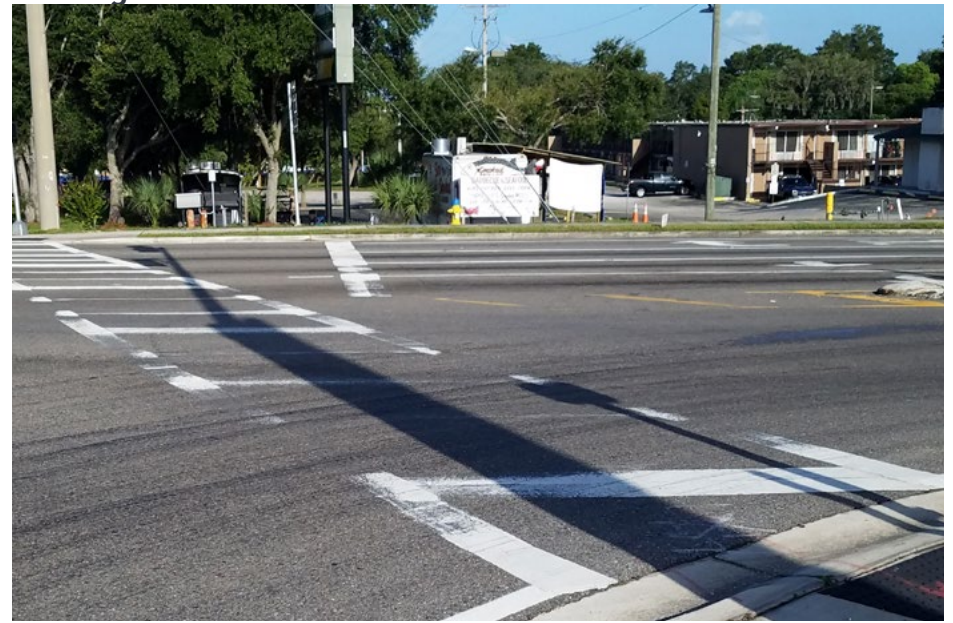
The intersection of Mango Road and US 92 at the north end of the project corridor is a large intersection with separate left turn lanes provided at all four approaches and separate right turn lanes provided for all approaches except for the south approach. Angle, left turn, and rear end crashes made up most of the reported crashes at the intersection between 2014 and 2018. Existing pedestrian facilities at this intersection consist of high visibility crosswalks, curb ramps with sidewalk connections, and pedestrian signals at all approaches. The pedestrian crossing distances on the north and south approaches are approximately 100 feet. The crossing distances on the east and west approaches are approximately 70 feet.

The recommended safety improvements for the intersection consist of replacing the existing five-section signal heads for the left turn lanes with separate four-section signal heads and three-section signal heads for the left turn movements. The left-turn movements should be evaluated for protective phasing in the future. It is also recommended to add signal backplates to the north and south approach signals to improve the visibility of the signals. In order to slow drivers approaching or crossing through the intersection, it is recommended to add a raised landscape median to the currently striped median and extend the curb on the south approach to reduce the turning radius and reduce the travel lane **(Figure 25)**. Pedestrian related safety improvements at the intersection consist of reconstructing the southeast curb ramps and restriping the crosswalks at all intersection approaches.

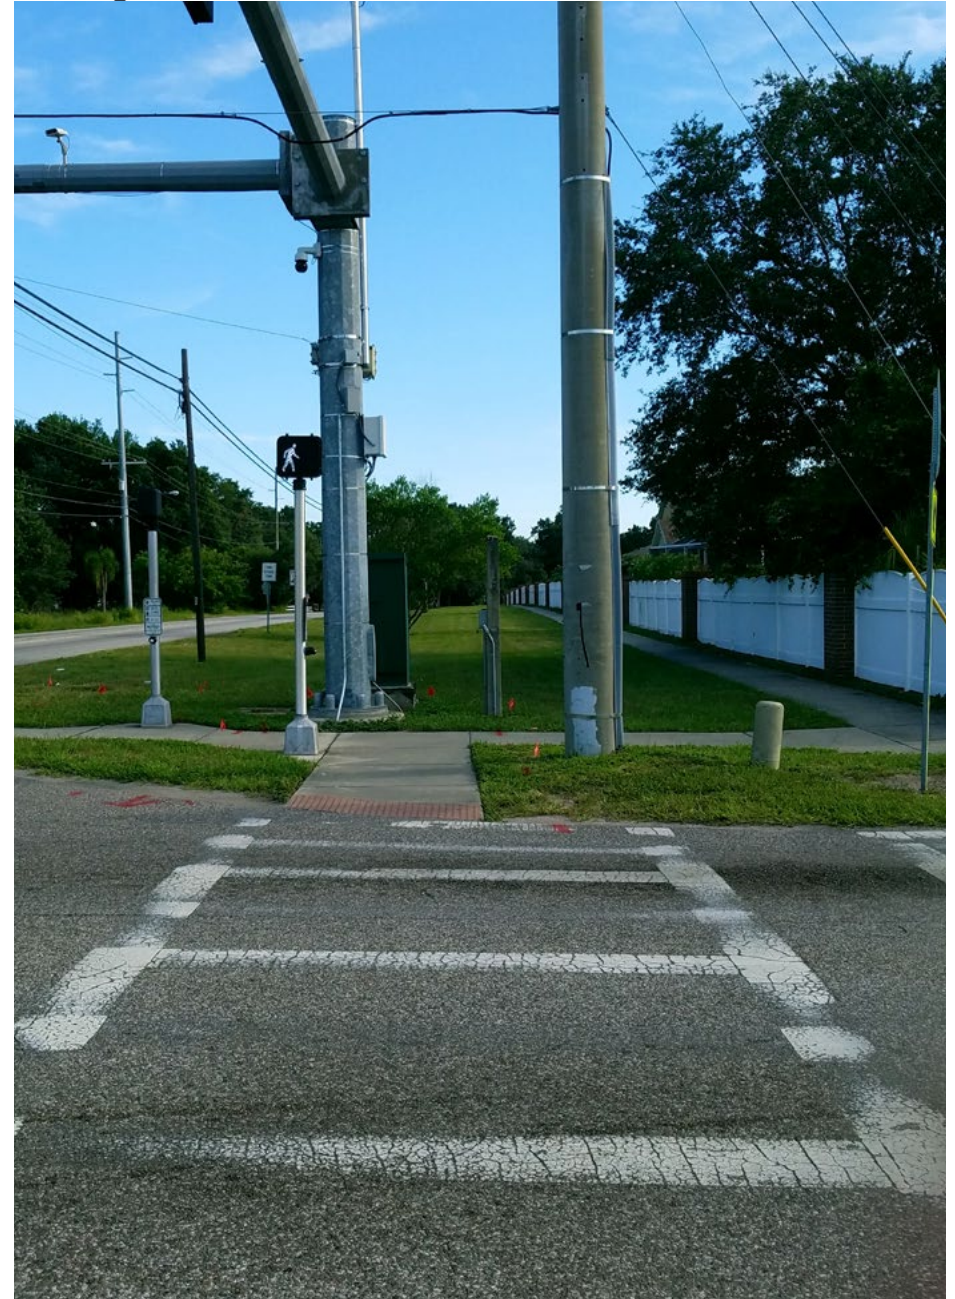
The intersection of Mango Road and Clay Pit Road is the only signalized intersection provided along the corridor between the two signalized intersections at the ends of the project limits. The intersection provides a signalized crossing for pedestrians accessing the adjacent park areas.

The recommended safety improvements at the intersection consist of safety enhancements for all modes that travel through the intersection. At the Mango Road and Clay Pit Road intersection it is recommended to restripe the existing worn crosswalks on all approaches and adjust the signal timing to allow for Leading Pedestrian Intervals (LPIS) due to the high level of pedestrian activity and proximity to the County parks. LPIS give pedestrians a “head start” to cross the intersection before any vehicles receive the concurrent green signal, enhancing the visibility of pedestrians in crosswalks **(Figure 26)**.

Other recommended improvements for the intersection include installing backplates on all signal heads and constructing curb and gutter along the roadway shoulder adjacent to Burnett Park to address the existing shoulder and sidewalk erosion. The construction of curb and gutter will increase the buffer distance between the sidewalks and roadway. A long-term improvement recommendation is the construction of sidewalk on the east side of the Mango Road between Clay Pit Road and the northern Walmart access driveway.

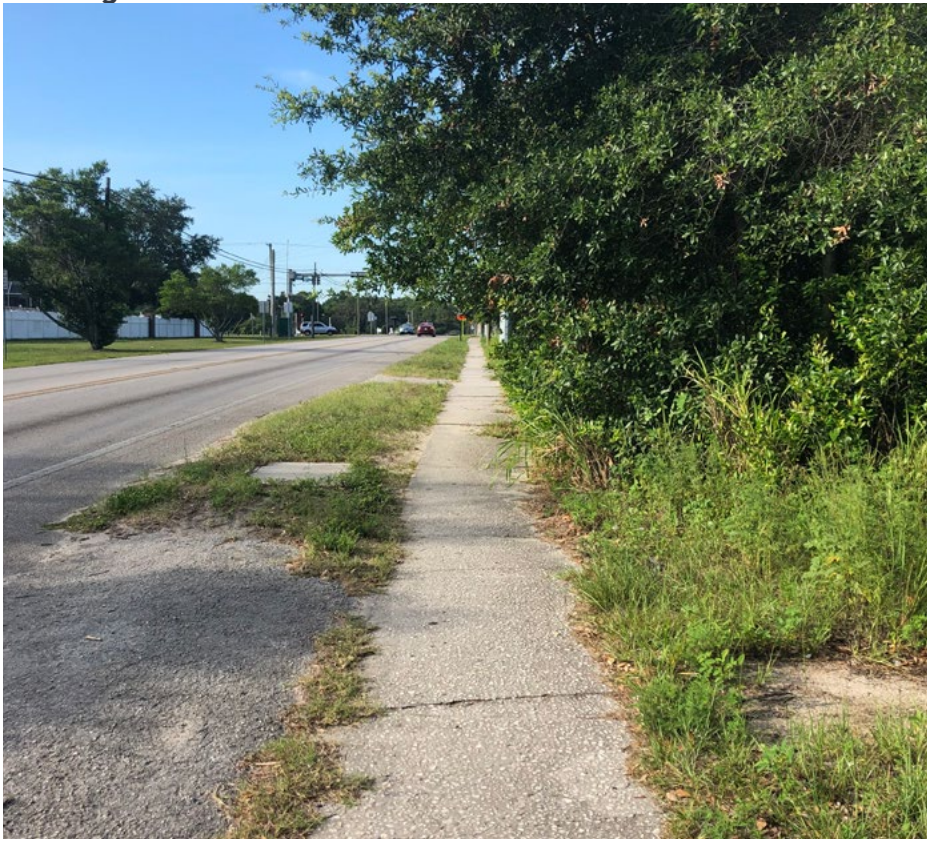
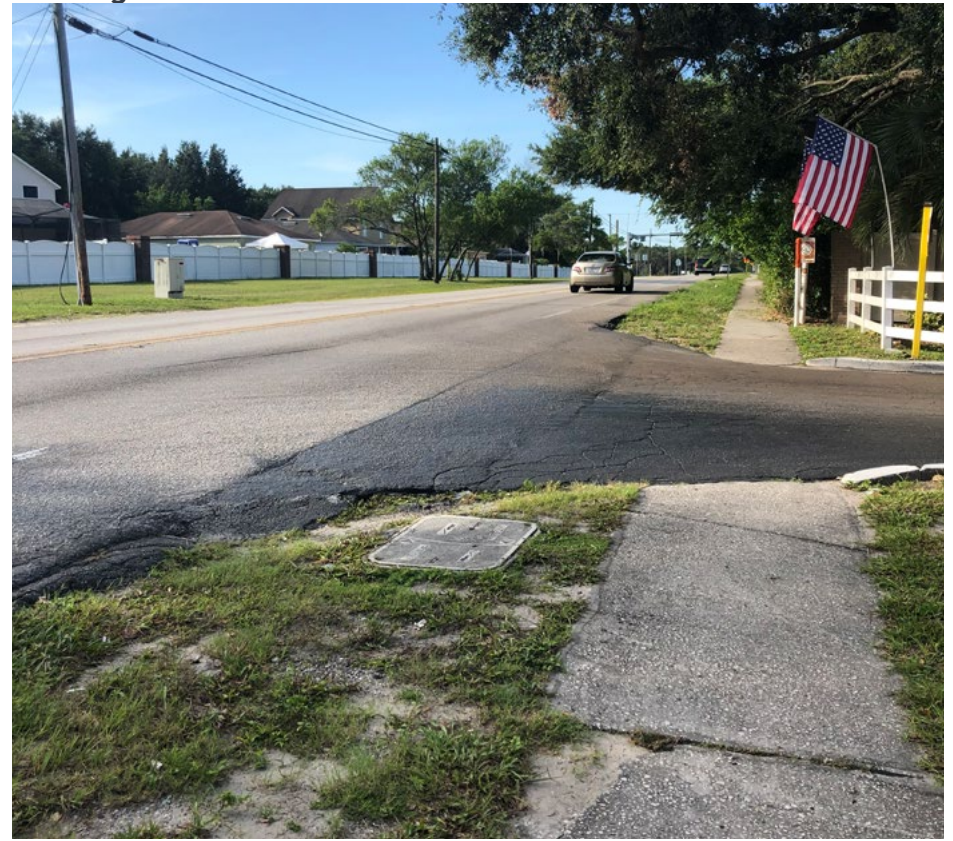
Canterbury Drive is a local residential road north of Clay Pit Road. Two serious injury crashes were reported at Canterbury Drive between 2014 and 2018. Both crashes were rear end crashes. In total, ten crashes occurred in proximity to Canterbury Drive during this time. Of the ten crashes, eight crashes were rear end crashes.

The recommended safety improvements at Canterbury Drive include widening the roadway at the intersection to include a left turn lane for enhanced access onto Canterbury Drive (**Figure 27**). The installation of the left turn will limit delay along Mango Road at this intersection and allow left turning vehicles to be separated from the through travel lane. Additional improvements at this location include installation of curb and gutter on both sides of the road through the intersection and south to Clay Pit Road to provide an additional buffer for pedestrians using the sidewalk. The installation of curb and gutter along the roadway will also serve as a traffic calming element in this portion of Mango Road. A high emphasis crosswalk should be added at Canterbury Drive. ADA curb ramps including the detectable warning pads surfaces should be added.

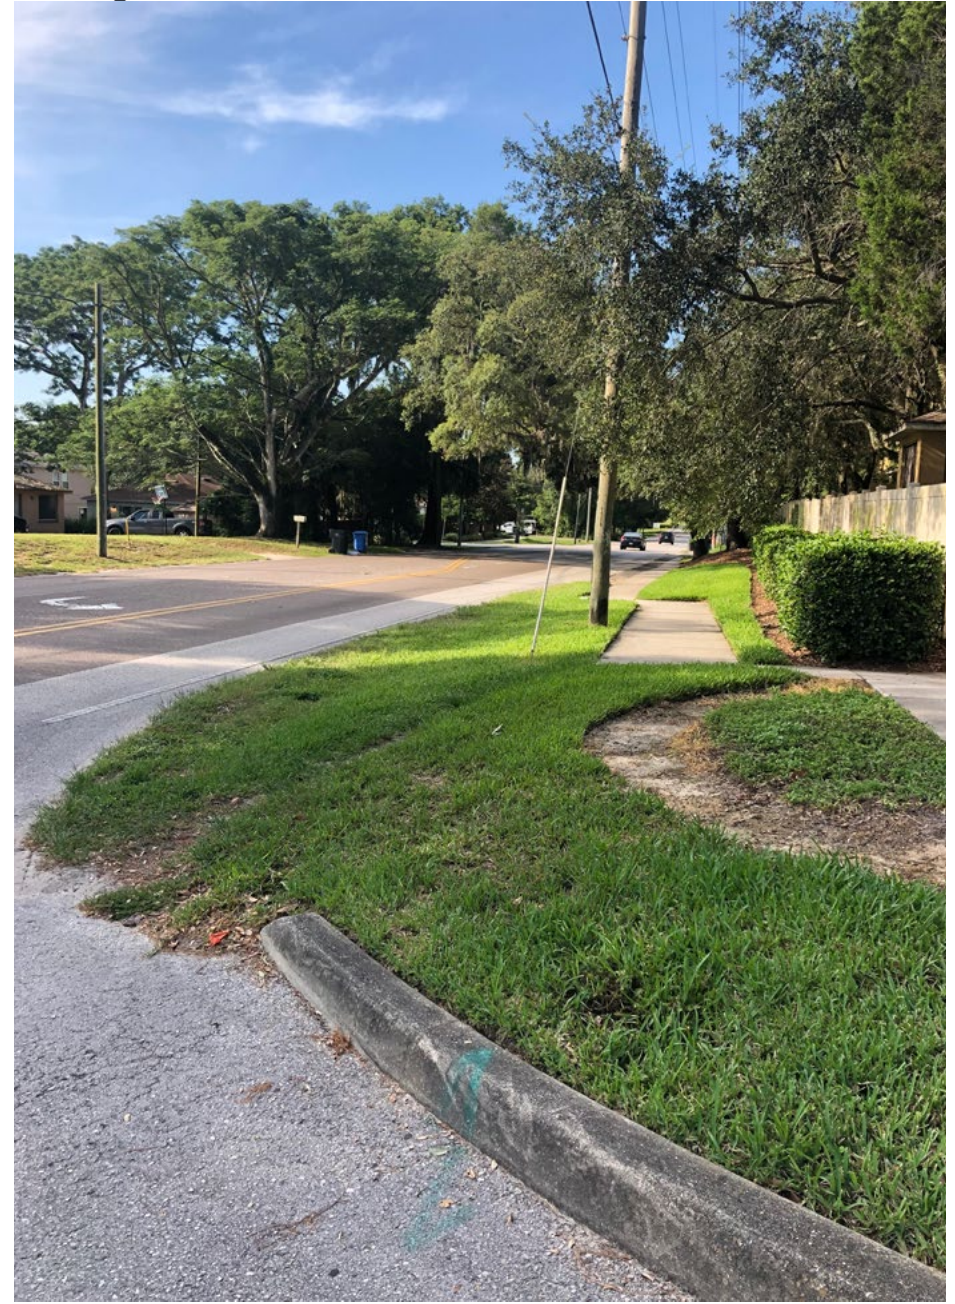
The section of Mango Road between Mango Ridge Boulevard and Mango Groves Boulevard provides connections to local residential roads and driveway access to residences. The safety improvements for this section of Mango Road consist of converting the existing striped median to a raised concrete median north of Mango Ridge Boulevard (**Figure 28**). The transformation of the median to a curbed concrete median will provide a traffic calming element to this residential section of Mango Road.

High emphasis crosswalks should be added at both Mango Ridge Boulevard and Mango Groves Boulevard. The curb ramps should be relocated at Mango Ridge Boulevard. The existing curb ramps are set back from the intersection but there are worn pedestrian paths outside of the existing path, as shown in **Figure 28**.

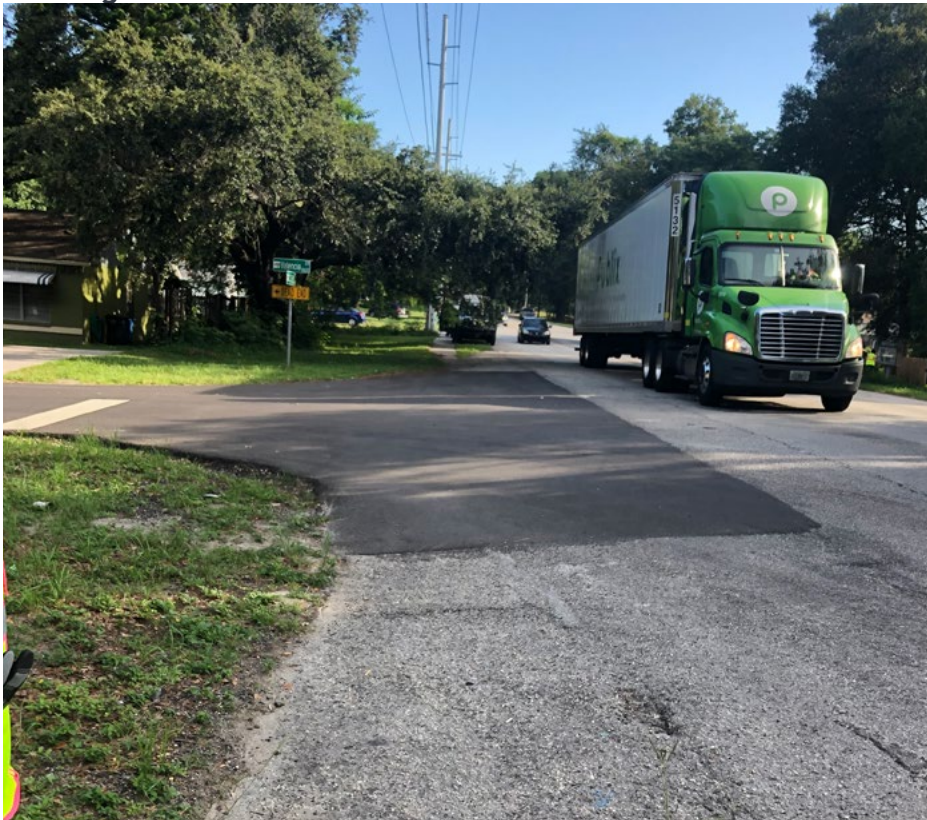
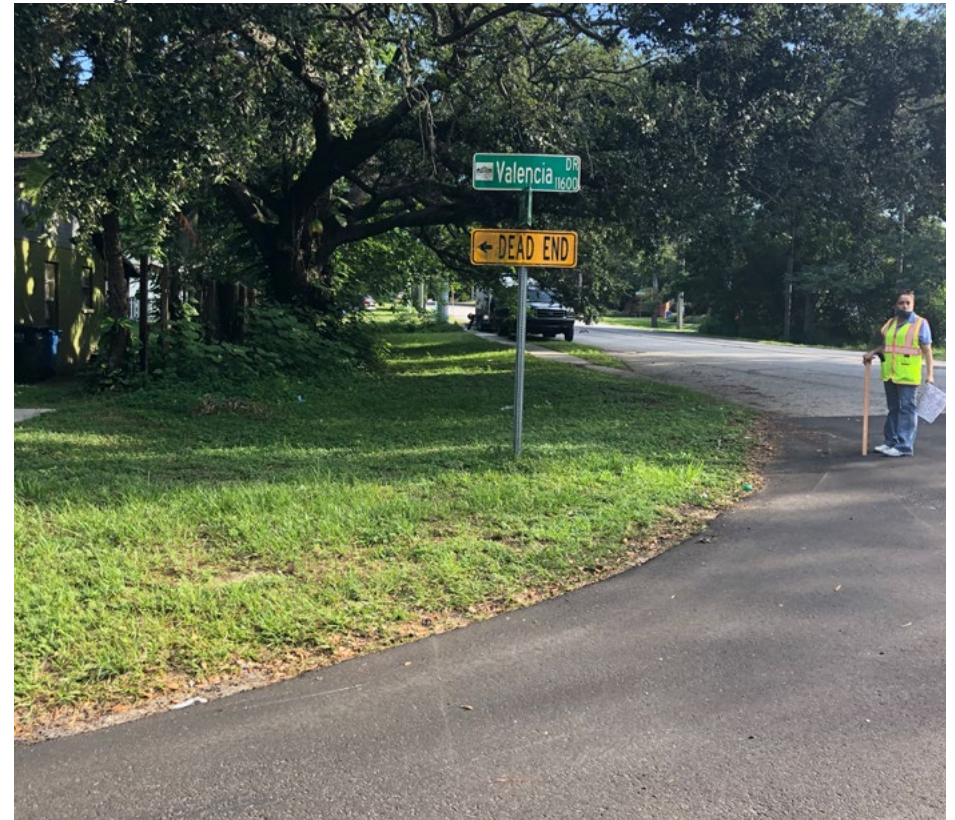
Valencia Drive is a local residential road located north of Canterbury Drive. Between 2014 and 2018, nine crashes were reported near Valencia Drive, one crash was a serious injury rear end crash and another crash involved a pedestrian.

The recommended safety improvements at Valencia Drive consist of adding a crosswalk and detectable warning across Valencia Drive and adding sidewalk to connect the existing sidewalk to the crosswalk from the north and south of the intersection. The existing sidewalk was covered by pavement which should be removed. The crosswalk and detectable warning will provide a safer crossing for pedestrians and provide a visual warning for drivers that pedestrians are present in the area **(Figure 29)**.

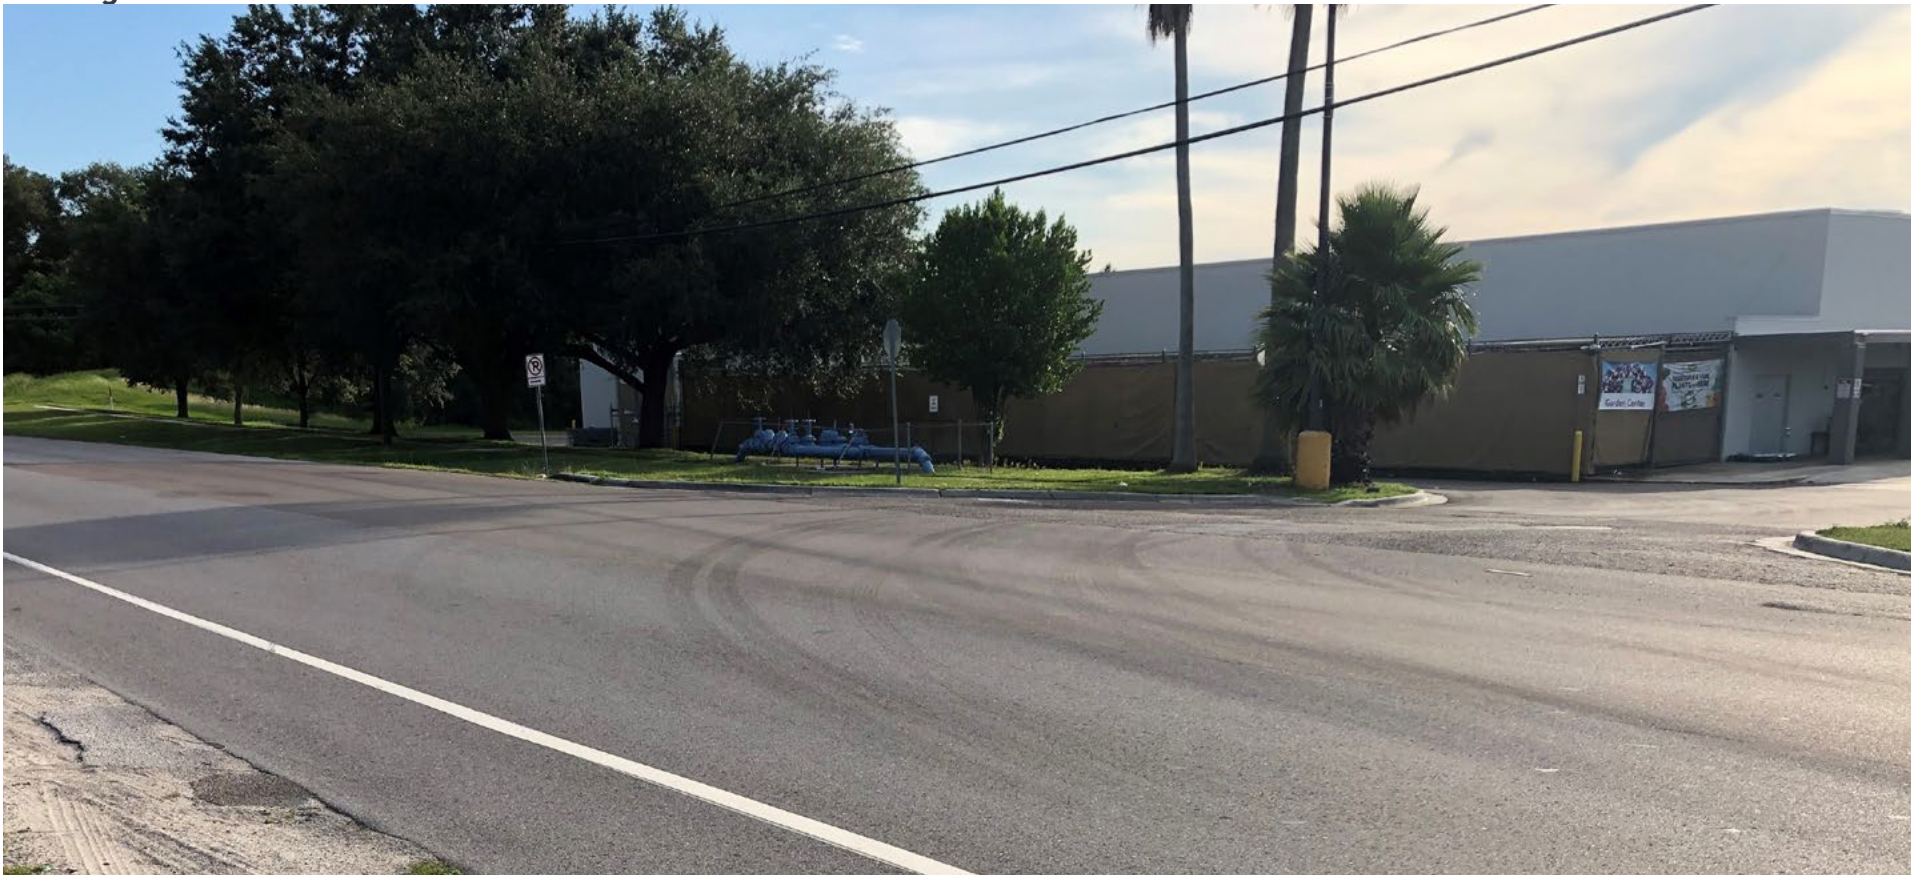
The northern access driveway to the Walmart shopping plaza is located on the east side of Mango Road between the Mango Elementary School driveways. In order to enhance pedestrian safety within the school zone, it is recommended to install high emphasis crosswalks and detectable warnings at the two school driveways on the west side and the Walmart driveway on the east side.

In conjunction with the recommend improvements to the south Walmart driveway (described below), it is recommended to construct a southbound left turn lane into the north Walmart driveway (**Figure 30**). The addition of an exclusive left turn lane will remove stopped vehicles from the through lanes, reducing the potential for rear-end crashes at this location. Sight distance should be further evaluated during the design phase to ensure vehicles have adequate line of sight exiting the driveway. Based upon the crash reduction factor for the installation of a left-turn lane, there is a potential 44% reduction of all crash types with the addition of a turn lane.

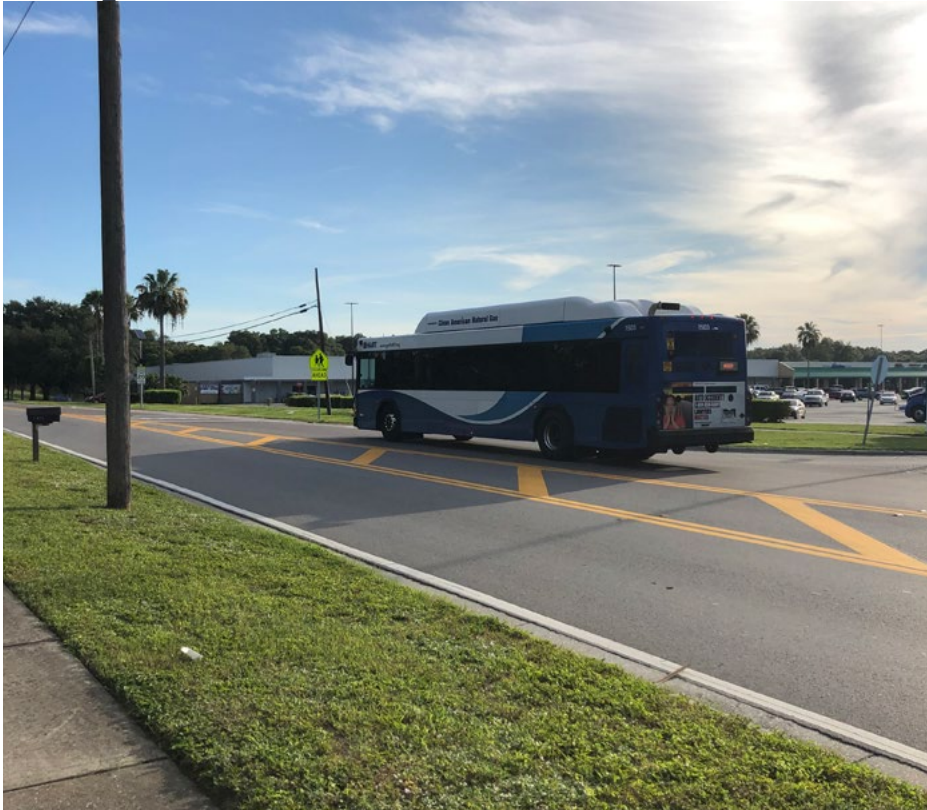
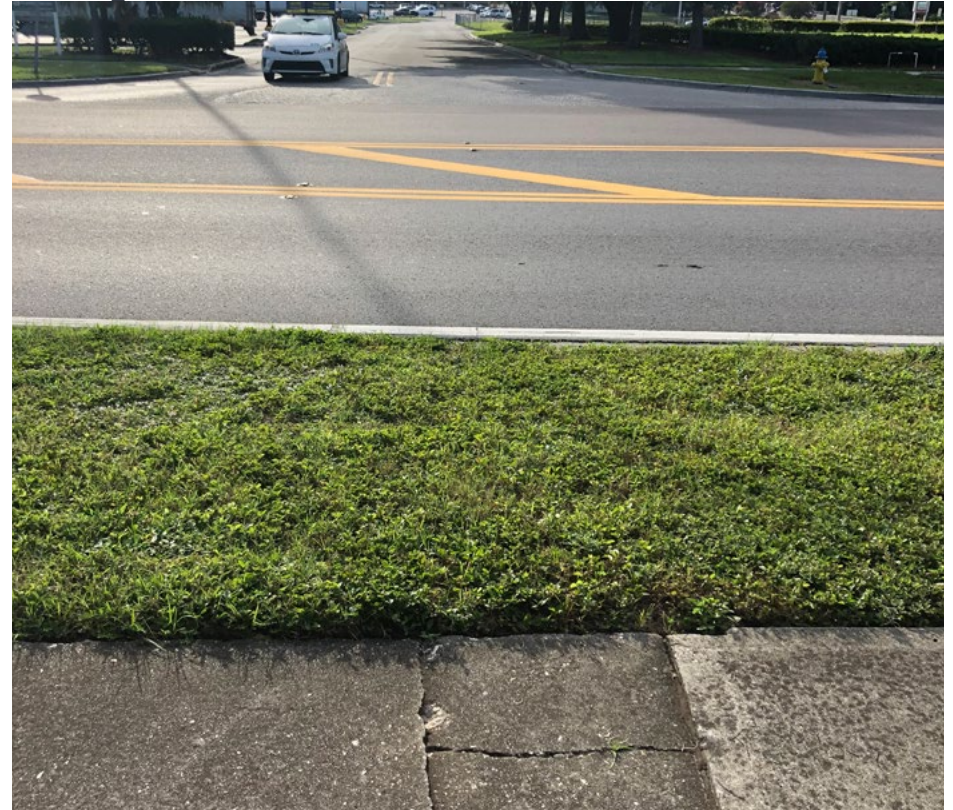
The southern access driveway to the Walmart shopping plaza is located on the east side of Mango Road approximately 280 feet from the SR 574 intersection. Between 2014 and 2018, five crashes including one rear end and two angle crashes were reported at the driveway.

The recommended safety improvements for the southern Walmart driveway consist of installing a concrete median in place of the existing striped median (**Figure 31**). The concrete median will limit access to and from the driveway to right turns in and right turns out. By prohibiting left turns into and out of the driveway, the conflict points between vehicles entering and exiting the driveway will be reduced. Hillsborough County is currently evaluating school zone upgrades to this section of the corridor.
