# Spruce Street Pedestrian and Bicycle Improvements Technical Memorandum

# Completed in Coordination with the Dale Mabry Pedestrian Overpass Technical Feasibility Analysis

## **Draft May 2017**

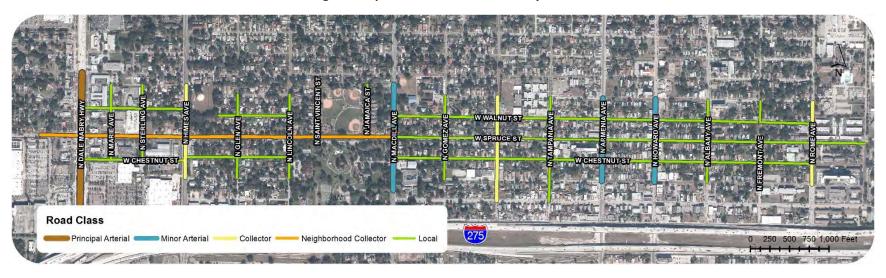
Figure 2: Spruce Street Corridor Roadway Classification

Roadways are grouped into classes according to the character of service they provide. Figure 2 illustrates the current roadway classes of the streets within the Spruce Street corridor. As shown, Spruce Street is divided into the following classes:

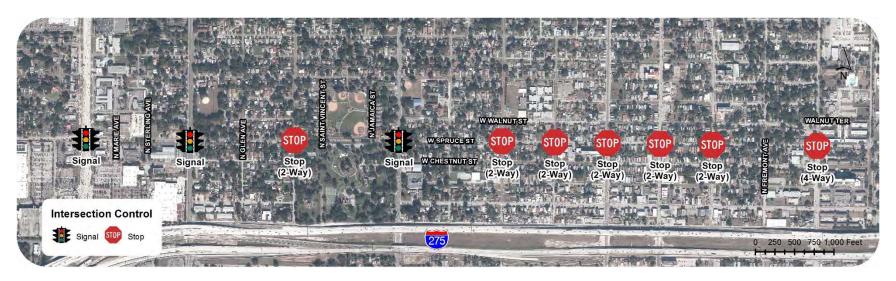
**Figure 3: Spruce Street Intersection Control**

Figure 3 illustrates the various intersection (stop) control types along the corridor. As shown, the signalized intersections along the corridor include Spruce Street at Dale Mabry Highway, Himes Avenue, and MacDill Avenue. At Rome Avenue, the intersection is completely stop-controlled with a four-way stop. The remaining intersections are two-way stop-controlled, with traffic along Spruce Street stopping at the intersections of Habana Avenue, Tampania Avenue, Armenia Avenue, Howard Avenue, and Albany Avenue.

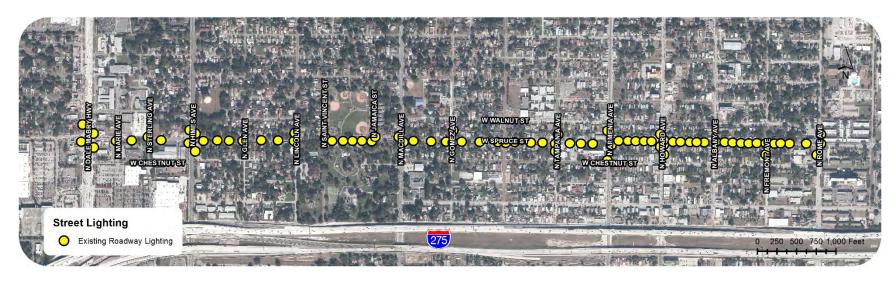
**Figure 4: Existing Street Lighting**

Existing overhead street lights were identified and mapped, as shown in Figure 4. For the most part, the presence and spacing of the existing overhead street lighting appears to be sufficient, especially for a more residential street such as Spruce Street. At the corridor-level, there appears to be sufficient street light coverage; a more detailed (qualitative) evaluation of street lighting at various intersections along the corridor was completed as part of this study.

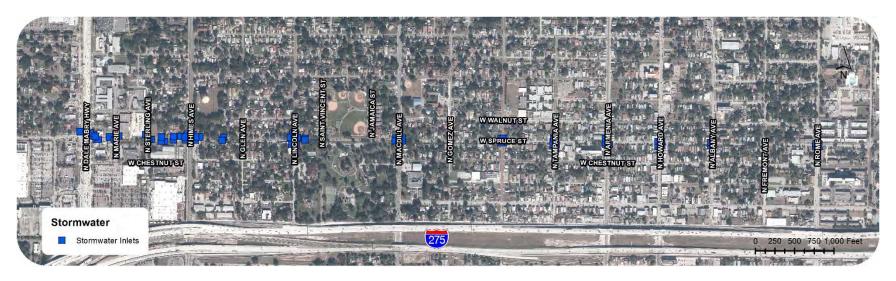
**Figure 5: Location of Existing Drainage Inlets**

Figure 5 shows the location of the existing stormwater inlets found along Spruce Street. Although not necessarily critical in the development of pedestrian and bicycle improvements, understanding the location of drainage inlets and how a recommendation may or may not impact that drainage helps in evaluating the feasibility of a recommendation.

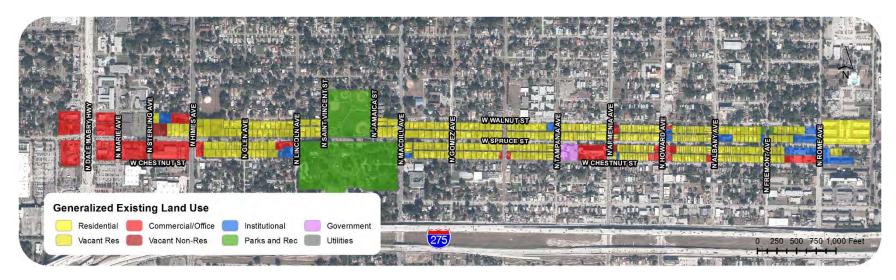
Figure 6: Existing Land Use

Existing land use, derived from Florida Department of Revenue (DOR) codes found in parcel data from the corridor, shows that most properties along Spruce Street are residential, with some commercial properties clustered primarily in the blocks between Dale Mabry Highway and Himes Avenue and around the intersections of Spruce Street at Armenia Avenue and Howard Avenue. Although not explicitly shown in Figure 6, the majority of the properties along Spruce Street are primarily single-family residential and have an average single-family home age in the study area of 57 years.

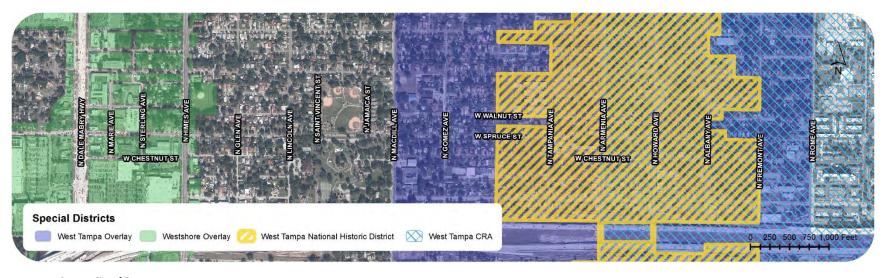
**Figure 7: Designated Special Districts**

There are multiple designated districts that fall within the Spruce Street corridor. Figure 7 shows the boundaries of these districts, which include the Westshore Overlay District, West Tampa Overlay District, West Tampa Community Redevelopment Area (CRA), and the Old West Tampa National Historic District. For the most part, these districts provide guidance on development and design elements and recognize the value and importance of enhancements that increase mobility options.

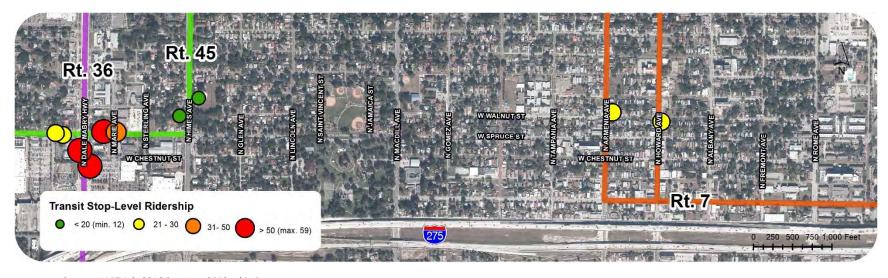
Figure 8: Transit Service and Ridership

Transit Service in the Spruce Street corridor is provided by Hillsborough Regional Transit Authority (HART) routes 7, 36, and 45. Figure 8 shows the extent of the transit service and average weekday ridership for the stops along and near the Spruce Street corridor. As shown, the area with the highest transit ridership is near the intersection of Spruce Street and Dale Mabry Highway, with approximately 270 people getting on or off of a bus near this intersection every day.

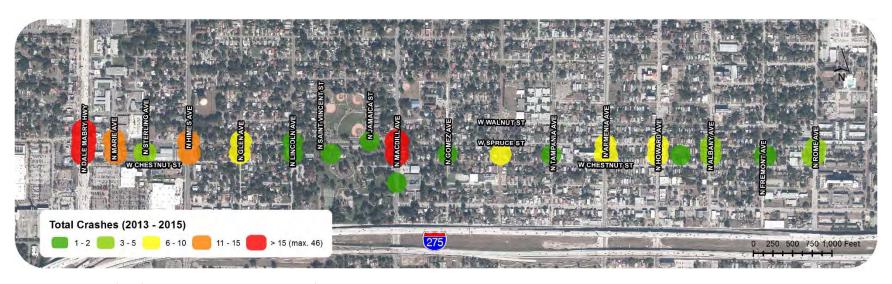
Figure 9: Total Crashes, Location, and Frequency

A three-year history of crashes within the corridor was analyzed using data extracted from the Crash Analysis Reporting System (CARS). During this analysis period, 143 crashes were reported within the corridor. Figure 9 shows the location and frequency of crashes within the corridor, indicating a concentration of crashes at the intersection of Spruce Street at Dale Mabry Highway and Spruce Street at MacDill Avenue. In total, there were zero fatal crashes, 9 incapacitating injury crashes, 20 non-incapacitating injury crashes, and 50 possible injury crashes. The most common crash types in the corridor were angle/left-turn crashes and rear-end crashes.

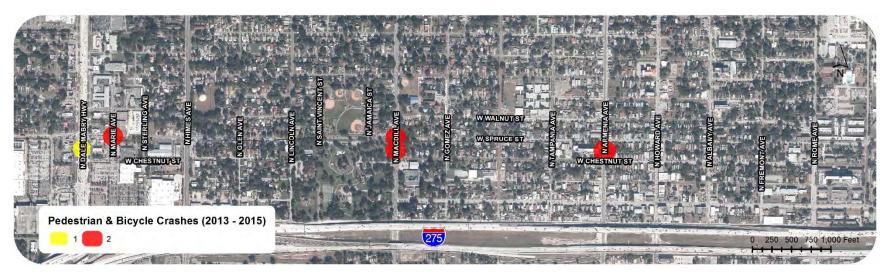
Figure 10: Pedestrian and Bicycle Crashes, Location, and Frequency

between 2013 and 2015 was conducted. Figure 10 shows the location and frequency of the one pedestrian and six bicycle crashes that occurred during the analysis timeframe. Five of the seven crashes were attributed to drivers failing to yield the right-of-way to pedestrians and bicyclists, one was the result of a vehicle traveling in the wrong direction to improperly pass a standing traffic queue, and one was the result of a bicyclist disregarding the traffic signal at Spruce Street and Dale Mabry Highway.

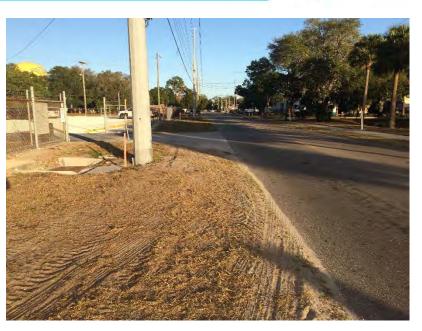
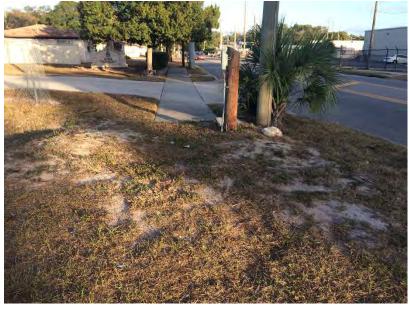
Figure 13: Existing Typical Section, Dale Mabry Highway to **Himes Avenue**

| Roadway Type: | Neighborhood Collector |
| Right-of-Way: | 60' |
| Pavement Width: | 22' |
| Road Edge Type: | Raised curb in first block, otherwise grass shoulder, no curb |
| Drainage: | Drainage swale along both sides; grate inlets along north side, open drainage along south side |
| Pedestrian<br>Facilities: | 5' sidewalk along south side, 5' sidewalk along<br>north side between Dale Mabry Hwy and<br>Marie Ave and small section east of Sterling<br>Ave |
| General<br>Observations: | Presence of electric/utility poles, especially high-voltage electric poles, along north side may present a challenge. Impacts to drainage will need to be carefully evaluated and mitigated. |

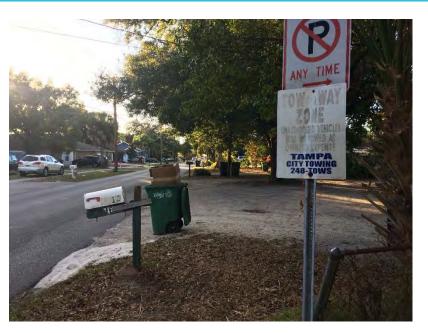
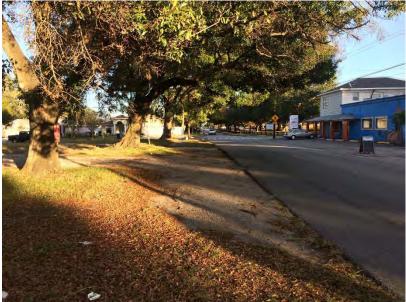
Figure 14: Existing Typical Section, Himes Avenue to **Lincoln Avenue**

| Roadway Type: | Neighborhood Collector |
| Right-of-Way: | 60' |
| Pavement Width: | 22' |
| Road Edge Type: | Grass shoulder, no curb |
| Drainage: | Swale with grate inlet drains along both sides |
| General<br>Observations: | Vegetation, including some larger trees, and personal property ROW encroachment along north side may present a challenge. Parking for commercial strip along south side west of Lincoln Ave may limit ability to continue sidewalk along south side. Impacts to drainage will need to be carefully evaluated and mitigated. |

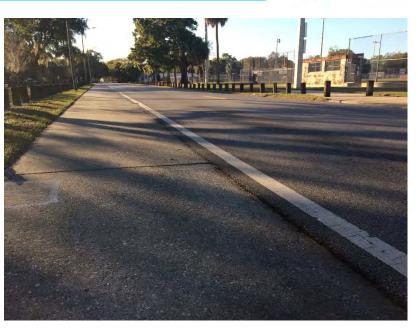
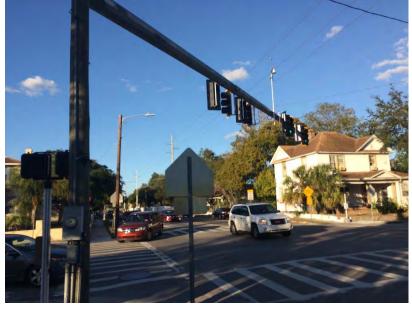
Figure 15: Existing Typical Section, Lincoln Avenue to MacDill Avenue

| Poadway Typo: | Naighbarhaad Callactor |
|---|--|
| Roadway Type: | Neighborhood Collector |
| Right-of-Way: | 60' |
| Pavement Width: | 20' |
| Road Edge Type: | St and Jamaica St; raised curb throughout |
| Drainage: | Curb inlets near Lincoln Ave and MacDill Ave |
| Osservations. | Spruce St and MacDill Ave appears to have been recently reconstructed along with addition of new LED intersection street lighting. |

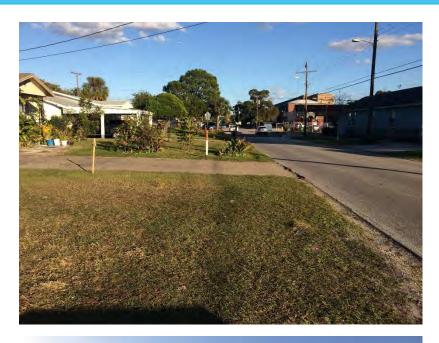
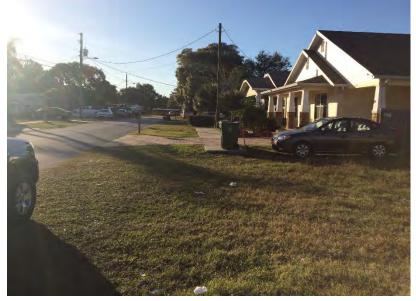
Figure 16: Existing Typical Section, MacDill Avenue to **Tampania Avenue**

| Roadway Type: | Local |
| Right-of-Way: | 60' |
| Pavement Width: | 22' |
| Road Edge Type: | Grass shoulder, no curb |
| Drainage: | Swale with inlets along side streets |
| Facilities: | 5' sidewalk along south side |

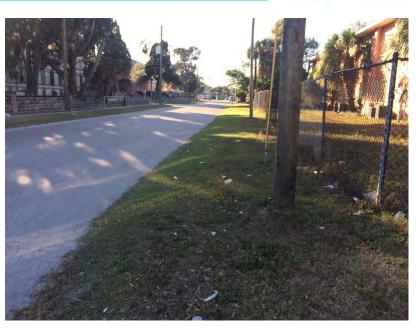
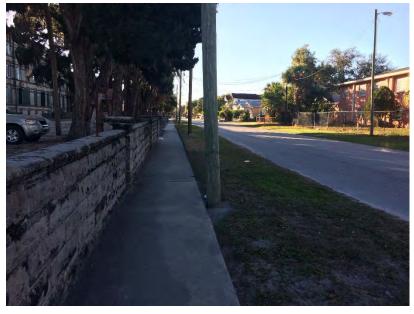
Figure 17: Existing Typical Section, Tampania Avenue to **Armenia Avenue**

| Roadway Type: | Local |
| Right-of-Way: | 60' |
| Pavement Width: | 26' |
| Road Edge Type: | Grass shoulder, no curb |
| Drainage: | Swale with inlets along side streets |
| Pedestrian | 5' sidewalk along south side, 6' sidewalk along |

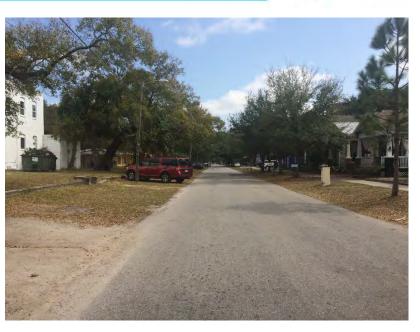
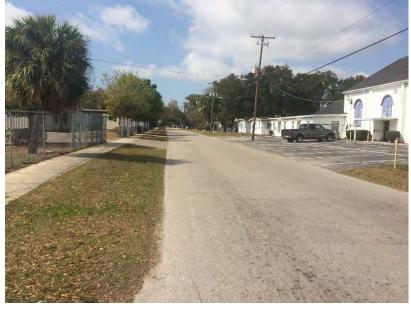
| Roadway Type: | Local |
|---|---|
| General<br>Observations: | Vegetation, including some larger trees, within ROW along north side may present challenges. Some on-street parking observed in segment. Fremont Ave dead-ends north of Spruce St; 8' path (part of Fremont Linear Park) continues north from dead-end along Fremont Ave ROW. |

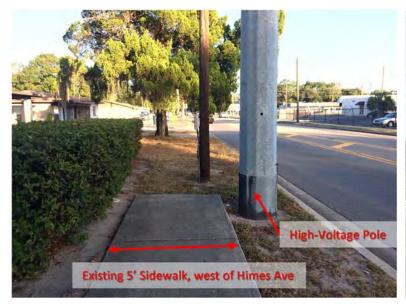
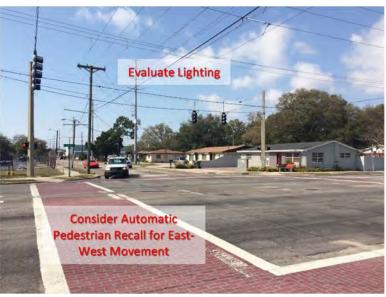
### 1. – Spruce Street from Dale Mabry Highway to Himes Avenue

| Ref. | Location | Description |
|---|---|--|
| 1.A.i | | <ul> <li>Consider constructing right-turn channelization islands within southeast and northwest quadrants of intersection to reinforce right-turn-only movements from northbound and southbound Dale Mabry Hwy onto Spruce St.</li> <li>During field visits, multiple drivers observed using right-turn-only as through lane to "jump" queues at intersection; poses potential safety concern; right-turn islands will help ensure that right-turn-only lane used as prescribed. Additionally, islands will help to reduce pedestrian crossing distance and exposure at intersection.</li> <li>Consider extending curb (construct bulb-outs) within northeast and southwest quadrants of the intersection in conjunction with construction of right-turn channelization islands in northwest and southeast quadrants of intersection.</li> </ul> |

| Ref. | Location | Description | Feasibility Review | Cost Estimate |
|---|---|---|--|---|
| 1.A.i | Spruce St at Dale Mabry Hwy | Consider constructing right-turn channelization islands within the southeast and northwest quadrants of the intersection to reinforce the right-turn only movements from northbound and southbound Dale Mabry Hwy onto Spruce St. During field visits multiple drivers were observed using the right-turn only as a through lane in order to "jump" queues at the intersection, this poses as a potential safety concern, the right-turn islands will help to ensure that the right-turn only lane is used as prescribed. Additionally, the islands will help to reduce pedestrian crossing distance and exposure at the intersection. | Cost estimate does not include potential impacts to | |

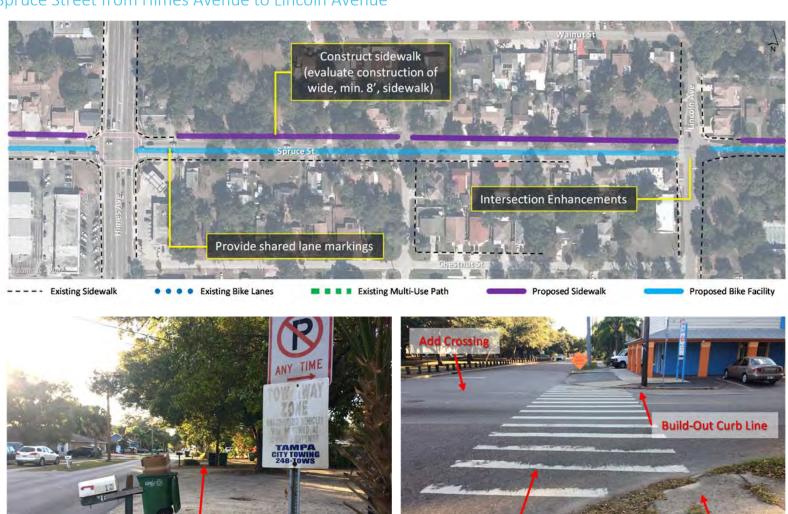
### 2. – Spruce Street from Himes Avenue to Lincoln Avenue

**Enhance Crosswalk Markings**

**Enhance Pedestrian**

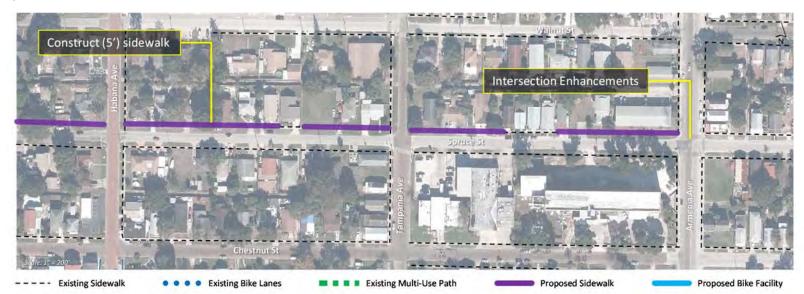
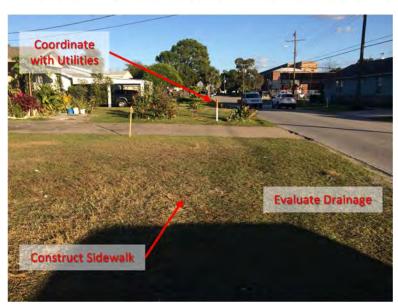
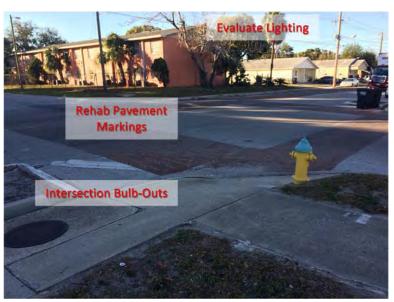
### 5. – Spruce Street from Habana Avenue to Armenia Avenue

| Ref. | Location | Description |
|---|---|---|
| | Spruce St at Armenia Ave | <ul> <li>Existing textured pattern pavement markings are worn and not very visible to drivers; consider<br/>rehabbing pavement markings and adding white parallel edge line crosswalk markings to<br/>improve crosswalk visibility.</li> </ul> |

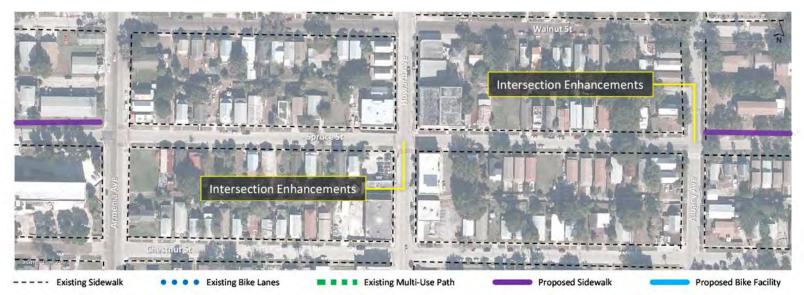
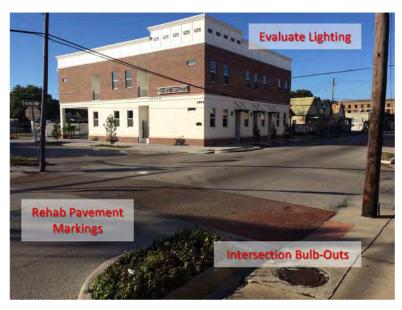
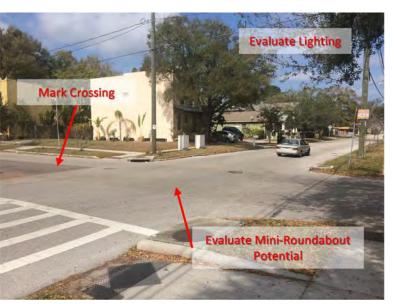
### 6. – Spruce Street from Armenia Avenue to Albany Avenue

| Ref. | Location | Description |
|---|---|---|
| 6.A.iv | | Textured pattern pavement markings are worn and are not very visible to drivers; consider |

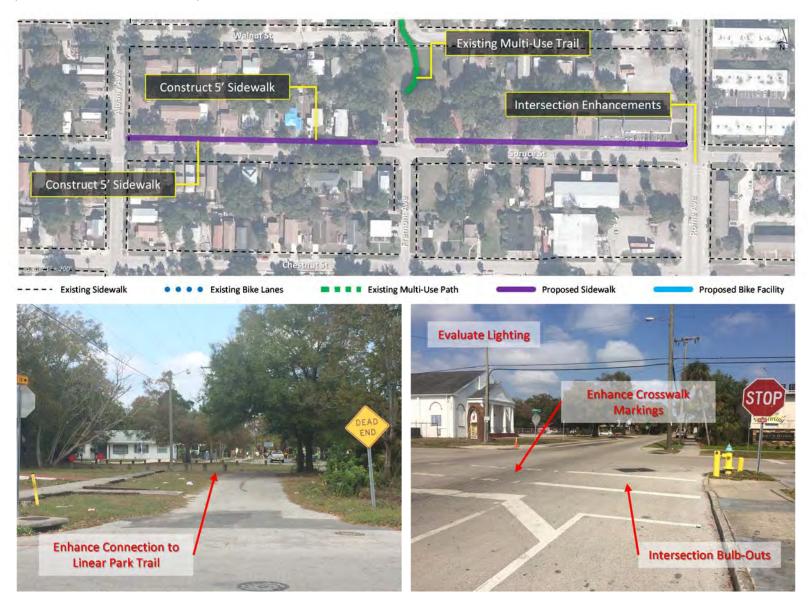
### 7. – Spruce Street from Albany Avenue to Rome Avenue

| Ref. | Location | Description |
|---|--|---|
| 7.C.i | | • Crosswalk markings across Rome Ave on southern leg of the intersection showing signs of wear; |
| 7.C.iv | | Evaluate intersection lighting conditions; only existing overhead street light located in northeast |

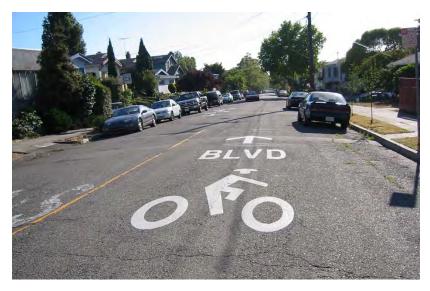
Figure 20: Example of a Bicycle Boulevard in Berkeley, CA

Bicycle boulevards are low-stress, low-speed shared roadways designed to encourage bicycle travel by offer priority treatments for bicyclists operating within a roadway shared with motor vehicles. Bicycle boulevards typically are located along neighborhood streets and may include traffic calming design treatments (speed cushions, pinch-points, chicanes, curb extensions, etc.), special signing, pavement markings (see Figure 20), traffic diversion, and intersection crossing treatments. The intention of a bicycle boulevard is to provide a comfortable, convenient, and attractive environment for bicyclists and pedestrians of all ages and experience.

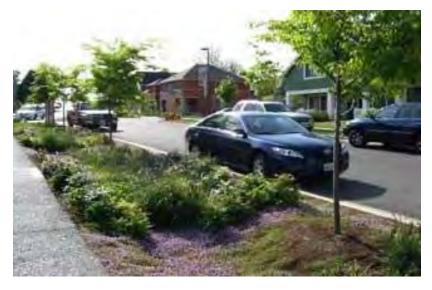
Figure 21: Bioswale along a Residential Street

A bioswale is a drainage treatment that uses a shallow depression to capture and treat stormwater before it enters into the sewer system and/or waterways. Unlike traditional stormwater drainage systems that are designed to quickly move water away from a location, bioswales often are designed to slow the flow of stormwater, which allows the water to be filtered and allows for the infiltration of some water back into the local water table before entering the sewer system. Bioswales often are filled with native plantings and an opengraded layer of rock beneath the plantings to help with erosion, which also facilitate filtration and the movement of water. Figure 21 shows an example of an existing bioswale located between the curb and sidewalk along a residential street. Using green infrastructure such as a bioswale can create healthier urban environments by mimicking the processes found in nature that help to reduce water pollution, runoff, and localized flooding.

Installing a bioswale along Spruce Street could be done as an alternative to installing a traditional urban curb and gutter system or could possibly be incorporated into the existing drainage system. Beyond the environmental benefits, a bioswale system could provide an opportunity to provide landscaping along Spruce Street that could help to enhance the walking and bicycling environment. As with the other options discussed in this section, community input and acceptance should be sought before moving forward with any actual plans for a bioswale along Spruce Street.

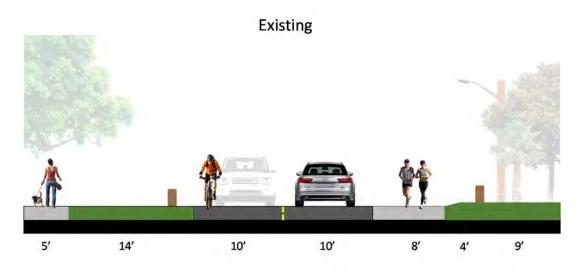
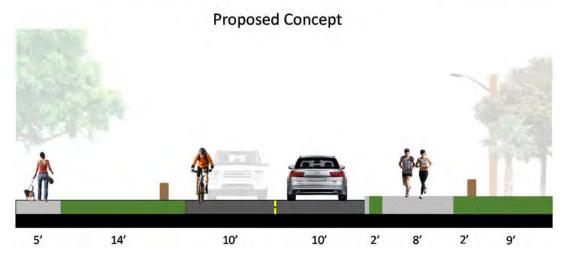
### Sidewalk Enhancements (Ref. # 3.C)

Install raised curb and rebuild sidewalk 2' to south using 4' of space between existing sidewalk and bollards. This provides 2' buffer (includes curb) between street and sidewalk and sidewalk and bollards.
