Hillsborough MPO | Hillsborough County

Fletcher Avenue Vision Zero Corridor Study

Technical Memorandum

February 2021

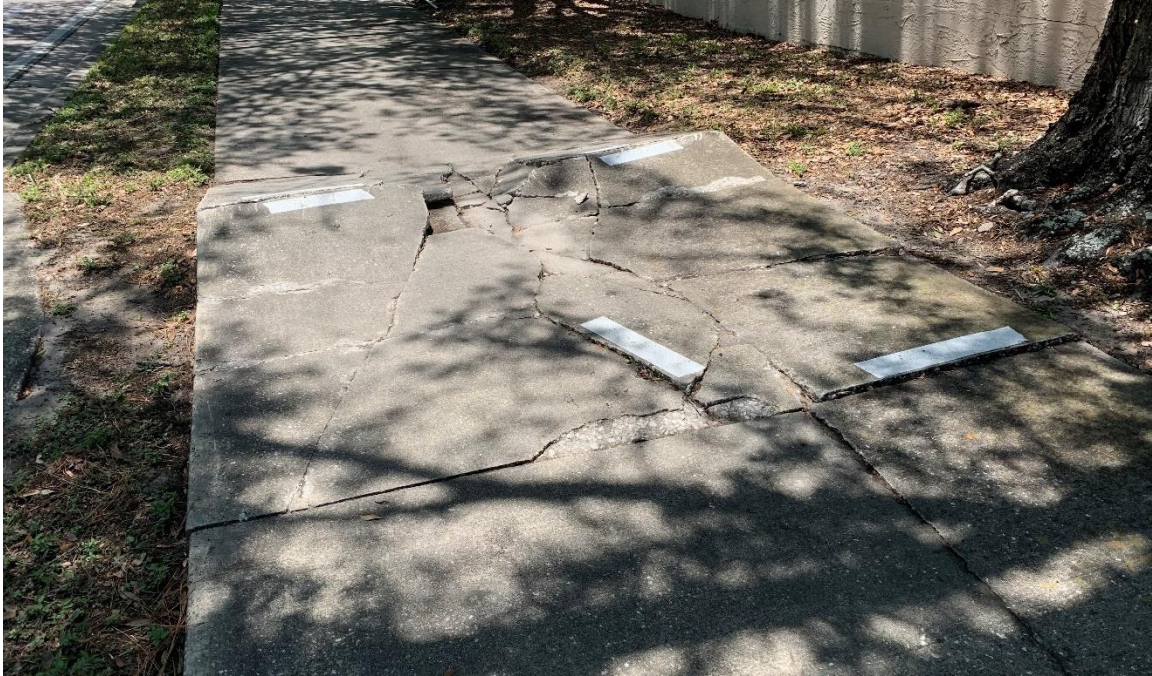
Cracked Sidewalk along the north side of Fletcher Avenue

- **Sidewalks** – are present along both sides of the roadway and are in fairly good condition with a few noticeable maintenance needs, largely related to tree root heaving and cracking. The sidewalk along the north side of Fletcher Avenue between Florida Avenue and Armenia Avenue appears to be a consistent 8' wide sidewalk; while not meeting the design standards of a shared use path, this sidewalk width can more comfortably accommodate both pedestrians and bicyclists compared to a typical 5' sidewalk.

An audit of existing sidewalk condition should be conducted to assist in identifying, programming, and completing crucial maintenance needs such as heaved, cracked, or obstructed sidewalks. A review of existing pavement markings should also be performed to increase visibility of items such as stop bars or lane markings.

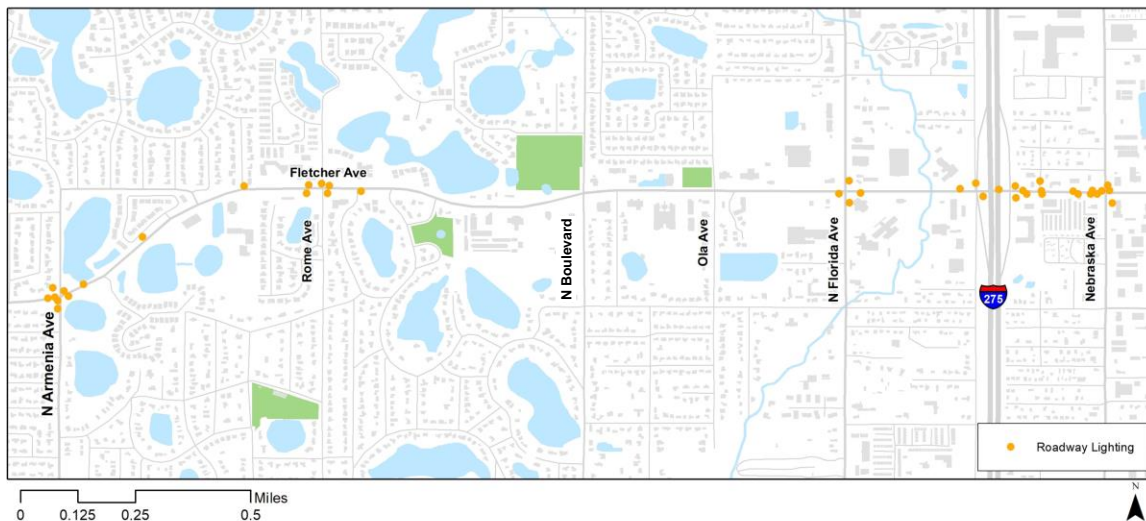
Figure 8: Existing Roadway Lighting

Roadway lighting is present at most of the major intersections along the corridor, with an exception at North Boulevard and Ola Avenue. There is existing lighting spaced along the corridor (Figure 8), while a formal lighting analysis was not conducted it does appear that there could be opportunities to further enhance roadway lighting along Fletcher Avenue utilizing existing utility poles.

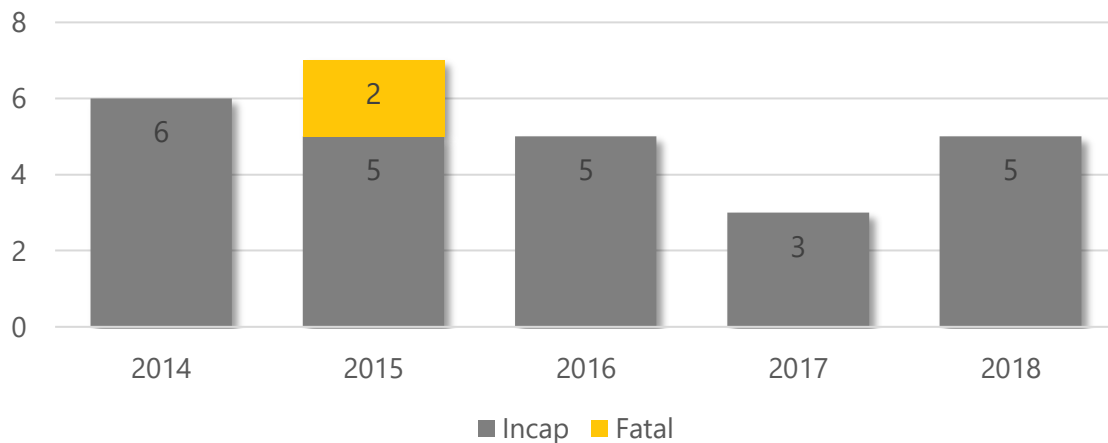
While the evaluation of total crashes provides a sense of the overall safety issues along the corridor, the fundamental principle of Vision Zero is the elimination of fatal and serious injury crashes. During the five-year analysis period there were a total of 26 serious injury crashes along Fletcher Avenue or 2.8% of the total crashes. Two of the serious injury crashes resulted in a fatality with 24 resulting in an incapacitating injury. Figure 27 shows the annual distribution of the serious injury crashes along Fletcher Avenue. As shown, 2015 experienced the highest number of serious injury crashes, including the two fatal crashes. Figure 28 shows the location and frequency of the serious injury crashes. 11 (42%) of the serious injury crashes occurred at or near the intersection of Fletcher Avenue and Nebraska Avenue, with the other serious injury crashes mostly located at the signalized intersections along the corridor. The fatal crashes occurred at Armenia Avenue and west of Florida Avenue.

Figure 27: Serious Injury Crash Annual Distribution

Figure 28: Serious Injury Crash Frequency

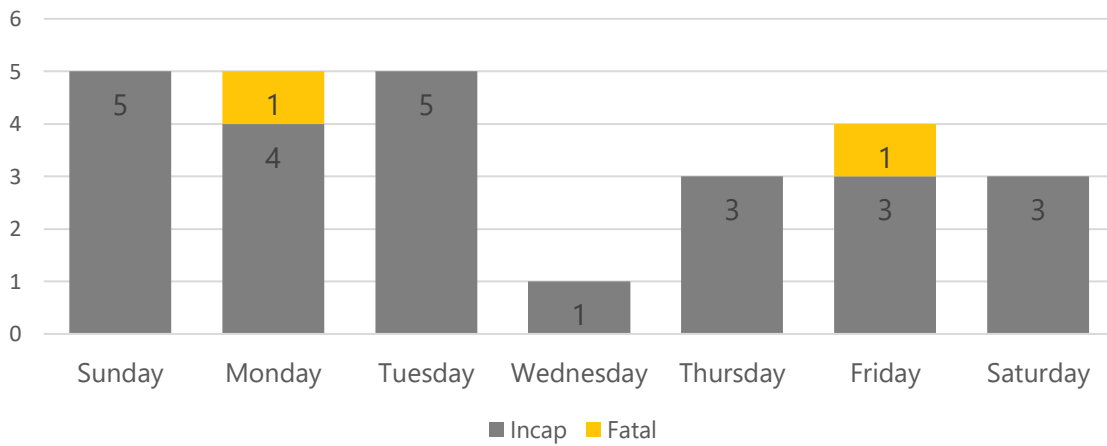
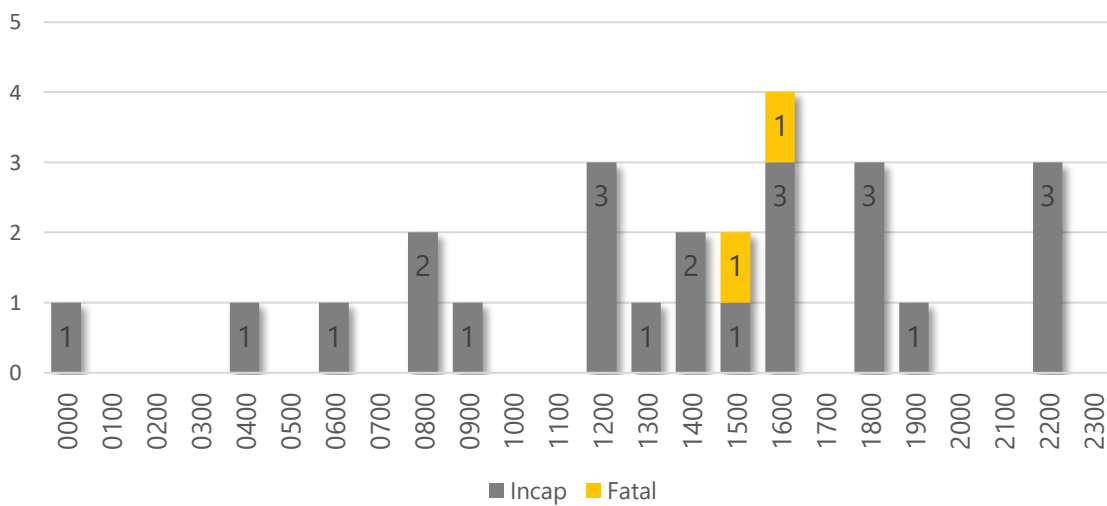
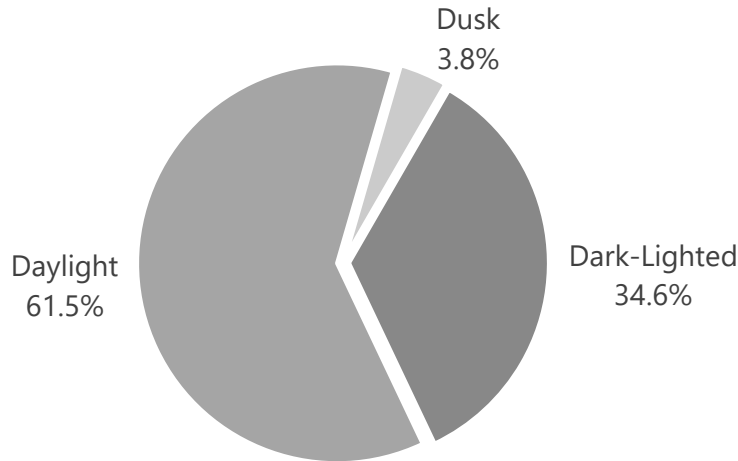
As with the total crashes, contributing crash factors were analyzed to better understand the trends and causes of the corridor’s serious injury crashes. Figure 29 shows the serious injury crashes by month of occurrence, as shown the months with the most serious injury crashes were March and June, each with 4 – both fatal crashes occurred during the month of June. Between 2014 and 2018 there were no serious injury crashes in the months of January and September (September was the month with the highest frequency of total crashes). Figure 30 shows the frequency of serious injury crashes by day of the week, Sunday, Monday, and Tuesday all had the most crashes with each having five. The 4:00 PM hour (Figure 31) had the most serious injury crashes with 4, followed by the 12:00 PM, 6:00 PM, and 10:00 PM hours each with 3 crashes. Additionally, serious injury crashes by lighting condition were evaluated (Figure 32), the data showed that 61.5% of the serious injury crashes occurred during daylight conditions, 3.8% during dusk conditions, and 36.4% during dark conditions with lighting. Considering that 77.1% of the total crashes occurred during daylight conditions, this evaluation shows that fewer serious injury crashes are occurring during the day and that lighting conditions in the darker hours may be a factor in causing serious injury crashes.

Figure 29: Serious Injury Crashes by Month

Figure 30: Serious Injury Crashes by Day of the Week

Figure 31: Serious Injury Crashes by Time of Day

Figure 32: Serious Injury Crashes by Lighting Conditions

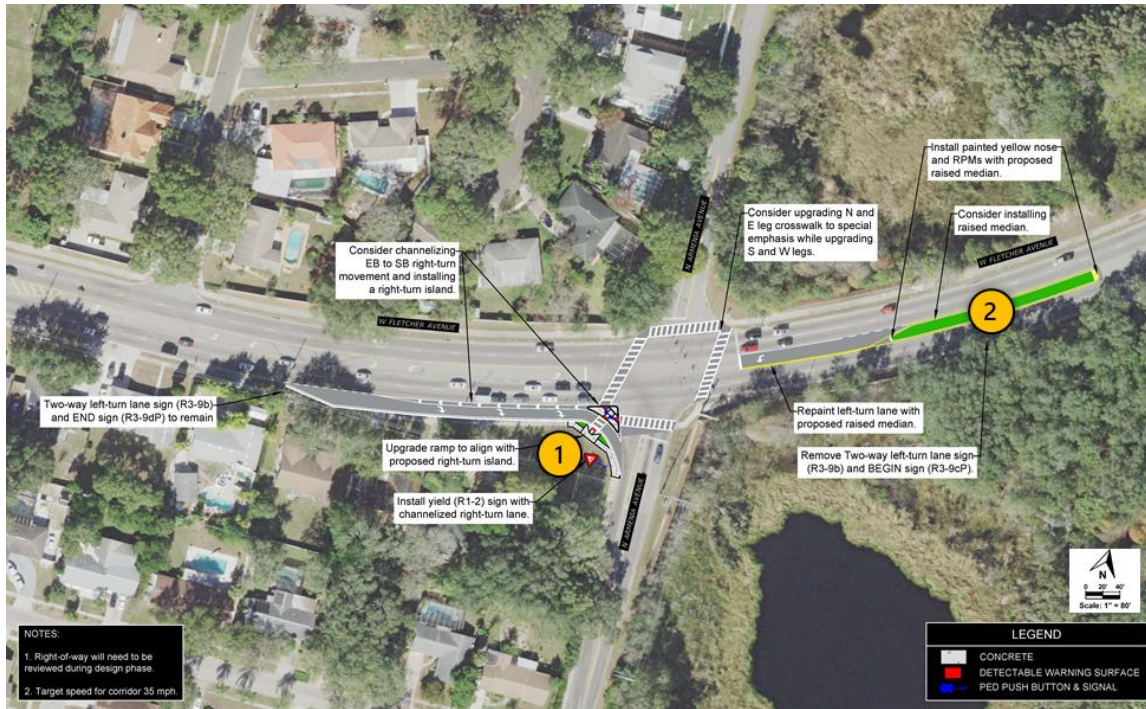
Figure 38: Site-Specific Opportunities – Sheet 1

ID	Location	Suggestion for Consideration	Timeframe
1	Fletcher Ave at Armenia Ave	Consider channelizing the eastbound-to-southbound right-turn movement and installing a raised right-turn island. Consider realigning the crosswalk along the west leg of the intersection to align with the new raised island.	Mid-Term
2	Fletcher Ave, Approximately 300' east of Armenia Ave to Greengage Ln	Consider constructing a raised median island.	Mid-Term

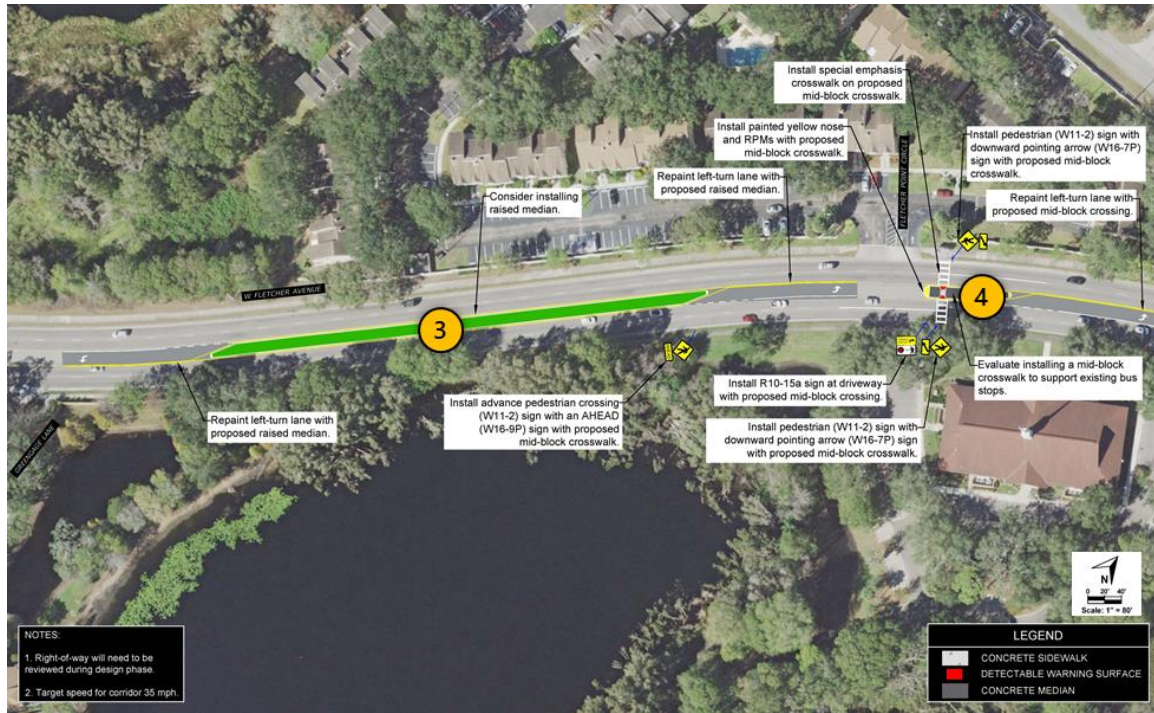
Figure 39: Site-Specific Opportunities – Sheet 2

ID	Location	Suggestion for Consideration	Timeframe
3	Fletcher Ave, approximately 250' east of Greengage Ln to approximately 250' west of Fletcher Point Cir	Consider constructing a raised median island.	Mid-Term
4	Fletcher Ave, Fletcher Point Cir to 200' west of Magdalene Shores Ave	Consider constructing a raised median island. Additionally, consider conducting a pedestrian crossing study to determine the feasibility of installing a mid-block crosswalk that could support crossings near the existing bus stops.	Mid-Term

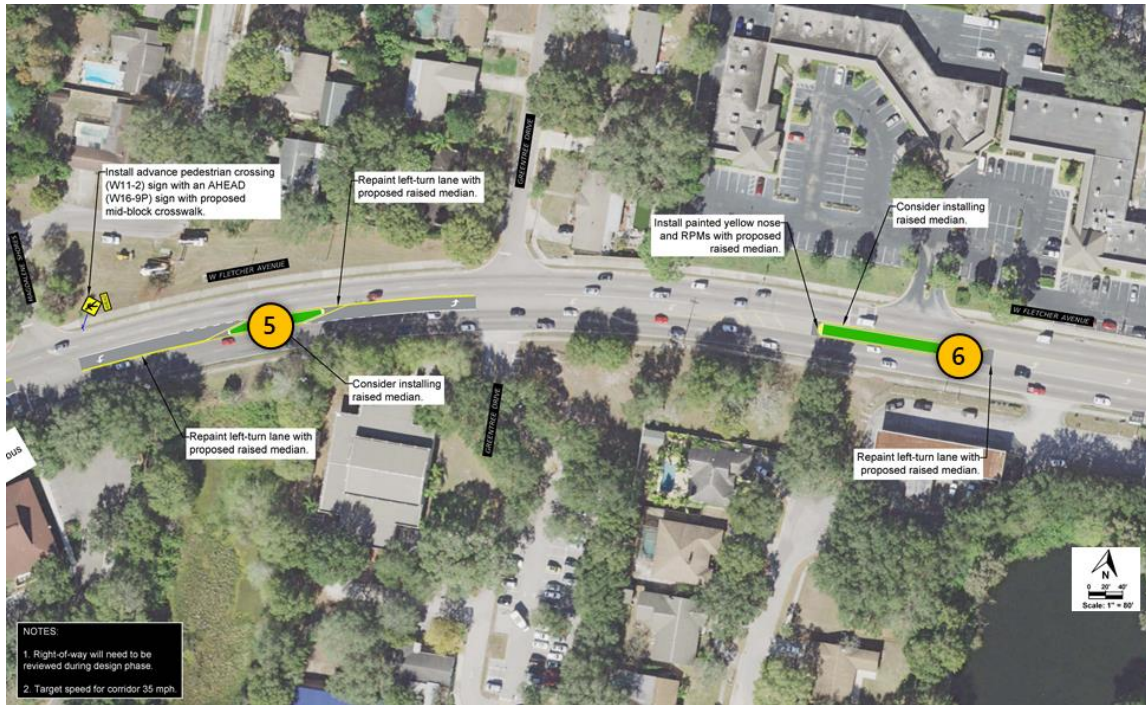
Figure 40: Site-Specific Opportunities – Sheet 3

ID	Location	Suggestion for Consideration	Timeframe
5	Fletcher Ave, halfway between Magdalene Shores Ave and Greentree Dr	Consider constructing a raised median island.	Mid-Term
6	Fletcher Ave, approximately 250' west of Rome Ave	Consider constructing a raised median island.	Mid-Term

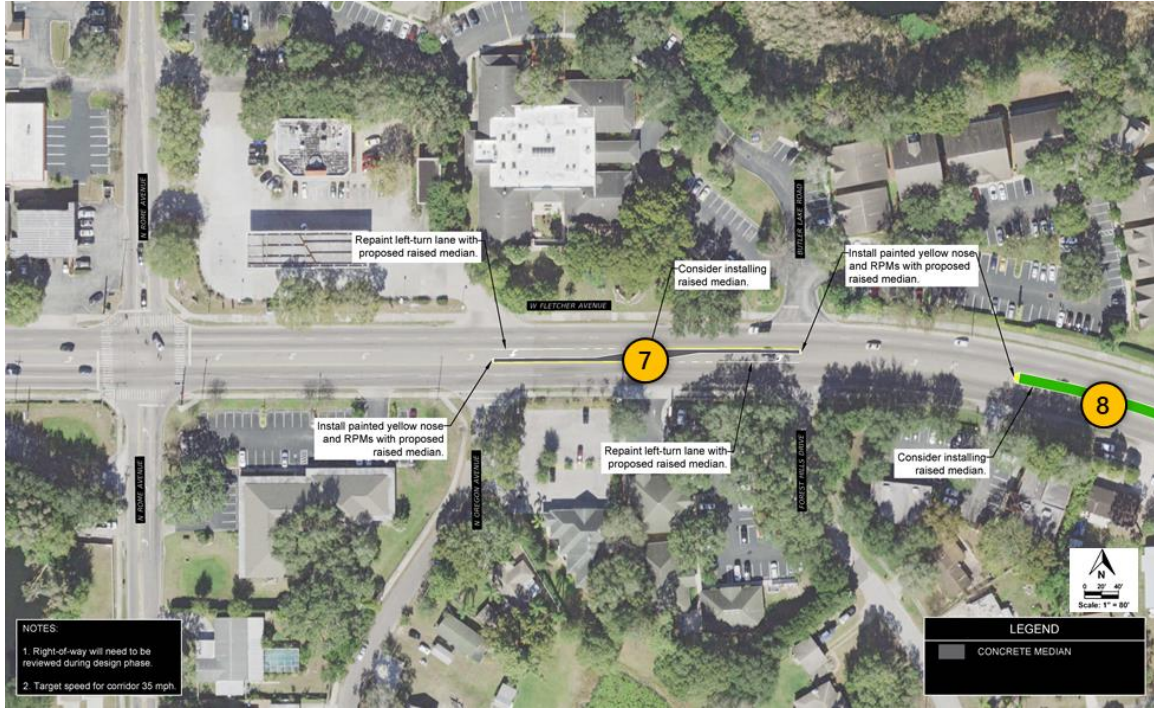
Figure 41: Site-Specific Opportunities – Sheet 4

ID	Location	Suggestion for Consideration	Timeframe
7	Fletcher Ave, halfway between Oregon Ave and Forest Hills Dr	Consider constructing a raised median island.	Mid-Term
8	Fletcher Ave, approximately 300' to 600' east of Forest Hills Dr	Consider constructing a raised median island.	Mid-Term

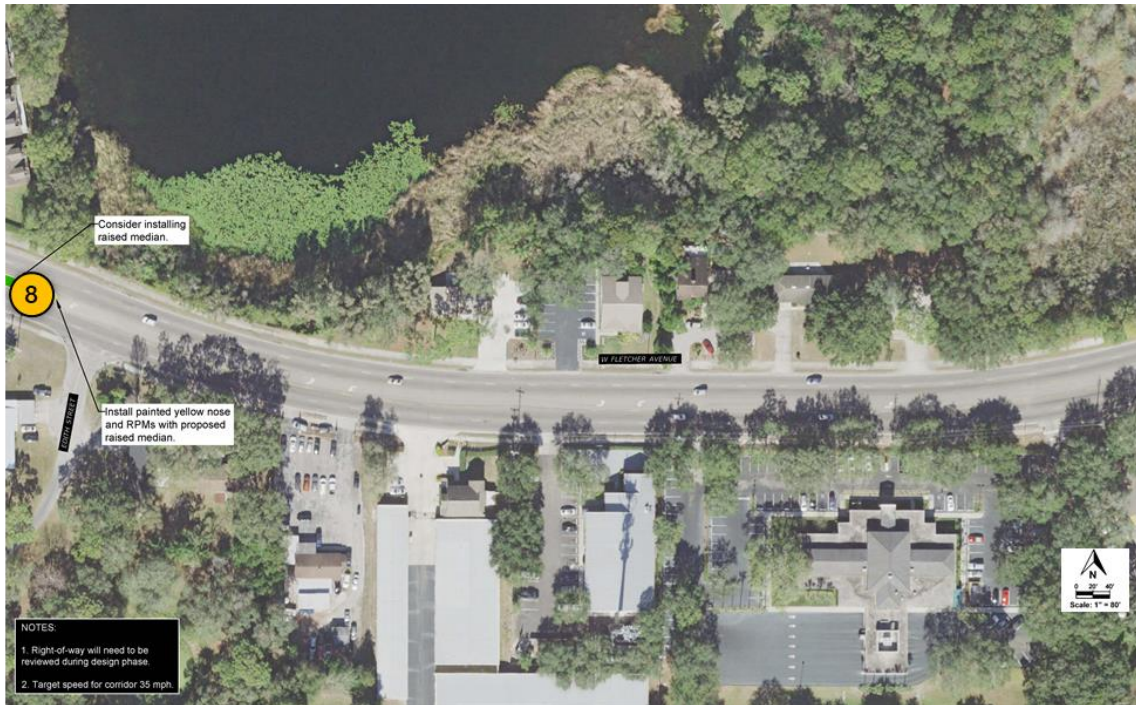
Figure 42: Site-Specific Opportunities – Sheet 5

ID	Location	Suggestion for Consideration	Timeframe
8	Fletcher Ave, approximately 300' to 600' east of Forest Hills Dr	Consider constructing a raised median island.	Mid-Term

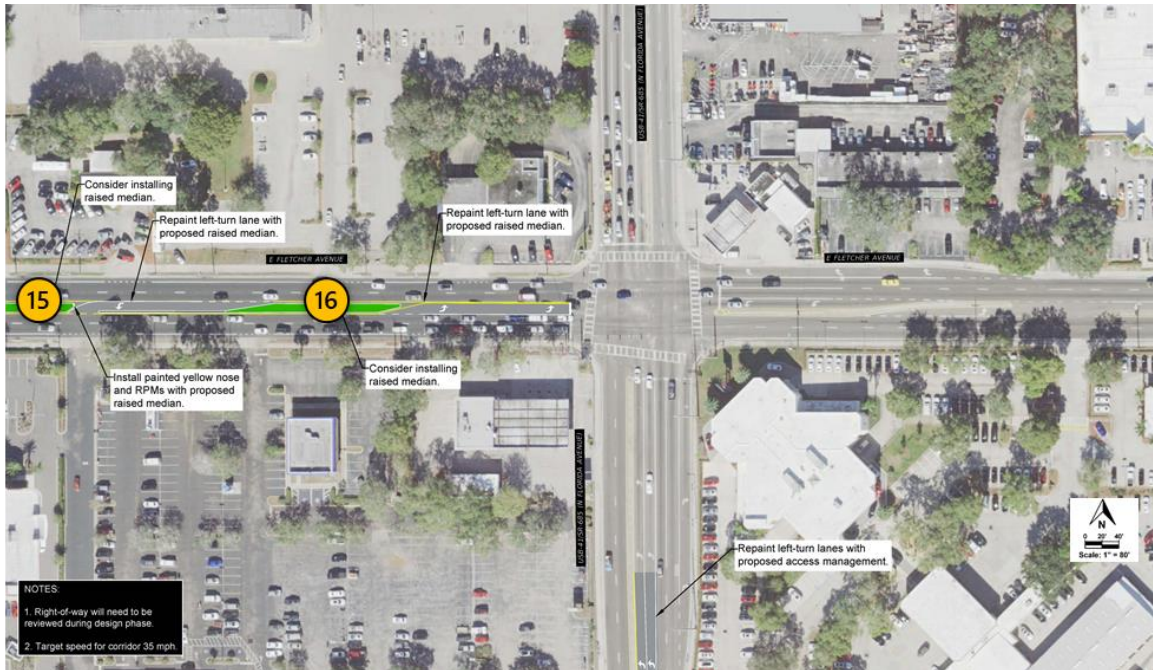
Figure 45: Site-Specific Opportunities – Sheet 8

ID	Location	Suggestion for Consideration	Timeframe
15	Fletcher Ave, from approximately 630' to 540' west of Florida Ave	Consider constructing a raised median island.	Mid-Term
16	Fletcher Ave, from approximately 325' to 400' west of Florida Ave	Consider constructing a raised median island.	Mid-Term

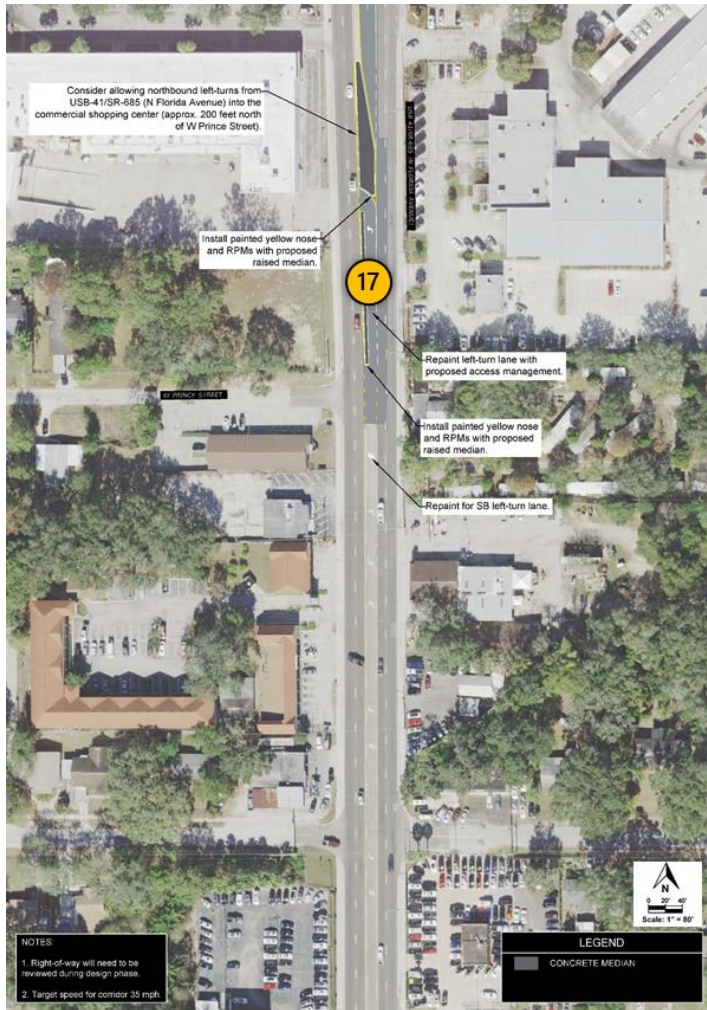
Figure 46: Site-Specific Opportunities – Sheet 9

ID	Location	Suggestion for Consideration	Timeframe
17	Florida Ave, south of Fletcher Ave	Consider coordinating with FDOT to evaluate allowing northbound left turns from Florida Ave into the commercial shopping center (approximately 200' north of Prince St) in the southwest quadrant of the intersection; this could help to reduce the number of northbound to westbound left turns onto Fletcher Ave and reduce the number of vehicles making an immediate left turn into the shopping center after turning onto Fletcher Ave.	Mid-Term

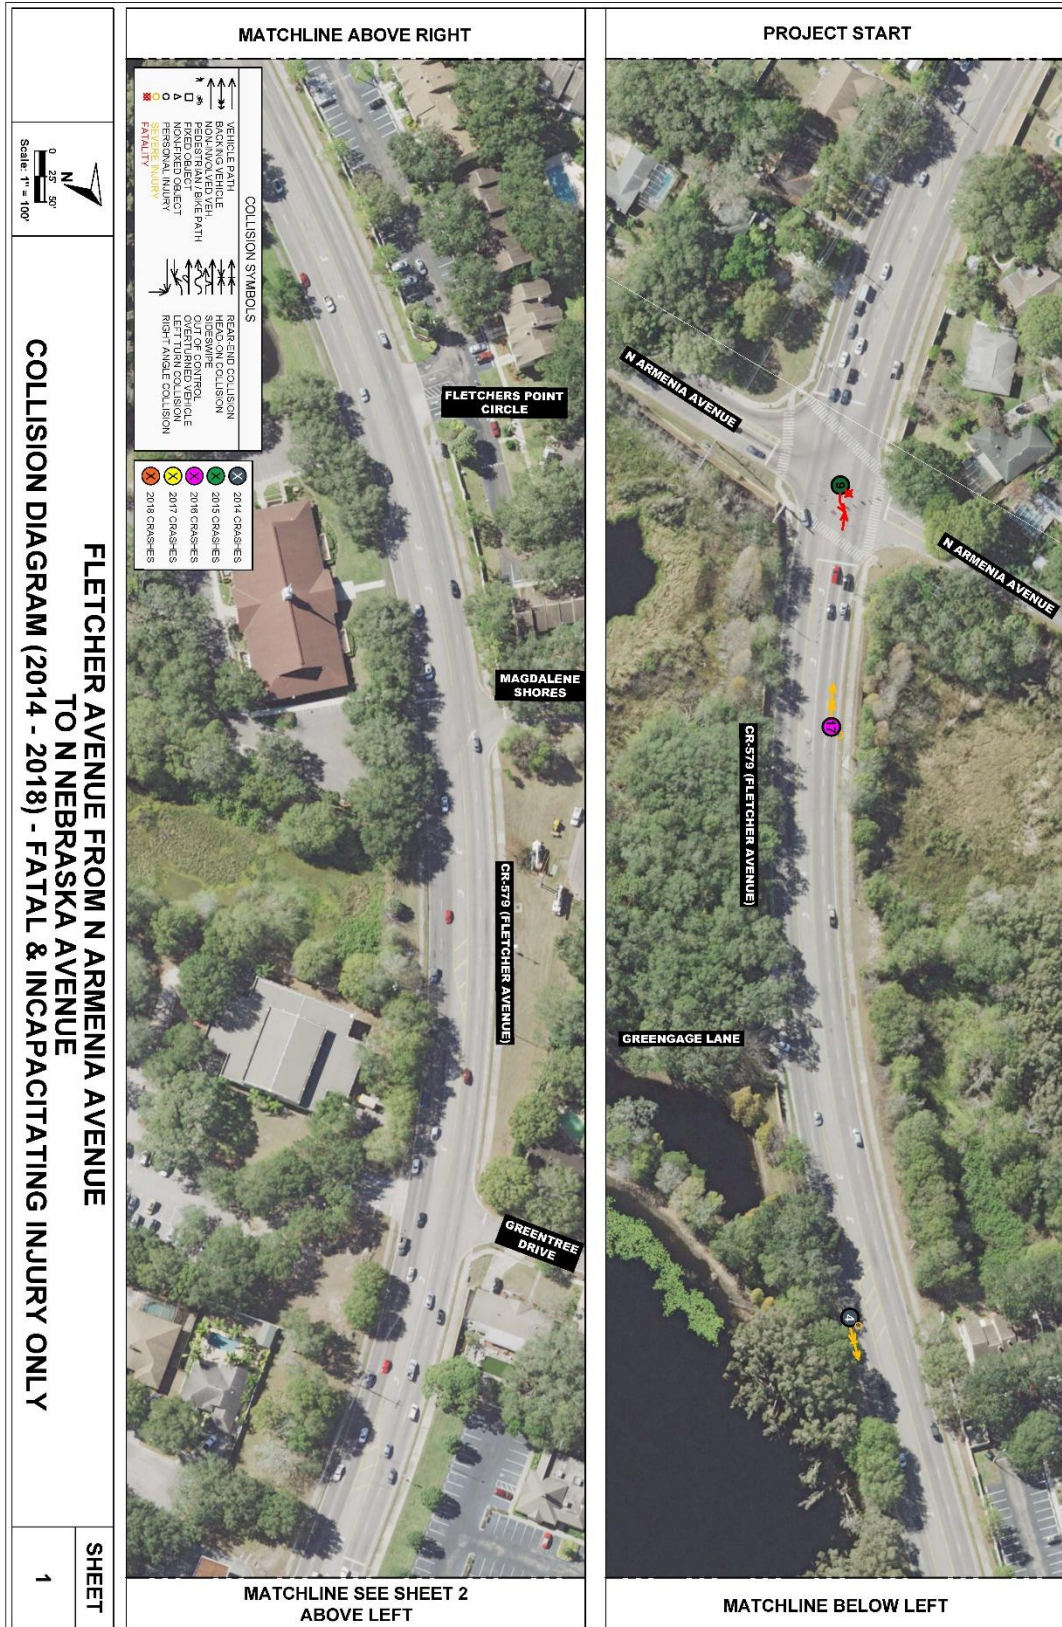
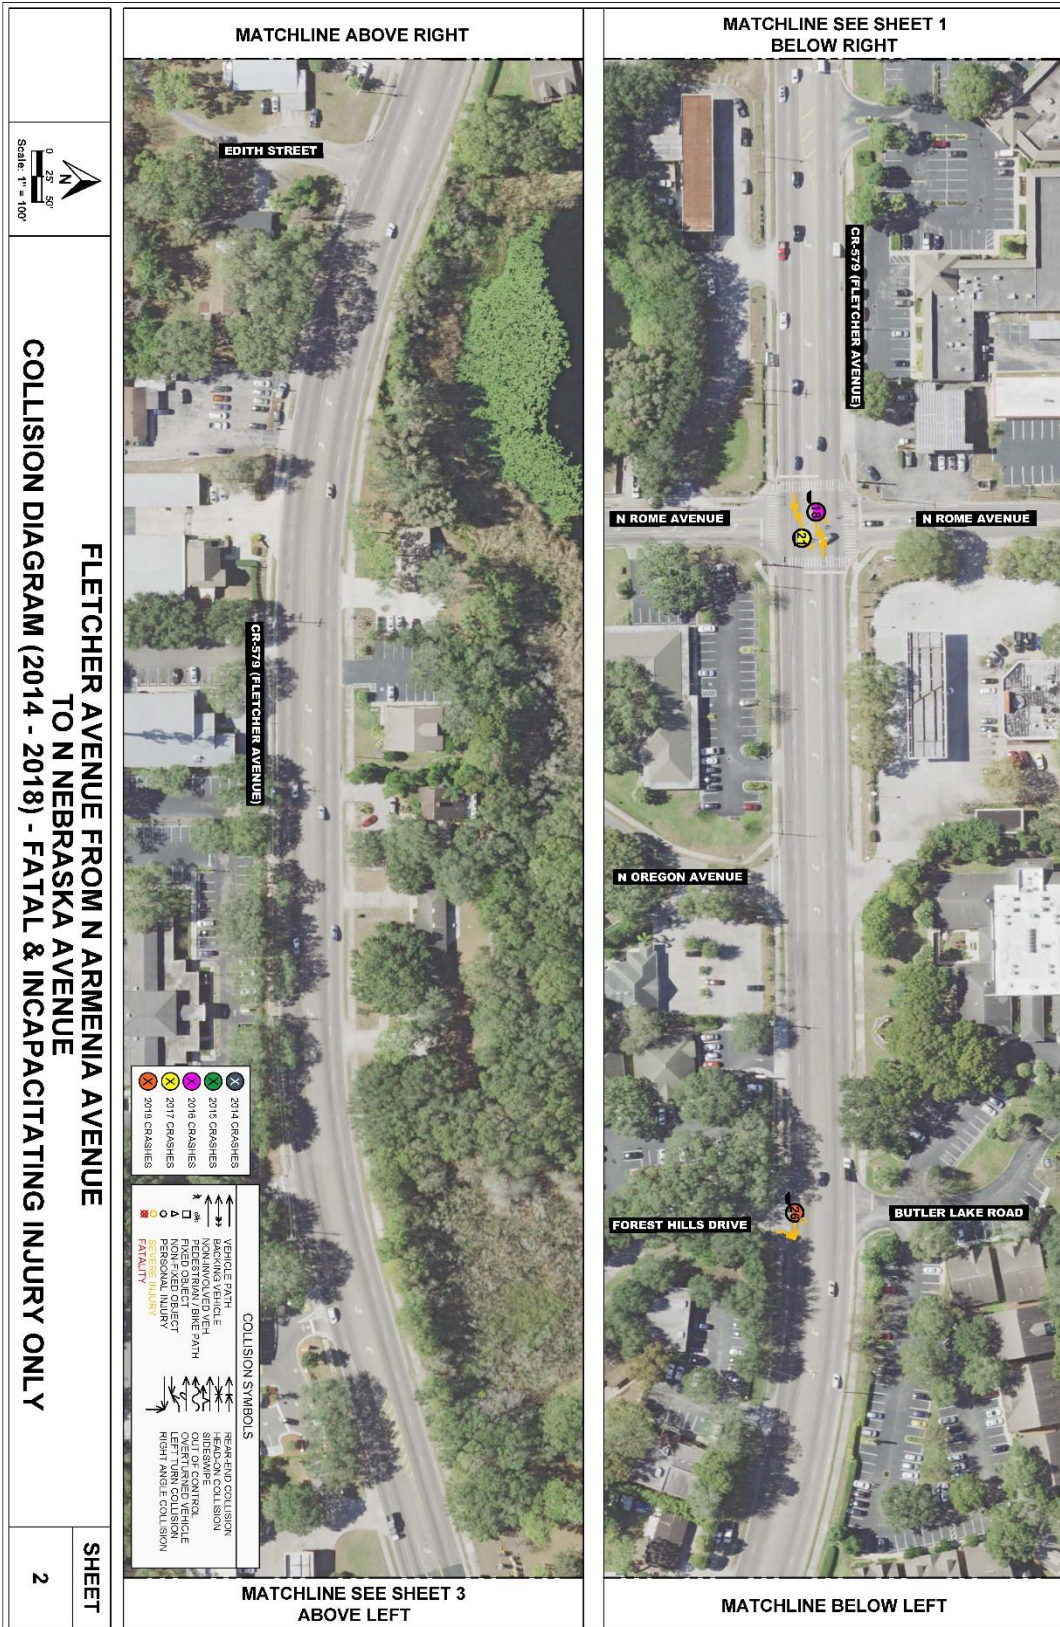
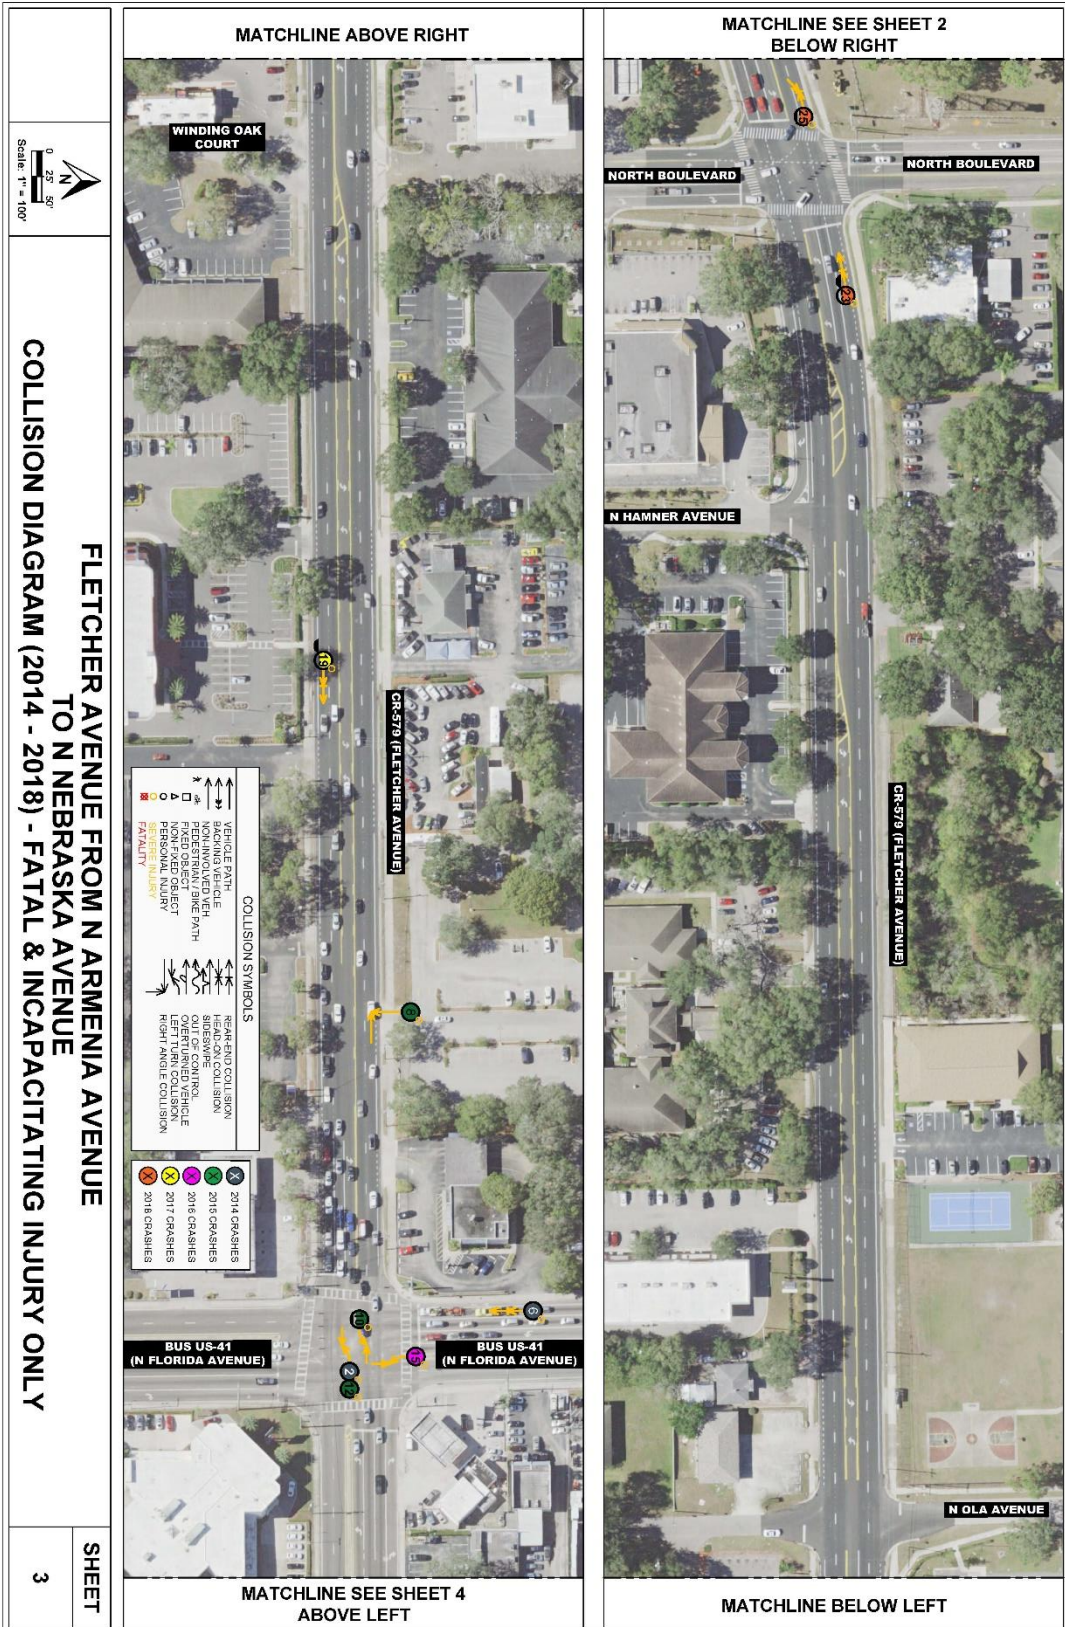
Appendix B: Severe Injury Crash Collision Diagrams

ID	Date	Day	Time	Crash Type	Contributing Cause
1	2/8/14	Saturday	2215	Left Turn	Ran Red Light
2	3/2/14	Sunday	1440	Left Turn	Failed to Yield Right-of-Way
3	3/29/14	Saturday	2235	Left Turn	Not Coded
4	5/15/14	Thursday	0805	Rear End	Operated MC in Careless or Negligent Manner
5	10/15/14	Wednesday	1258	Hit Fixed Object	Operated MC in Careless or Negligent Manner
6	12/30/14	Tuesday	1309	Rear End	Operated MC in Careless or Negligent Manner
7	2/8/15	Sunday	1539	Left Turn	Failed to Yield Right-of-Way
8	6/8/15	Monday	1617	Angle	Failed to Yield Right-of-Way
9	6/12/15	Friday	1540	Left Turn	Failed to Yield Right-of-Way
10	6/21/15	Sunday	1211	Left Turn	Failed to Yield Right-of-Way
11	7/31/15	Friday	0635	Pedestrian	No Contributing Action
12	10/23/15	Friday	0457	Left Turn	Failed to Yield Right-of-Way
13	11/17/15	Tuesday	1210	Rear End	Operated MC in Careless or Negligent Manner
14	4/21/16	Thursday	2238	Left Turn	Failed to Yield Right-of-Way

15	7/31/16	Sunday	0006	Left Turn	Not Coded
16	8/6/16	Saturday	2035	Pedestrian	Other Contributing Actions
17	12/2/16	Friday	1907	Rear End	Operated MC in Careless or Negligent Manner
18	12/26/16	Monday	0914	Left Turn	Improper Passing
19	4/13/17	Thursday	0835	Rear End	Operated MC in Careless or Negligent Manner
20	5/1/17	Monday	1445	Rear End	Followed too Closely
21	6/26/17	Monday	1640	Left Turn	Failed to Yield Right-of-Way
22	3/4/18	Sunday	1935	Bike	No Contributing Action
23	3/13/18	Tuesday	1908	Rear End	Operated MC in Careless or Negligent Manner
24	7/23/18	Monday	1642	Rear End	Operated MC in Careless or Negligent Manner
25	8/7/18	Tuesday	1825	Head On	Wrong Side of Wrong Way
26	10/9/18	Tuesday	1637	Right Turn	Failed to Yield Right-of-Way
