Vision Zero

Corridor Studies

Vision Zero Corridor Studies

North 15th Street

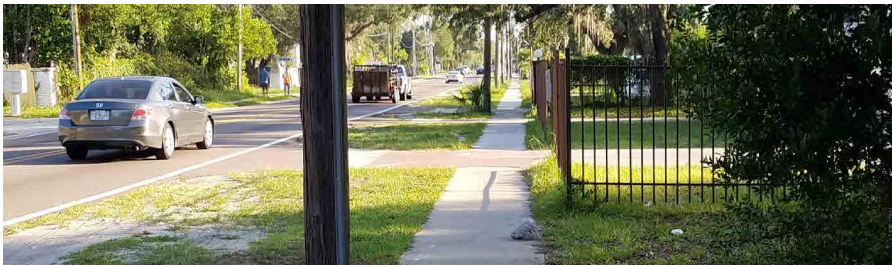
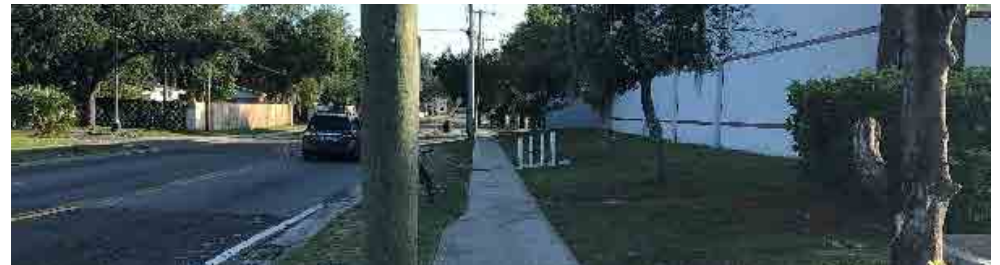
Figure 2 - Sidewalk Existing Conditions

Multimodal facilities on North 15th Street include a continuous sidewalk ranging from four to five feet wide on the east side of the roadway. On the west side, there is fragmented sidewalk ranging from four to five feet wide.

The gaps in the sidewalk on the west side are located between the Hillsborough Area Regional Transit Authority (HART) bus stops at East 124th Avenue and south of Villena Avenue (approximately 700 feet), between Millerman Pines Drive and East 131st Avenue (approximately 340 feet), and between East 131st Avenue and Fletcher Avenue (approximately 1,250 feet) **(Figure 2)**. Dedicated bicycle facilities are not provided along the corridor.

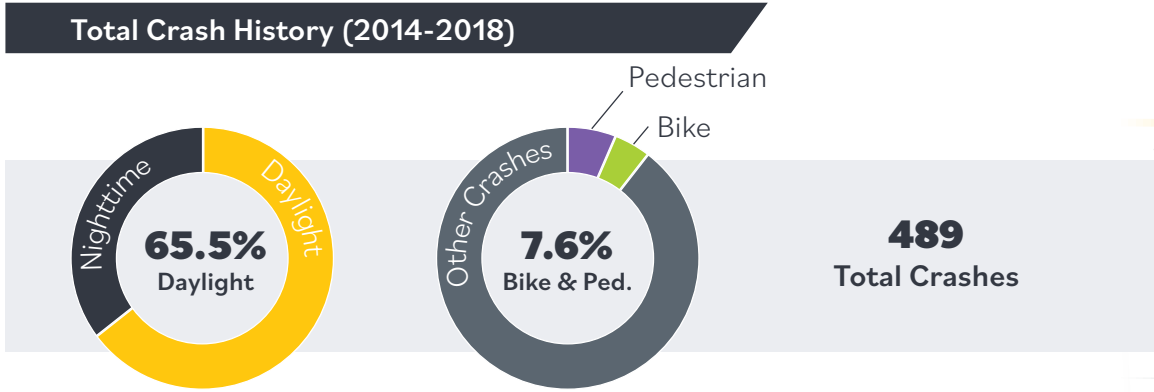
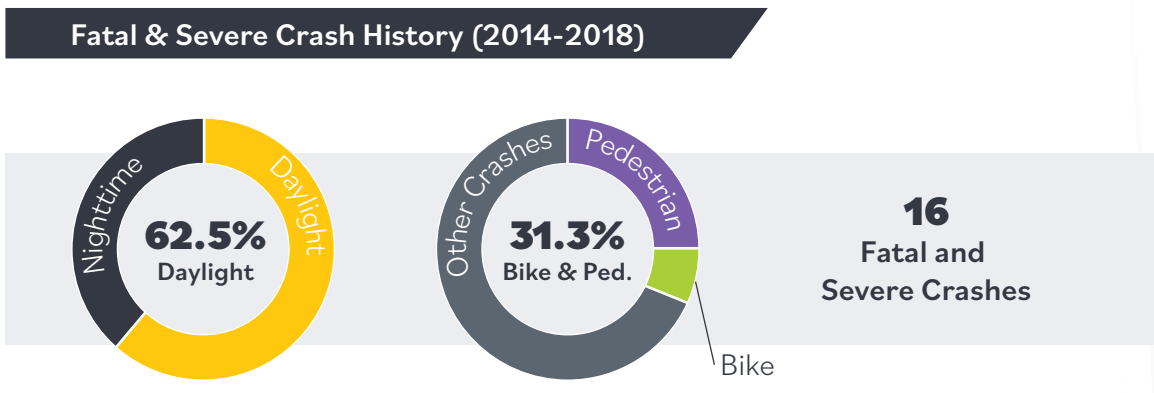
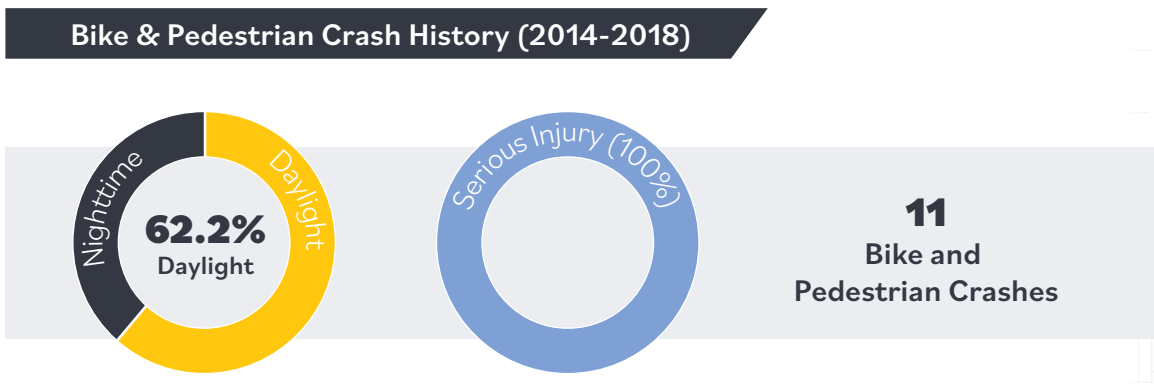
Figure 5 - Crash Data Summary

As shown in **Figure 5**, most crashes (66%) occurred in Daylight conditions, as did most serious injury crashes (63%). It should be noted that 25% of serious injury crashes occurred during Dark-Lighted conditions. Of all crashes, 57% occurred at an intersection. Of serious injury crashes, 65% occurred at an intersection. As shown in the crash heat map (**Figure 6**), most crashes at intersections occurred at Fletcher Avenue, East 131st Avenue, and Fowler Avenue. **Figure 7** shows the serious injury and pedestrian crash locations in relation to bus stops located along the corridor.

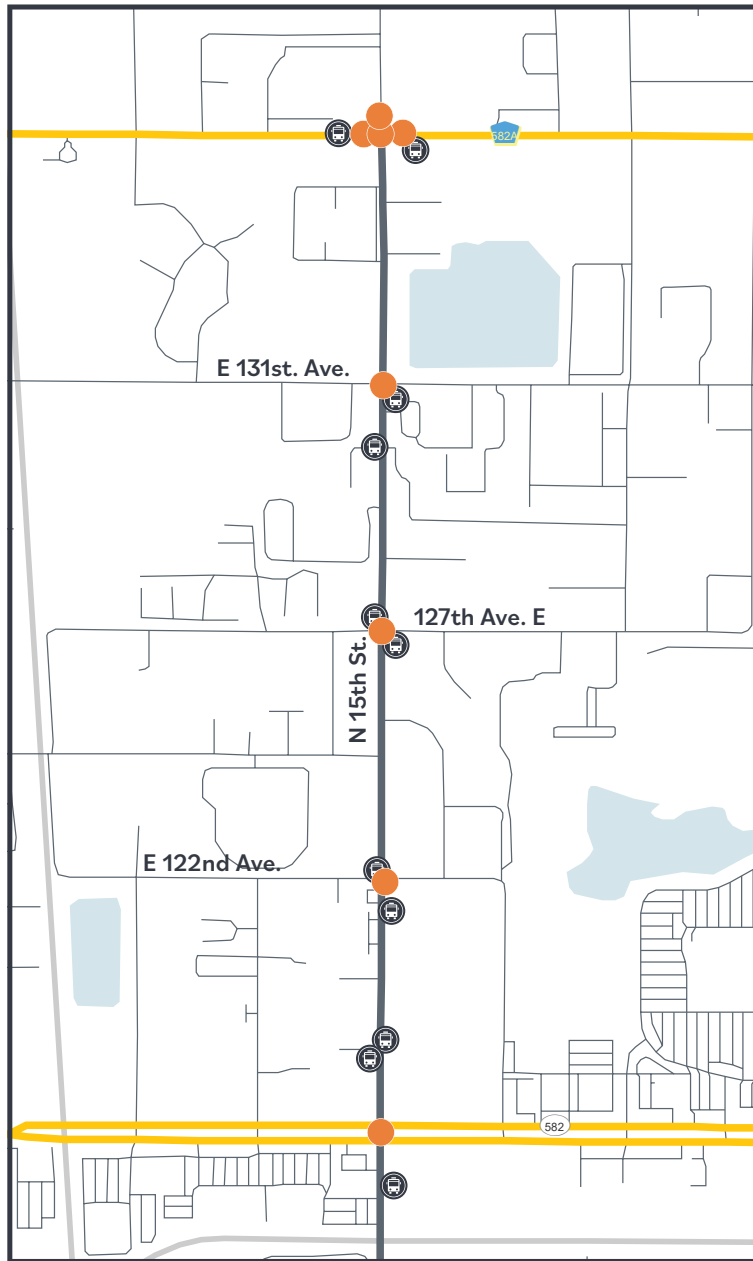
Figure 7 - Serious Injury and Pedestrian Crash Locations

- Serious Injury Crashes
- Pedestrian Crashes
- Ⓜ N 15th Street Bus Stop

Notably, 31% of the severe crashes on this corridor involved either pedestrians or bicyclists as compared to the 16% countywide (Vision Zero Action Plan). The serious crashes and the pedestrian crashes often occurred by the existing transit stops.

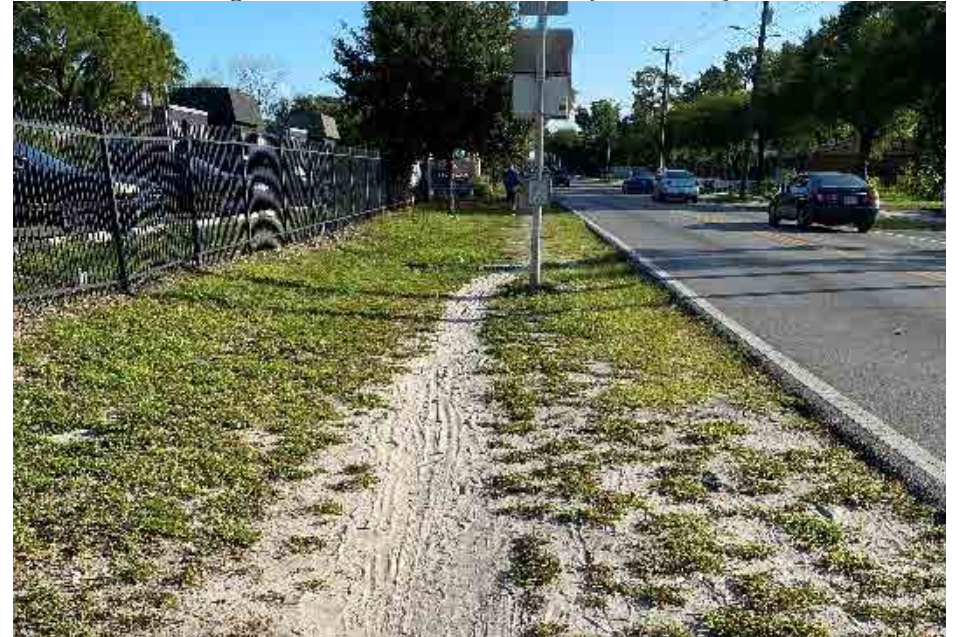
Figure 12 - Pedestrian Travel (West Side)

Other observations from the audit include the need of detectable warnings and crosswalks which are recommended to be placed on the side streets of unsignalized intersections. At the time of the audit, there were sidewalk gaps along the corridor on the west side of the corridor. Where the sidewalk is missing, there are indications of high pedestrian travel and wear and tear in these areas (**Figure 12 and Figure 13**). The detailed audit for North 15th Street is provided in **Appendix B**.

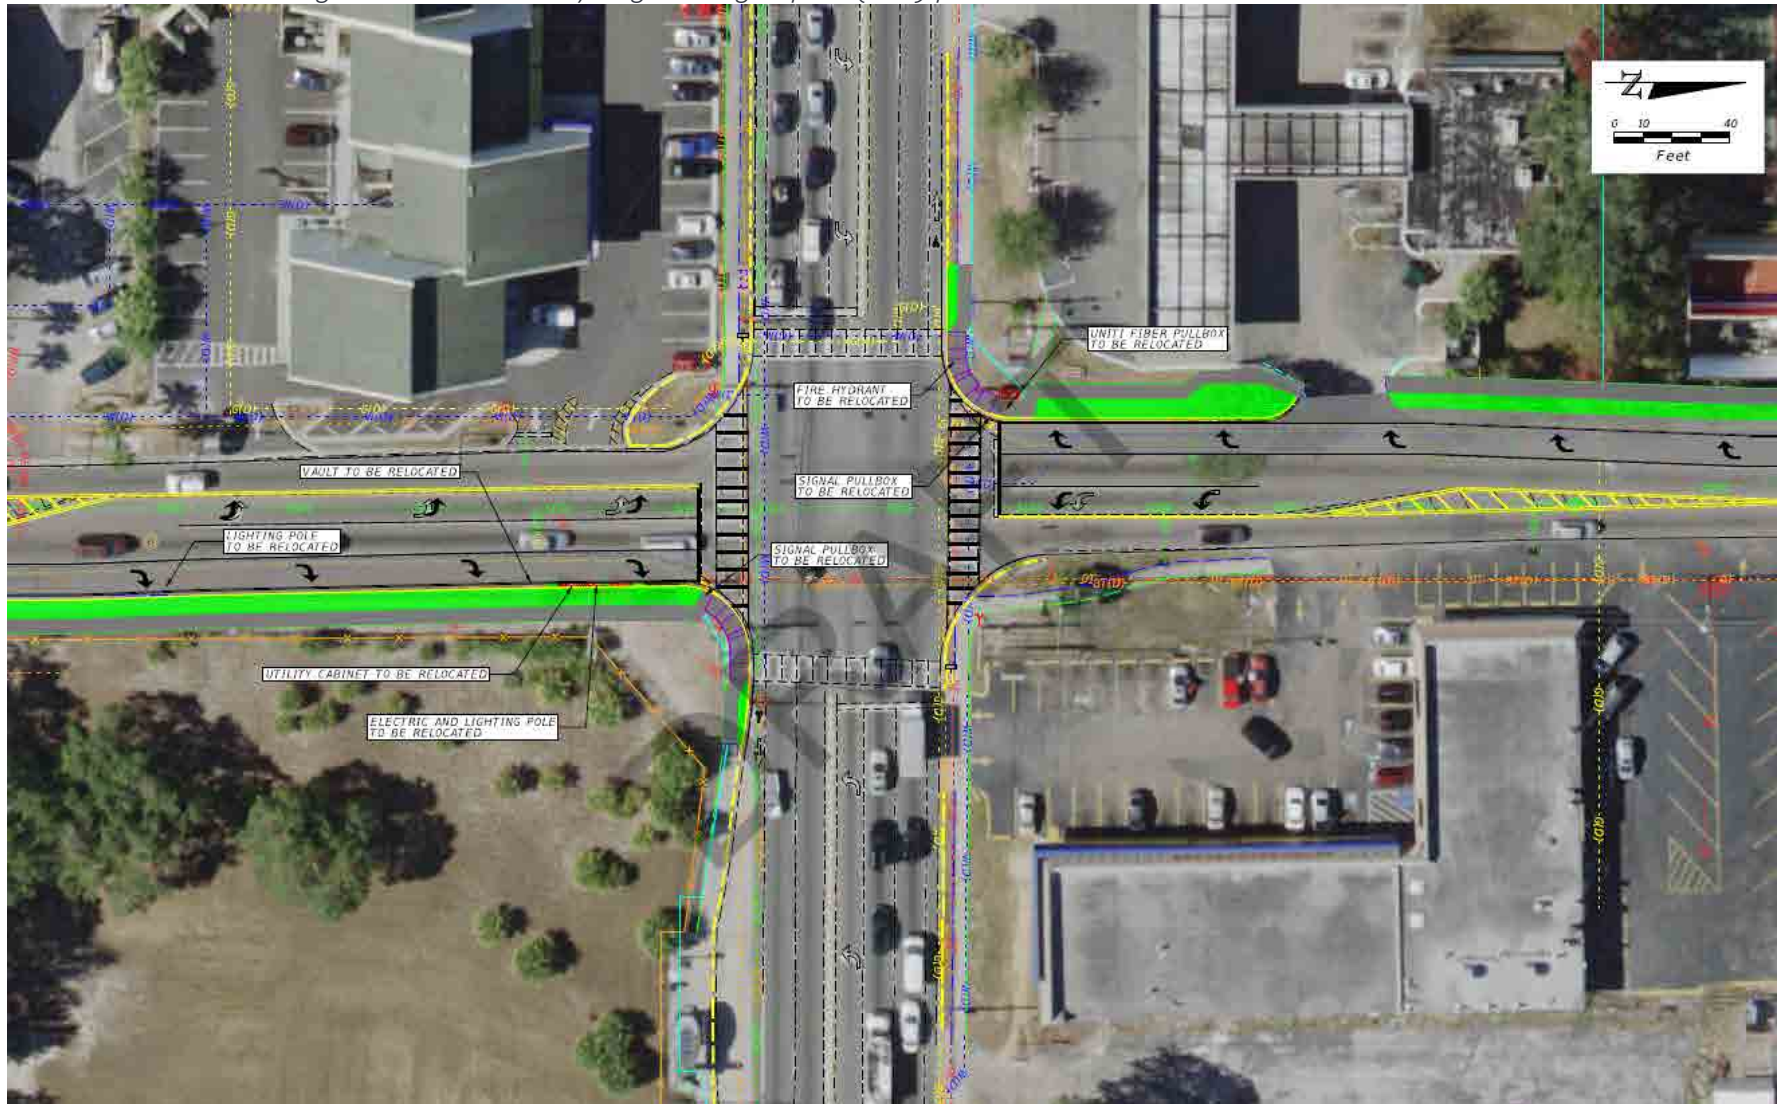
Figure 23 - Preliminary Engineering Report (PER) for Fletcher Avenue and North 15th Street

The Preliminary Engineering Report (PER) for Fletcher Avenue and North 15th Street recommends intersection improvements that include widening the intersection to include right turn lanes for the northbound and southbound intersection approaches (on North 15th Street) while maintaining the existing travel lanes and left turn lanes in each direction **(Figure 23)**.

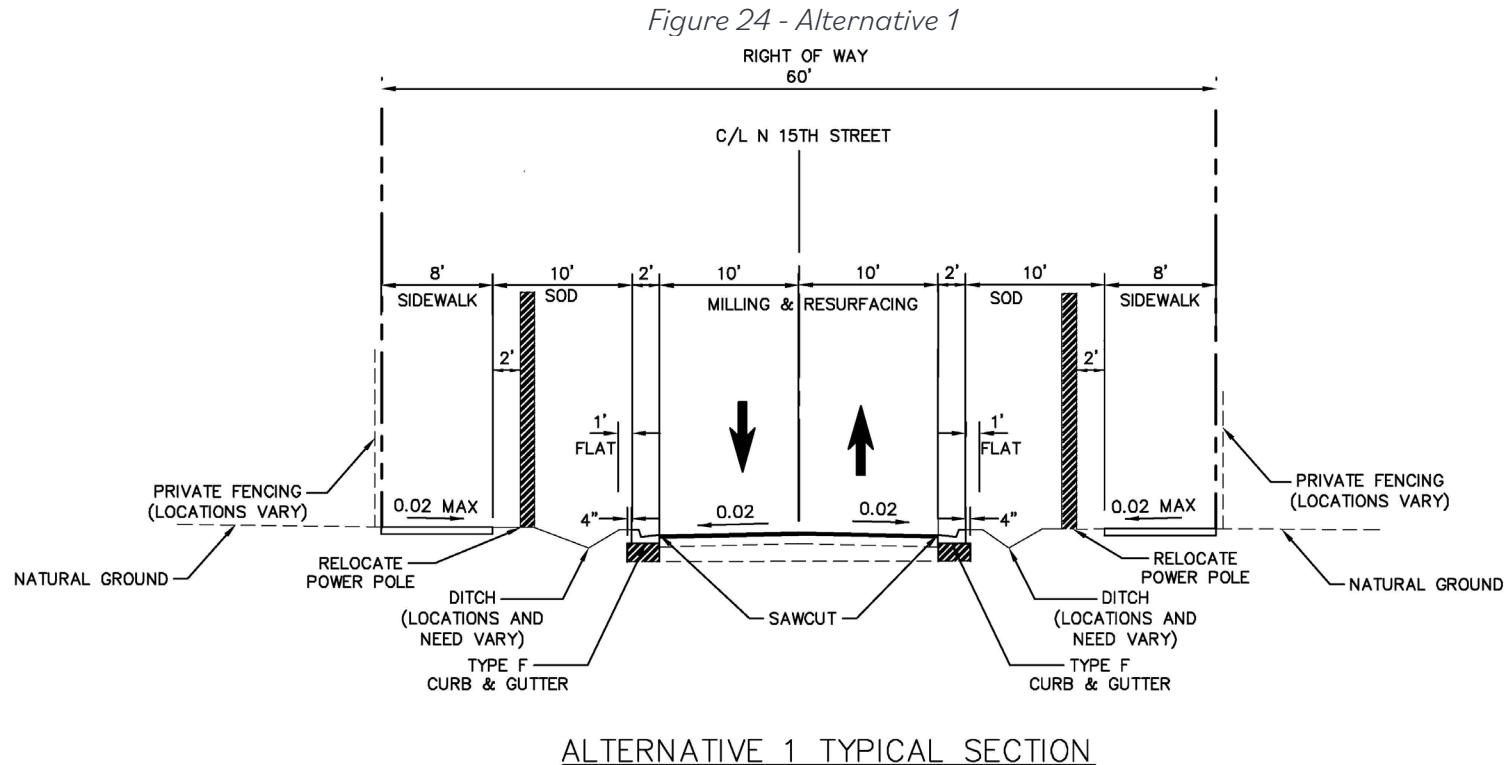
The recommended long-term safety improvements for Alternative 1 consist of wider sidewalks throughout the entire corridor (**Figure 24**). The wider sidewalks are recommended to be eight feet in width and be provided continuously along both sides of the corridor. The wider sidewalks on both sides of the roadway will contribute to an enhanced pedestrian facility. Based on design criteria and the TTM updates, shared lane markings (SLMs) should be evaluated for implementation based upon the roadway volumes with the Alternative 1 improvements.

A lane width reduction is also recommended as part of Alternative 1. The lane widths are currently 12 feet wide and are recommended to be reduced to 10 feet wide. The narrowed traffic lanes serve as a traffic calming element along the corridor to slow vehicles and enhance safety for all modes traversing the corridor. The enhanced buffer will provide separation between pedestrians and vehicles. Furthermore, it is recommended that curb and gutter be added to the roadway to provide an additional buffer between the roadway and upgraded sidewalks. Coordination will be required with emergency services during the design phase to determine the type of curb and gutter.

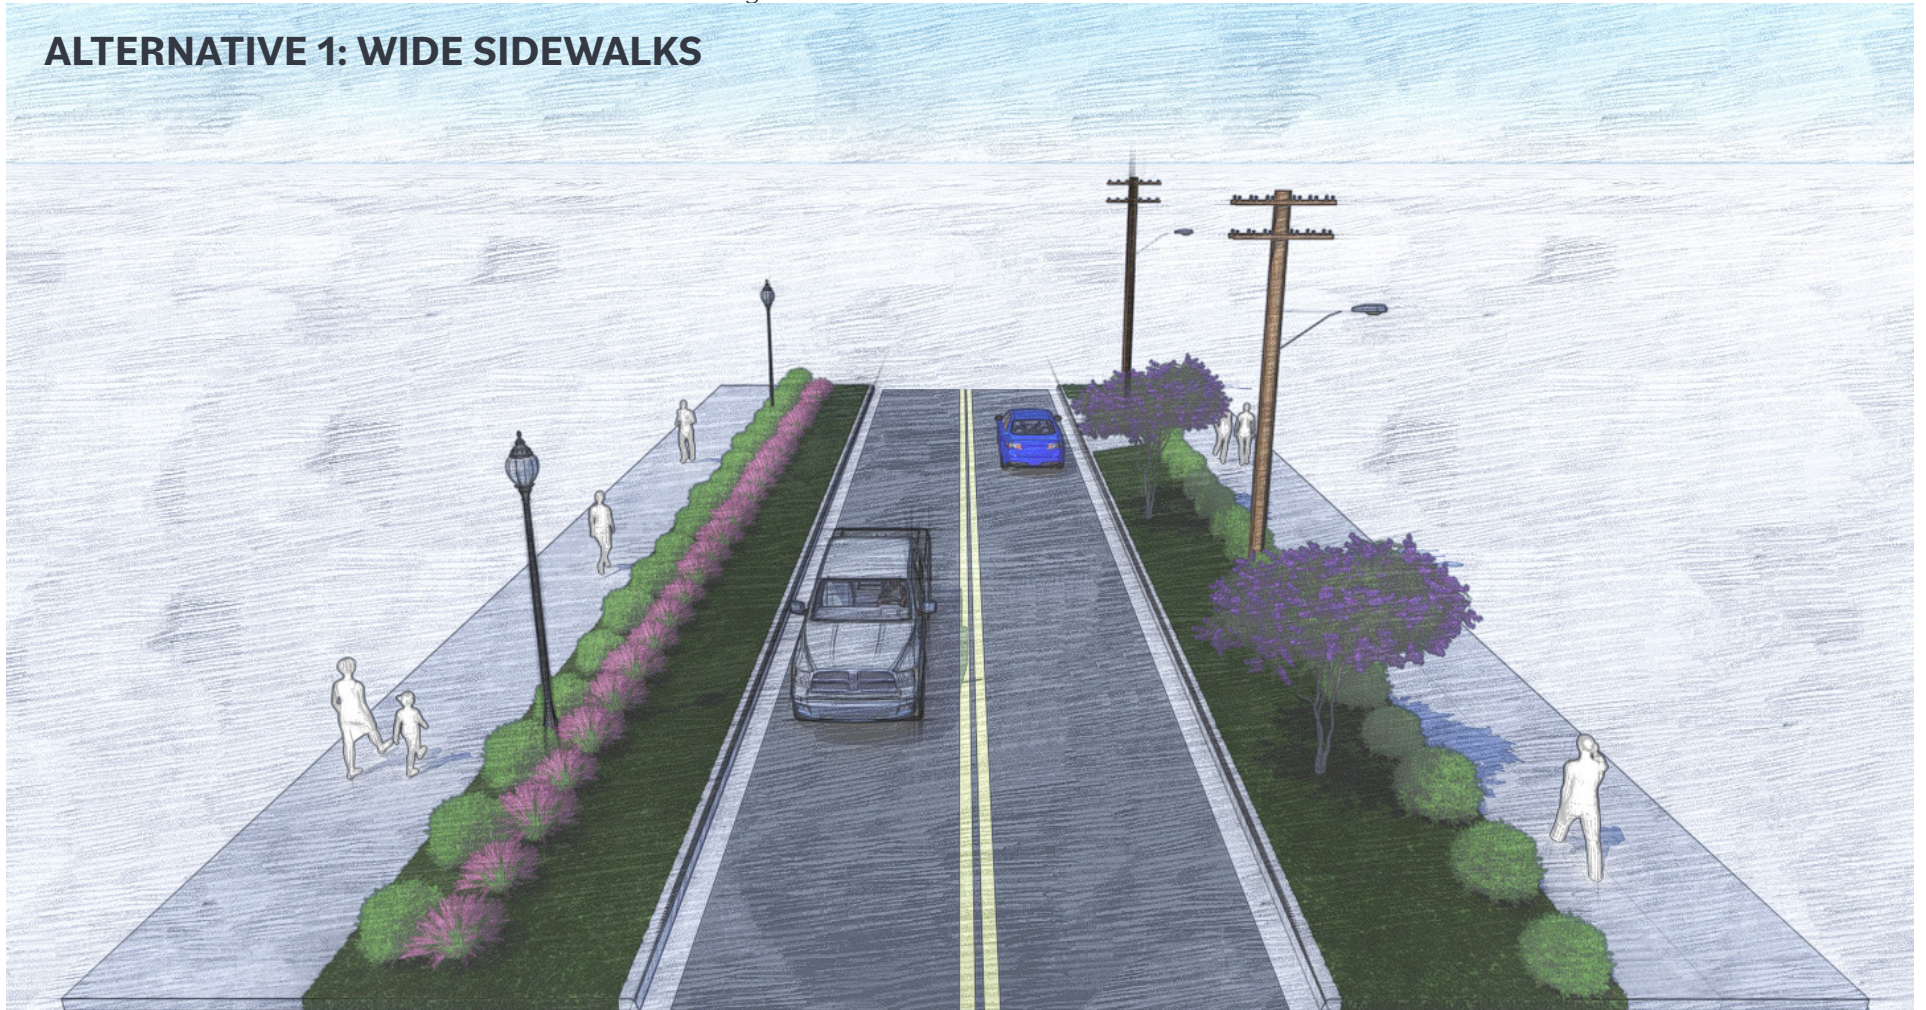
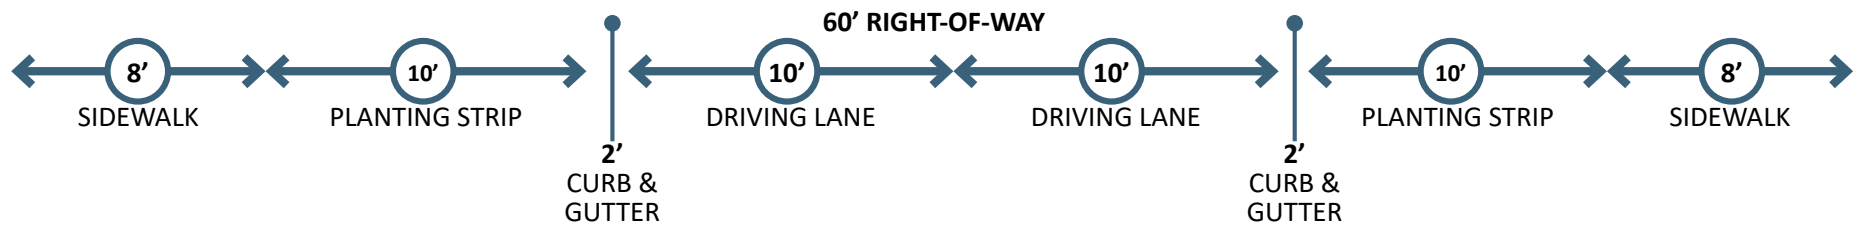
Figure 25 - Alternative 1 Illustration

ALTERNATIVE 1: WIDE SIDEWALKS

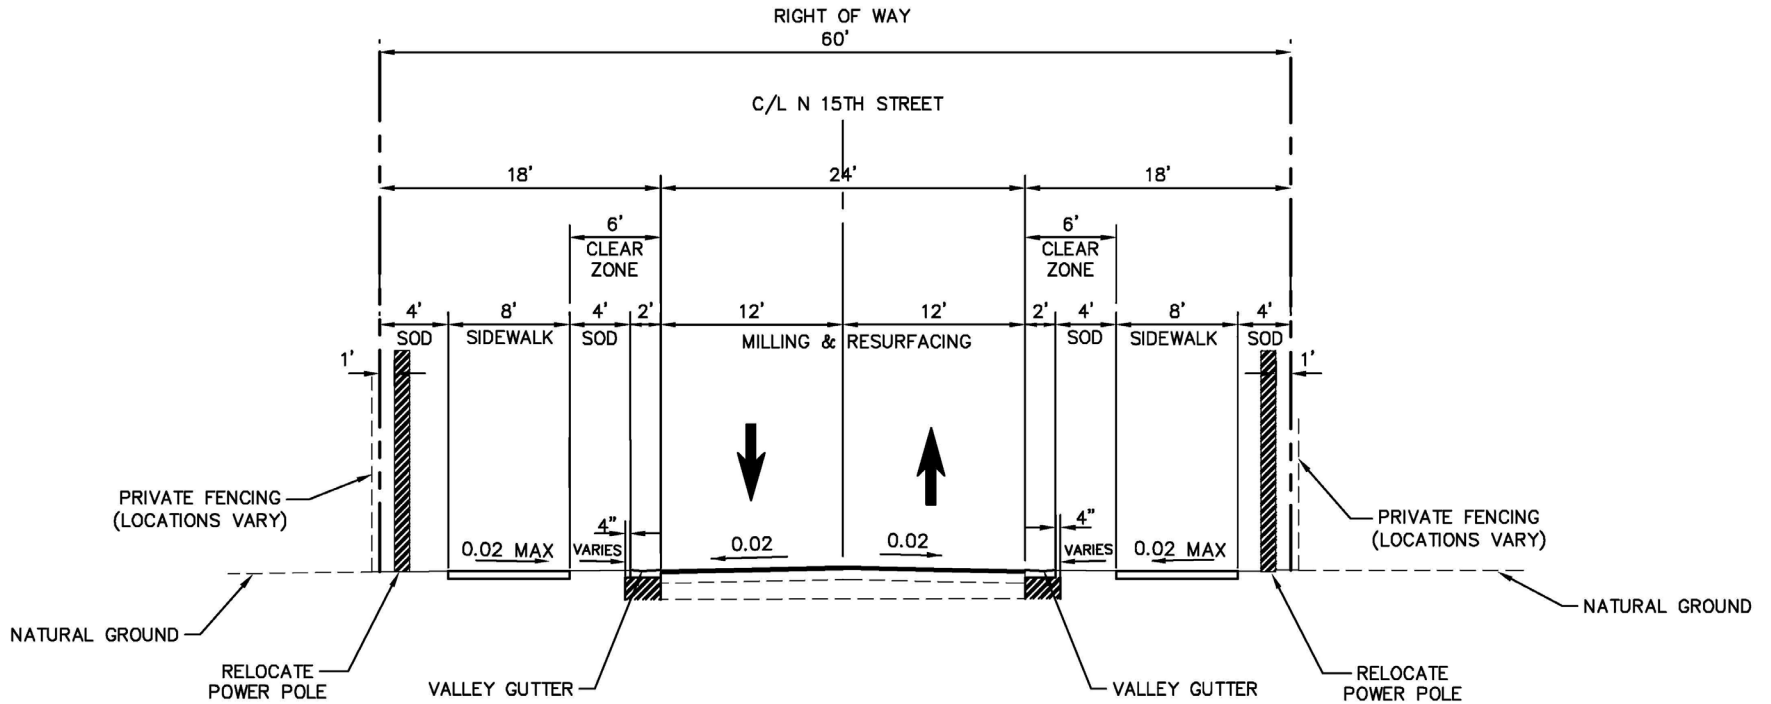
Figure 26 - Alternative 2

The recommended long-term safety improvements for Alternative 2 consist of an 8-foot wide sidewalk on the west and east side of the roadway (Figure 26). The wider sidewalk will provide an enhanced pedestrian facility along the corridor. Based on design criteria and the TTM updates, shared lane markings (SLMs) should be evaluated for implementation based upon the roadway volume with the Alternative 2 improvements.

The travel lanes remain at the existing width of 12-feet as part of Alternative 2. There is existing valley gutter along the corridor that is recommended to be extended along both sides of the corridor to provide an additional buffer between the roadway and upgraded sidewalks to accommodate the drainage. The four-foot buffer will provide separation between pedestrians and vehicles.

ALTERNATIVE 2 TYPICAL SECTION

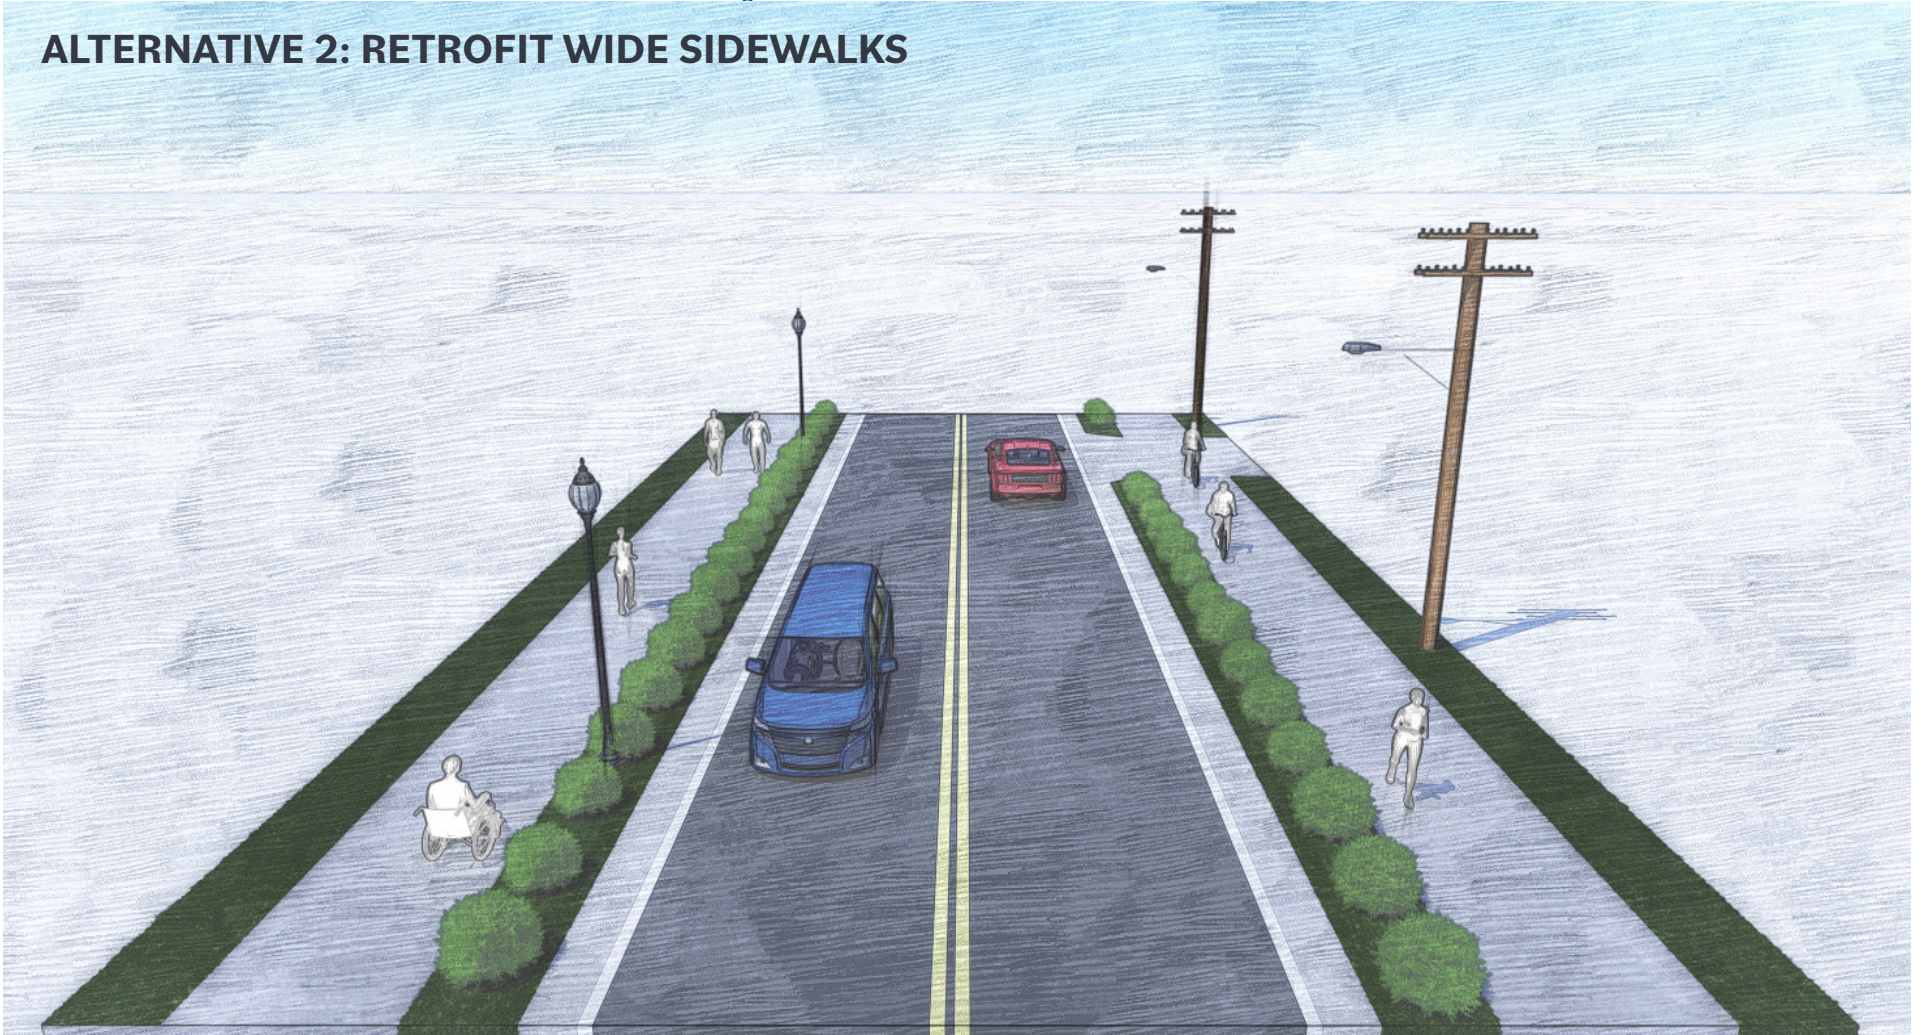
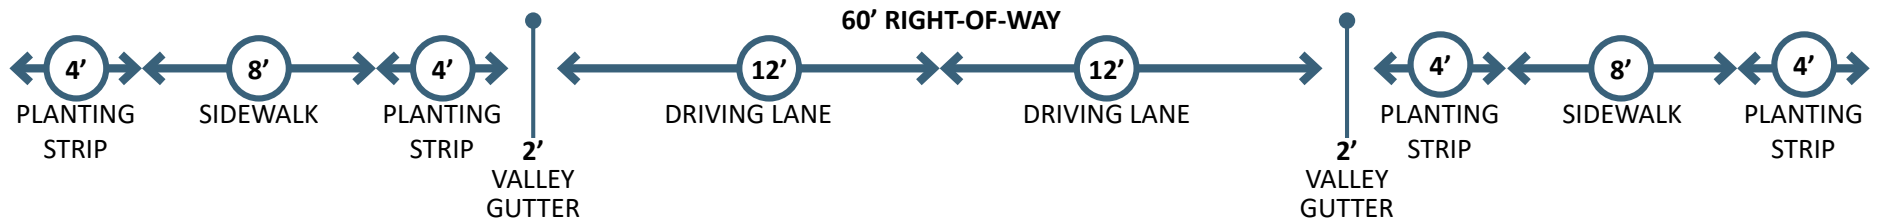
Figure 27 - Alternative 2 Illustration

ALTERNATIVE 2: RETROFIT WIDE SIDEWALKS

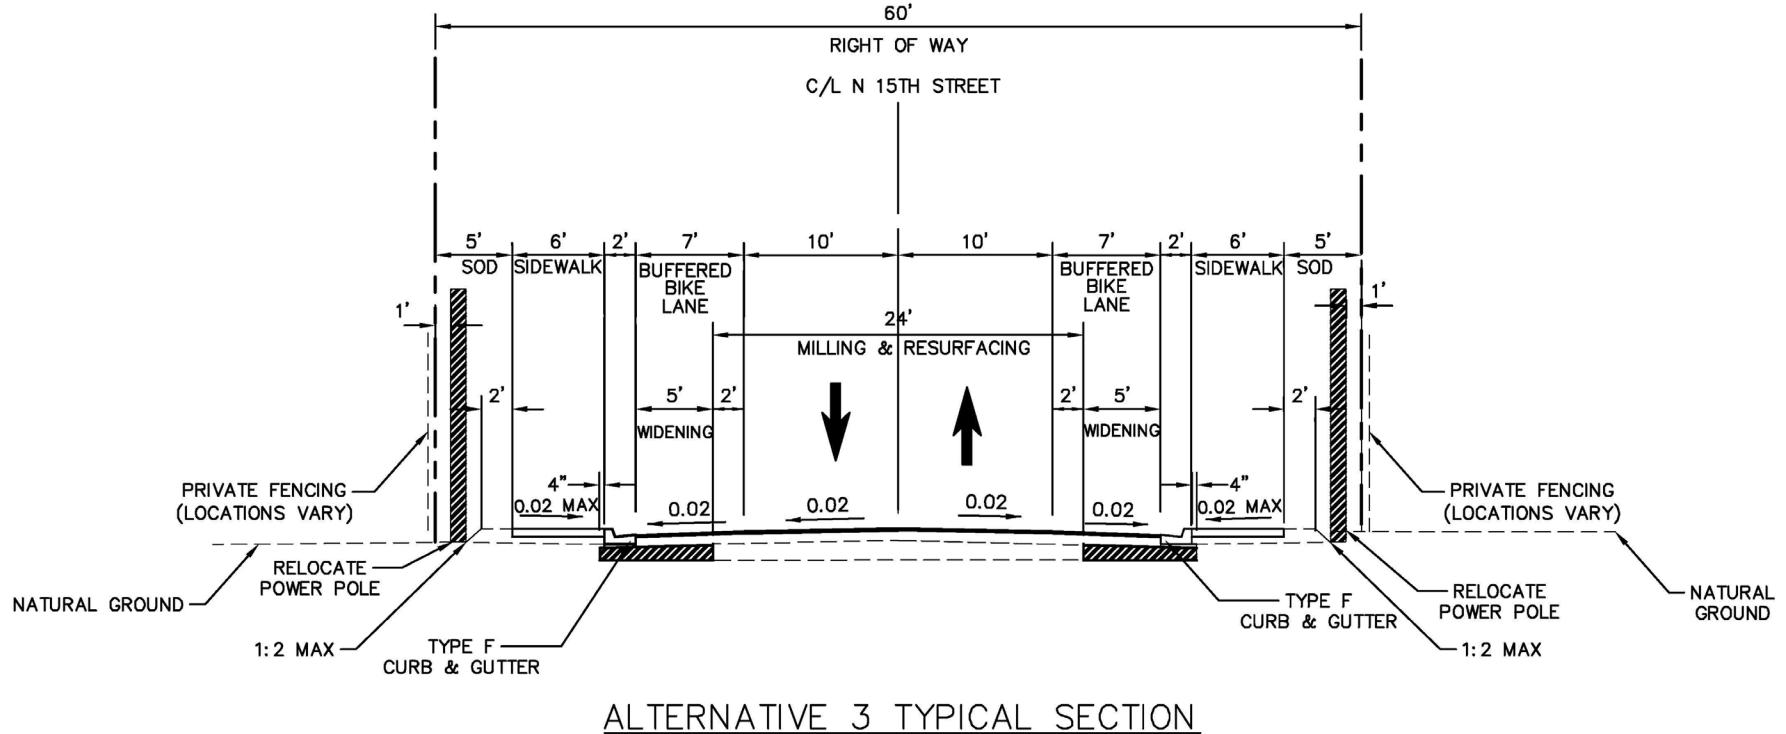
Figure 28 - Alternative 3

The recommended long-term safety improvements for Alternative 3 consist of 6-foot wide sidewalks and buffered bike lanes throughout the corridor (**Figure 28**). The wide sidewalks are recommended to be six feet in width continuously along both sides of the corridor. The wider sidewalks on both sides of the roadway will contribute to an enhanced pedestrian facility. The 7-foot buffered bike lanes will provide a dedicated space for bicyclists on the roadway.

A lane width reduction is also recommended as part of Alternative 3. The lane widths are currently 12 feet wide and are recommended to be reduced to 10 feet wide. The narrowed traffic lanes serve as a traffic calming element along the corridor to slow vehicles and enhance safety for all modes traversing the corridor. Furthermore, it is recommended that curb and gutter be added to the roadway to provide an additional buffer between the roadway and upgraded sidewalks. Coordination will be required with emergency services during the design phase to determine the type of curb and gutter.

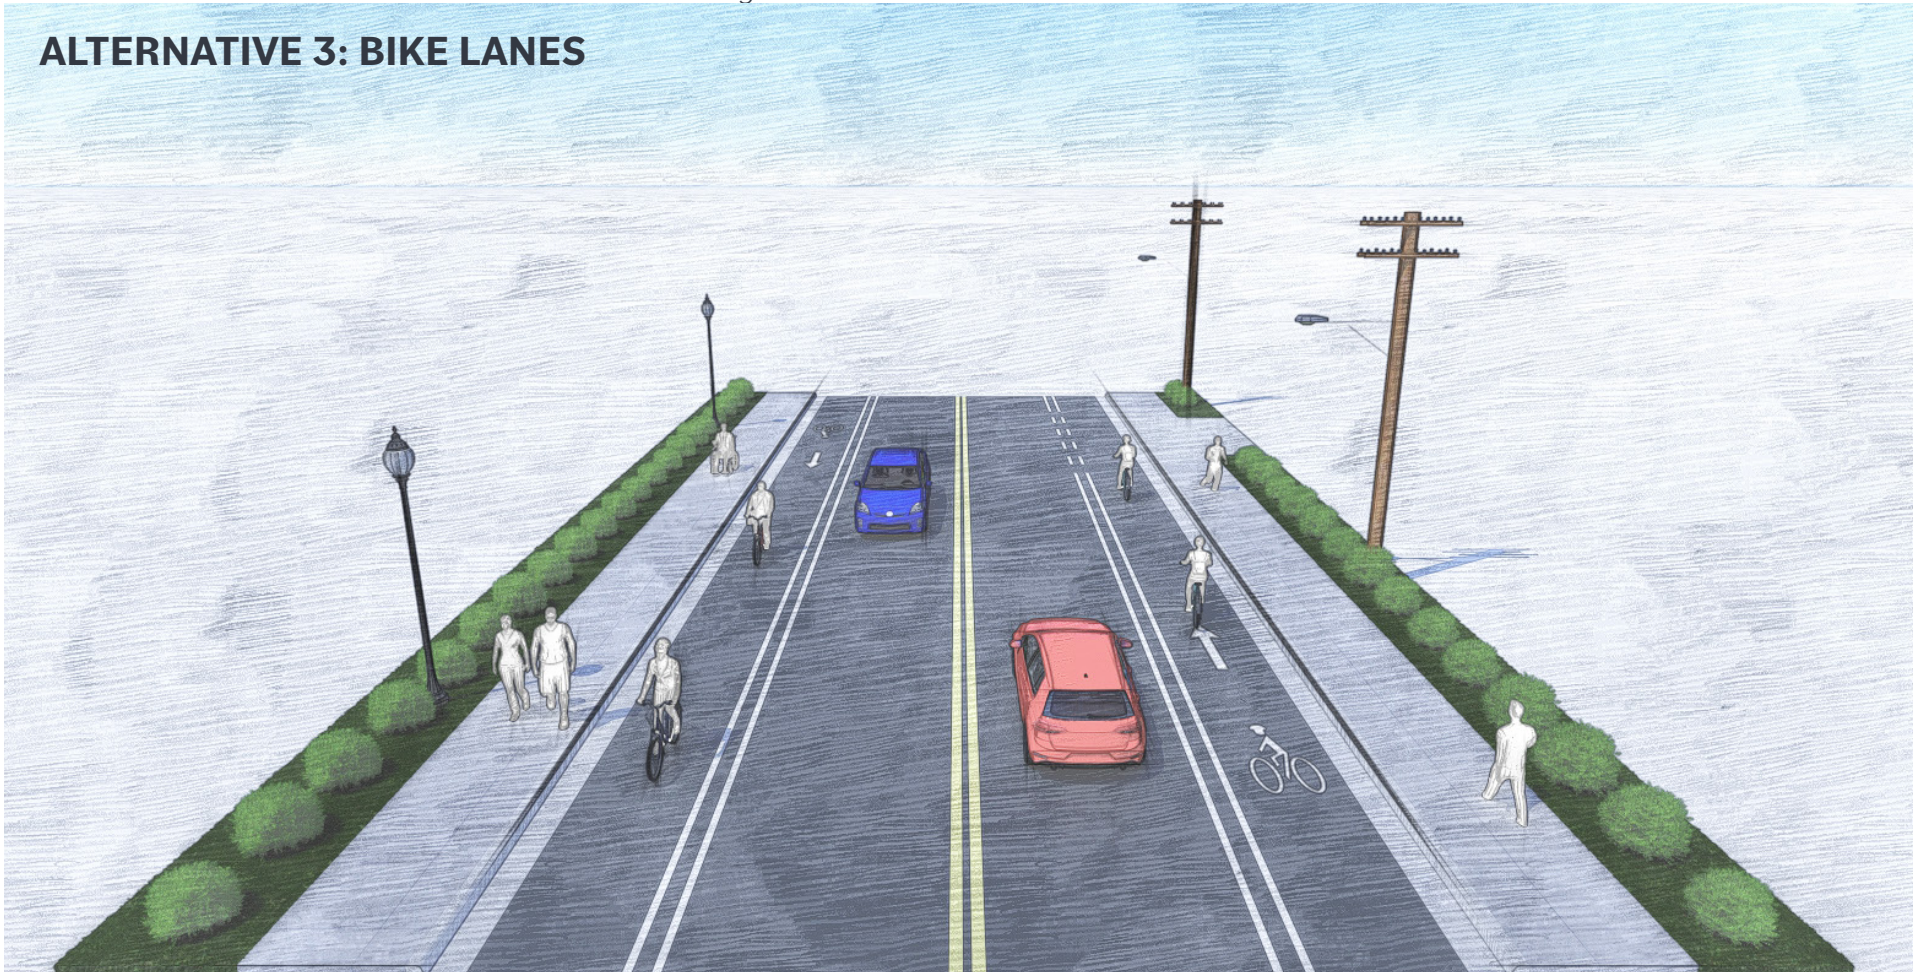
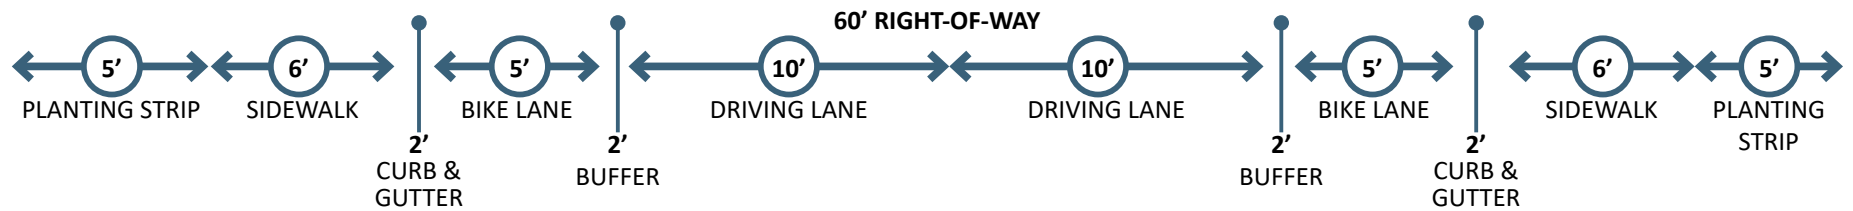
Figure 29 - Alternative 3 Illustration

ALTERNATIVE 3: BIKE LANES

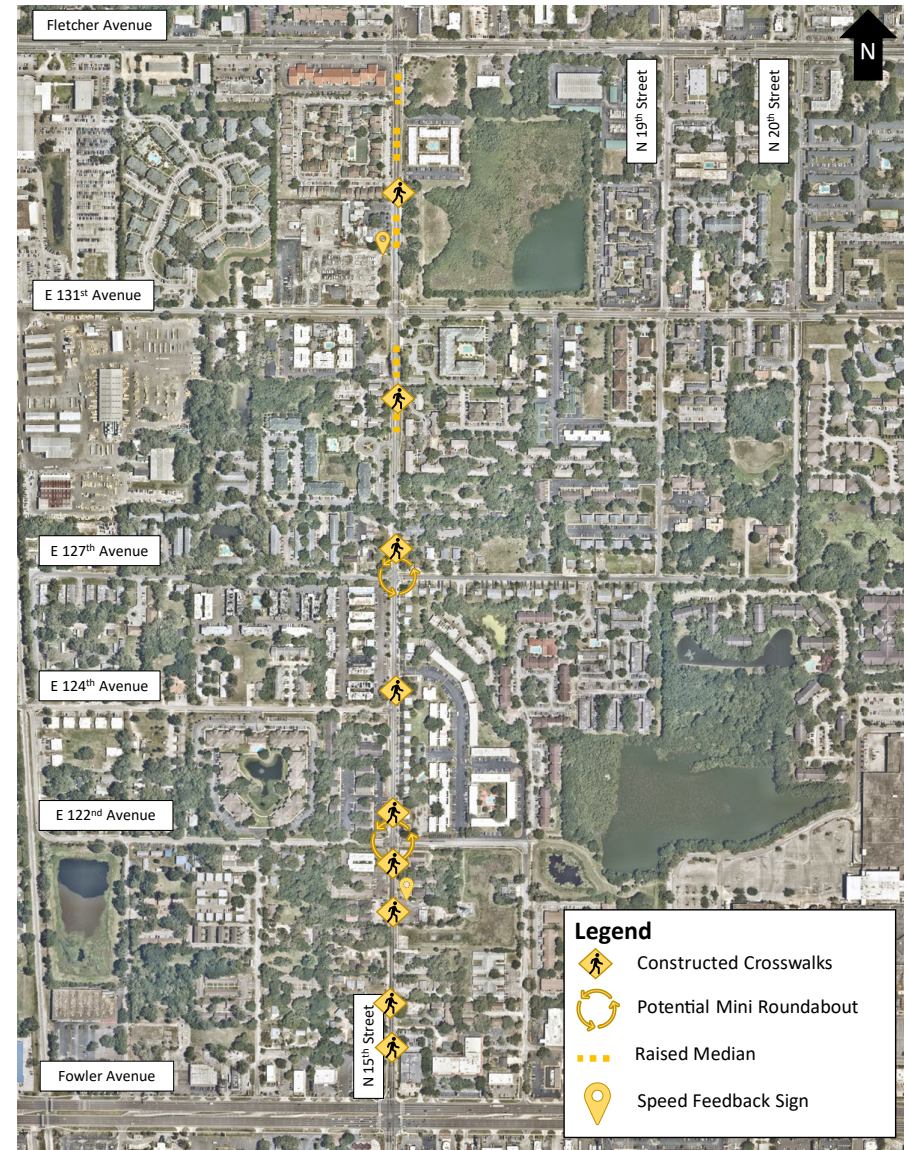
Figure 30 - Corridor-Wide Improvements

Raised medians and mini roundabouts (**Figure 30**) are recommended to be implemented along the corridor to provide traffic calming. The raised medians and mini roundabouts are intended to slow traffic by creating a slight horizontal shift of the travel lanes. The raised crosswalks shown in **Figure 30** have recently been constructed by Hillsborough County.
