# Vision Zero

# Vision Zero Corridor Studies

CR 579/Mango Road

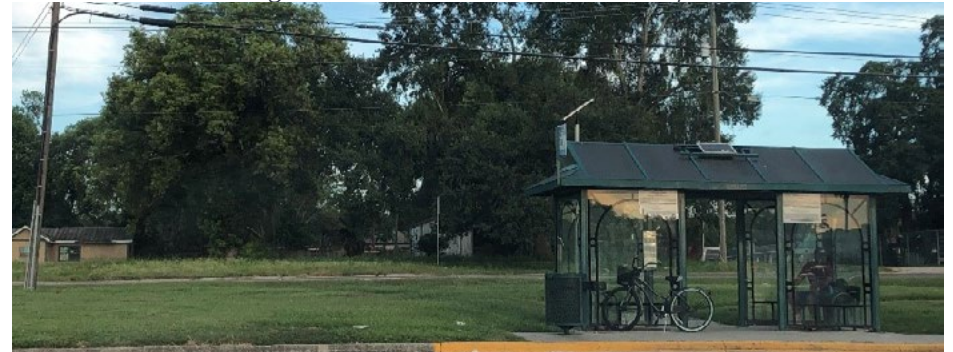
Figure 5 - Local Route 38 Bus Stop

The Hillsborough Area Regional Transit Authority (HART) operates local service in proximity to Mango Road. Local Route 38 operates along SR 574 and serves a stop at the shopping plaza located at the northeast corner of the intersection of SR 574 and Mango Road (**Figure 5**). There are bus stops located at the southwest and southeast corner of the Mango Road and Clay Pit Road intersection that were served by Megabus (**Figure 6**). Megabus provides city-to-city bus service across North America. The bus stop includes a shelter and bench on the west side. On the east side there is a sign for the Megabus stop.

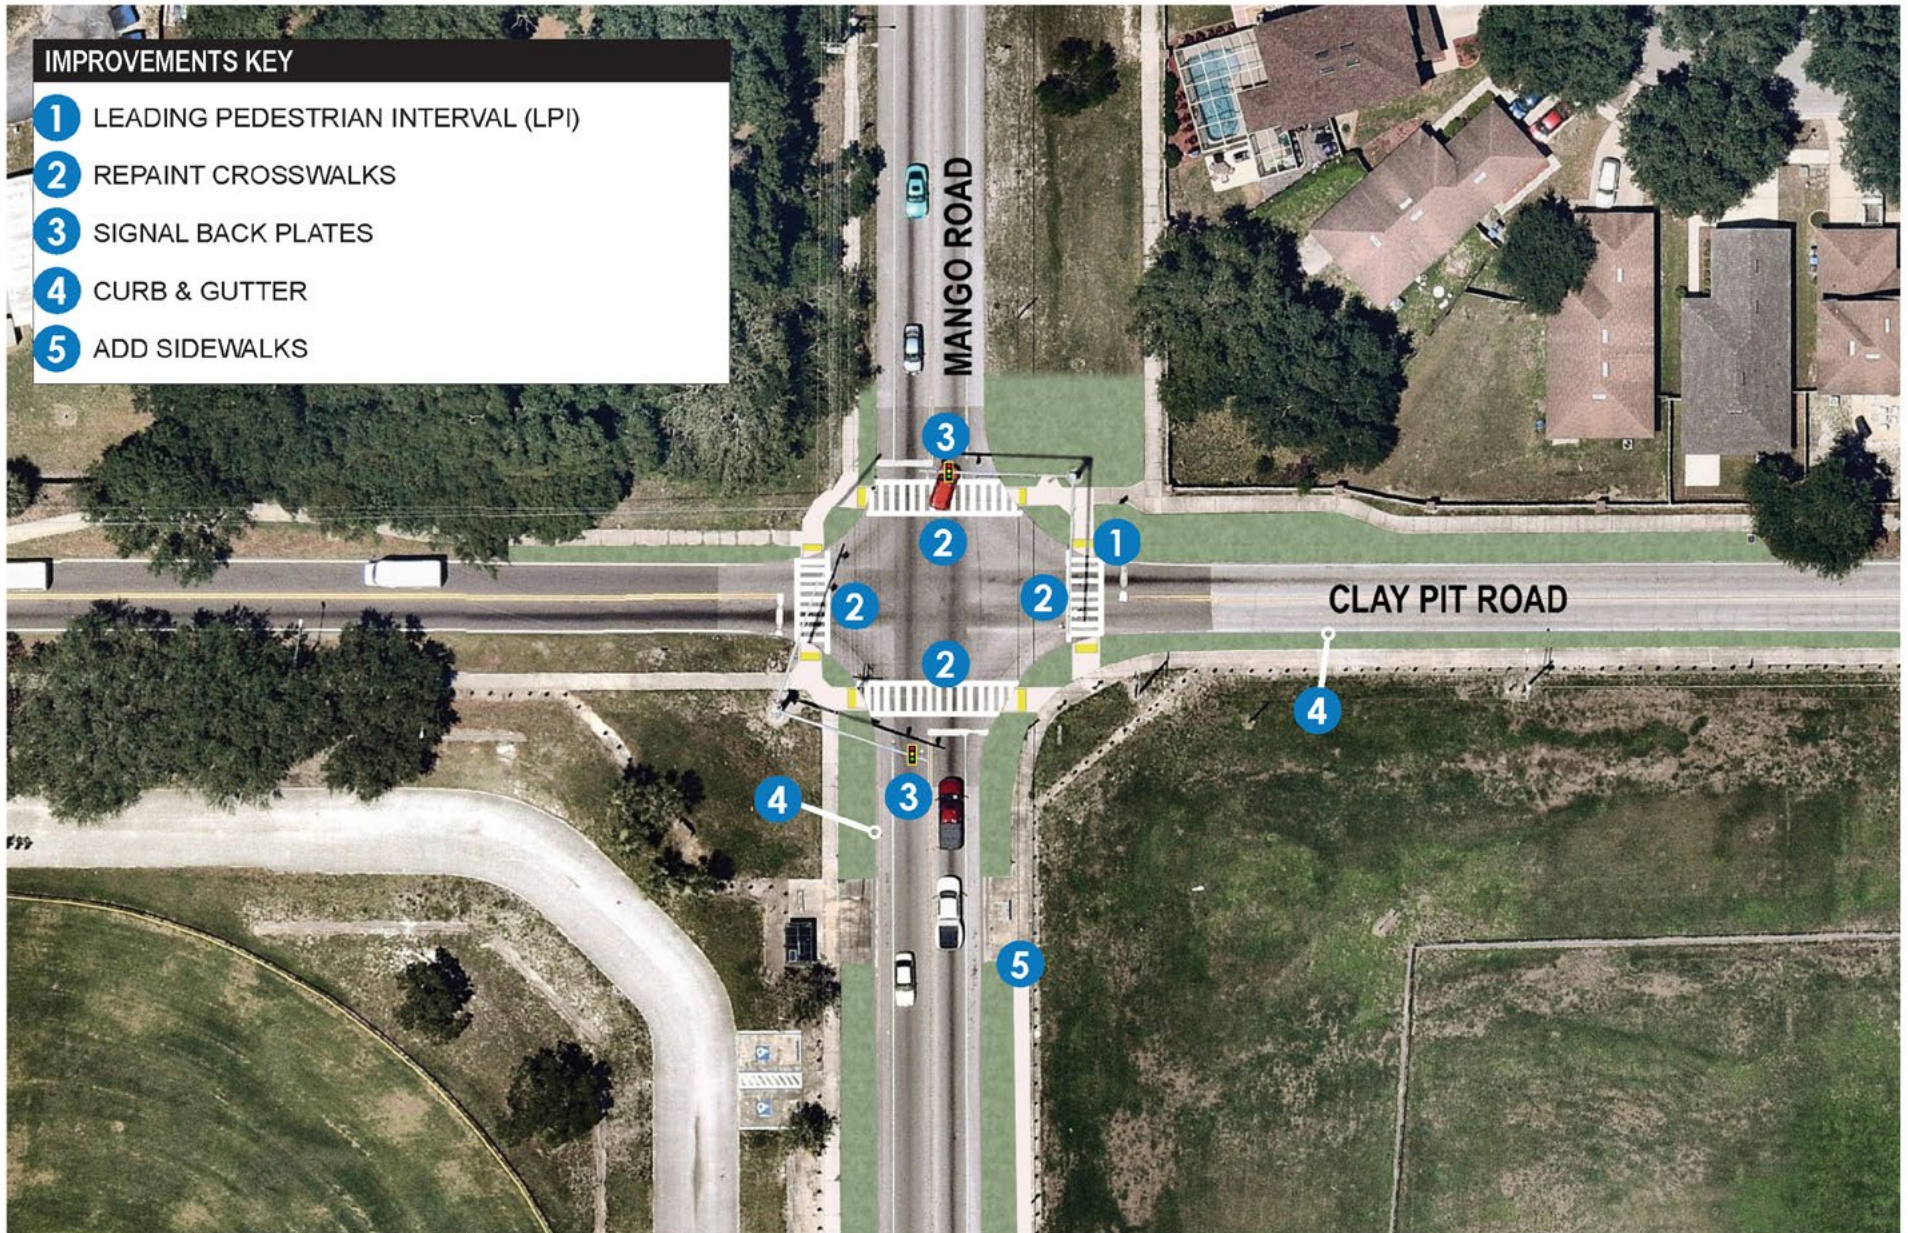
Figure 26 - Mango Road and Clay Pit Road

The intersection of Mango Road and Clay Pit Road is the only signalized intersection provided along the corridor between the two signalized intersections at the ends of the project limits. The intersection provides a signalized crossing for pedestrians accessing the adjacent park areas.

The recommended safety improvements at the intersection consist of safety enhancements for all modes that travel through the intersection. At the Mango Road and Clay Pit Road intersection it is recommended to restripe the existing worn crosswalks on all approaches and adjust the signal timing to allow for Leading Pedestrian Intervals (LPIS) due to the high level of pedestrian activity and proximity to the County parks. LPIS give pedestrians a “head start” to cross the intersection before any vehicles receive the concurrent green signal, enhancing the visibility of pedestrians in crosswalks **(Figure 26)**.

Other recommended improvements for the intersection include installing backplates on all signal heads and constructing curb and gutter along the roadway shoulder adjacent to Burnett Park to address the existing shoulder and sidewalk erosion. The construction of curb and gutter will increase the buffer distance between the sidewalks and roadway. A long-term improvement recommendation is the construction of sidewalk on the east side of the Mango Road between Clay Pit Road and the northern Walmart access driveway.

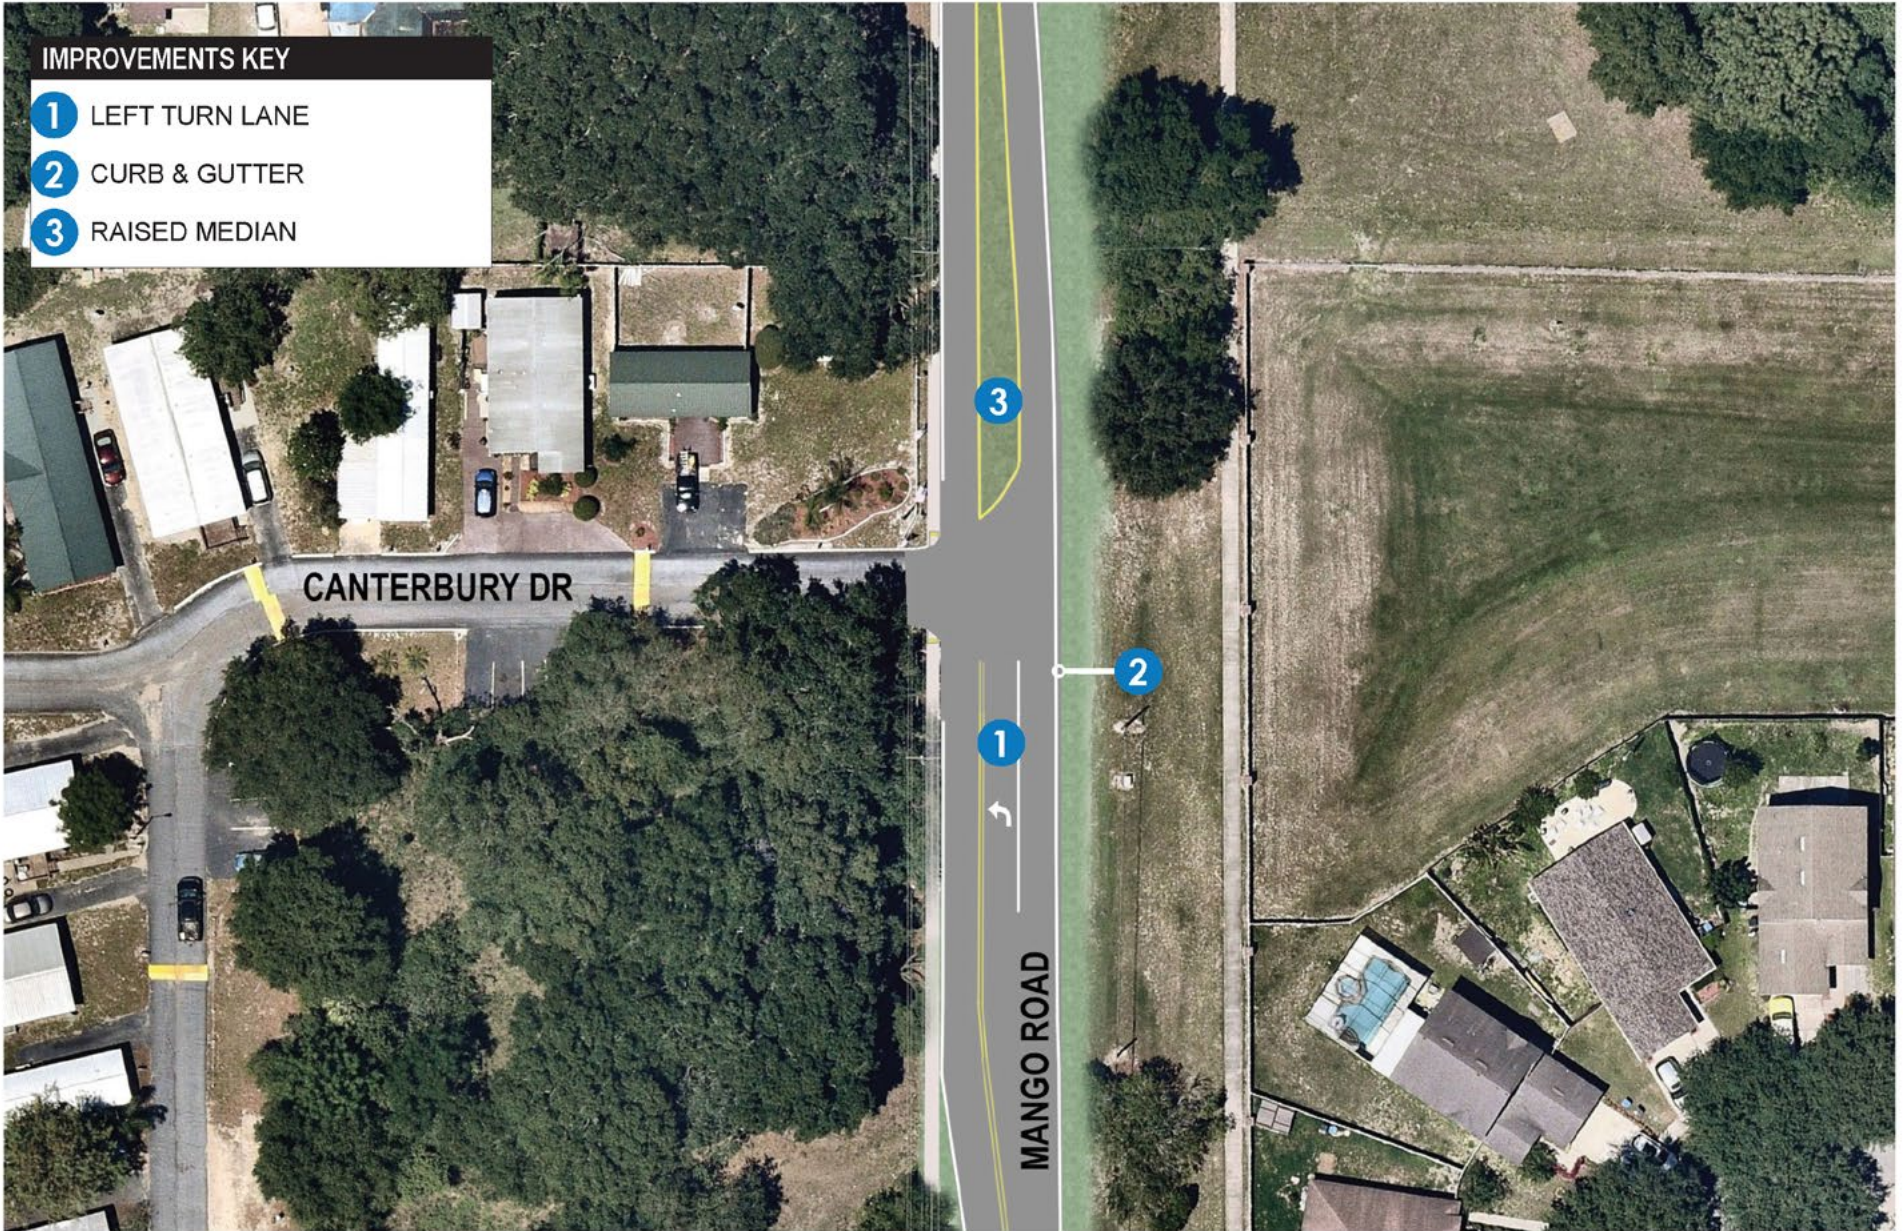
Figure 27 - Mango Road and Canterbury Drive

Canterbury Drive is a local residential road north of Clay Pit Road. Two serious injury crashes were reported at Canterbury Drive between 2014 and 2018. Both crashes were rear end crashes. In total, ten crashes occurred in proximity to Canterbury Drive during this time. Of the ten crashes, eight crashes were rear end crashes.

The recommended safety improvements at Canterbury Drive include widening the roadway at the intersection to include a left turn lane for enhanced access onto Canterbury Drive (**Figure 27**). The installation of the left turn will limit delay along Mango Road at this intersection and allow left turning vehicles to be separated from the through travel lane. Additional improvements at this location include installation of curb and gutter on both sides of the road through the intersection and south to Clay Pit Road to provide an additional buffer for pedestrians using the sidewalk. The installation of curb and gutter along the roadway will also serve as a traffic calming element in this portion of Mango Road. A high emphasis crosswalk should be added at Canterbury Drive. ADA curb ramps including the detectable warning pads surfaces should be added.

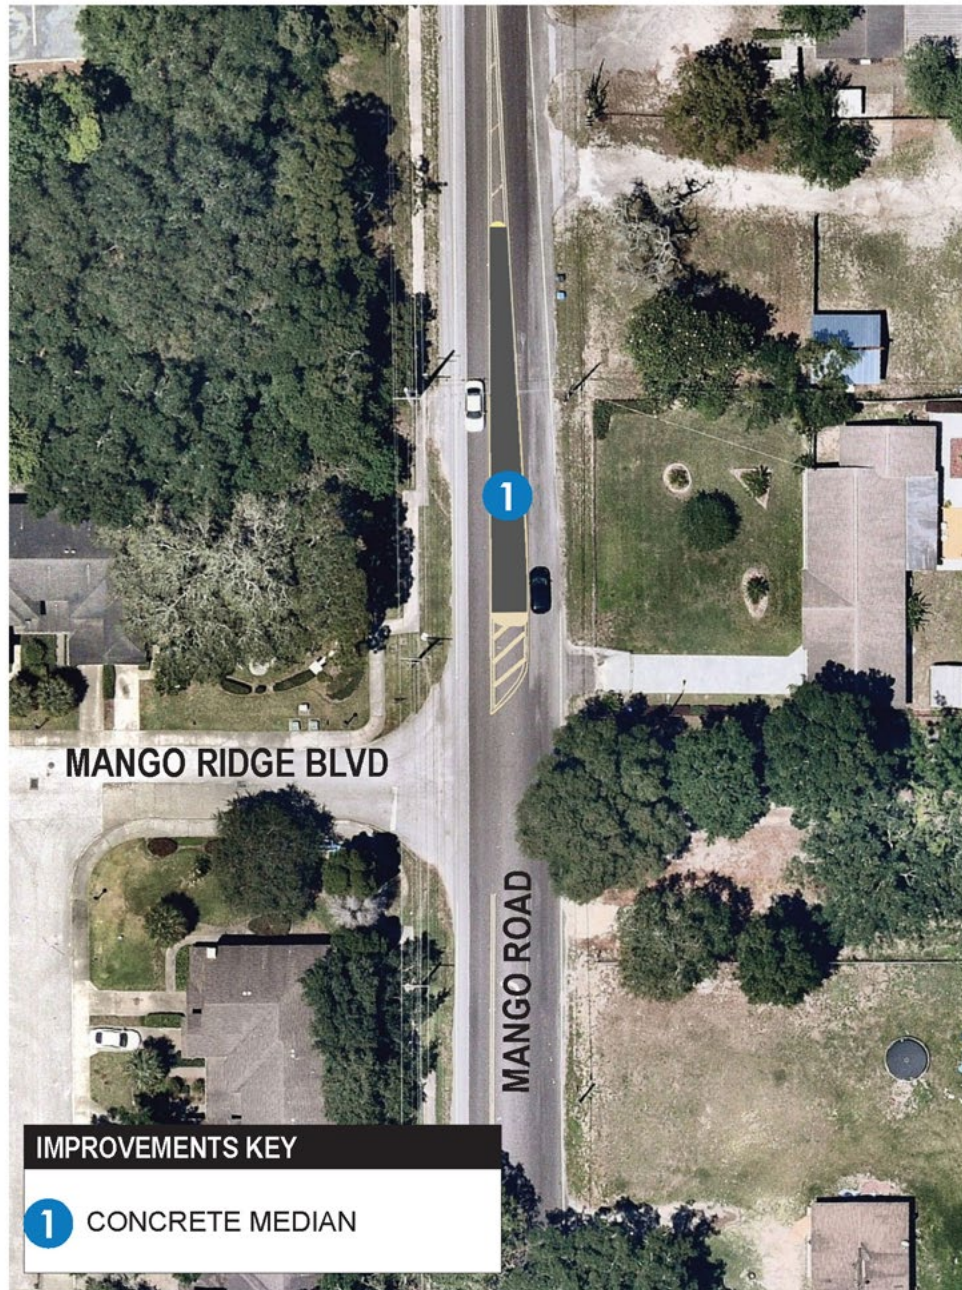
Figure 28 - Mango Road and Mango Ridge Blvd.

High emphasis crosswalks should be added at both Mango Ridge Boulevard and Mango Groves Boulevard. The curb ramps should be relocated at Mango Ridge Boulevard. The existing curb ramps are set back from the intersection but there are worn pedestrian paths outside of the existing path, as shown in **Figure 28**.

The section of Mango Road between Mango Ridge Boulevard and Mango Groves Boulevard provides connections to local residential roads and driveway access to residences. The safety improvements for this section of Mango Road consist of converting the existing striped median to a raised concrete median north of Mango Ridge Boulevard (**Figure 28**). The transformation of the median to a curbed concrete median will provide a traffic calming element to this residential section of Mango Road.

The recommended raised median can be considered for mid-block crossing locations in the future to provide an additional pedestrian crossing on Mango Road. The current distance between pedestrian crossings is approximately half a mile between Martin Luther King Jr Boulevard and Clay Pit Road and approximately eight tenths of a mile between Clay Pit Road and US 92. The planned intersection improvements at Old Hillsborough Avenue will add east and west crosswalks to reduce the crossing distance between Clay Pit Road and US 92.

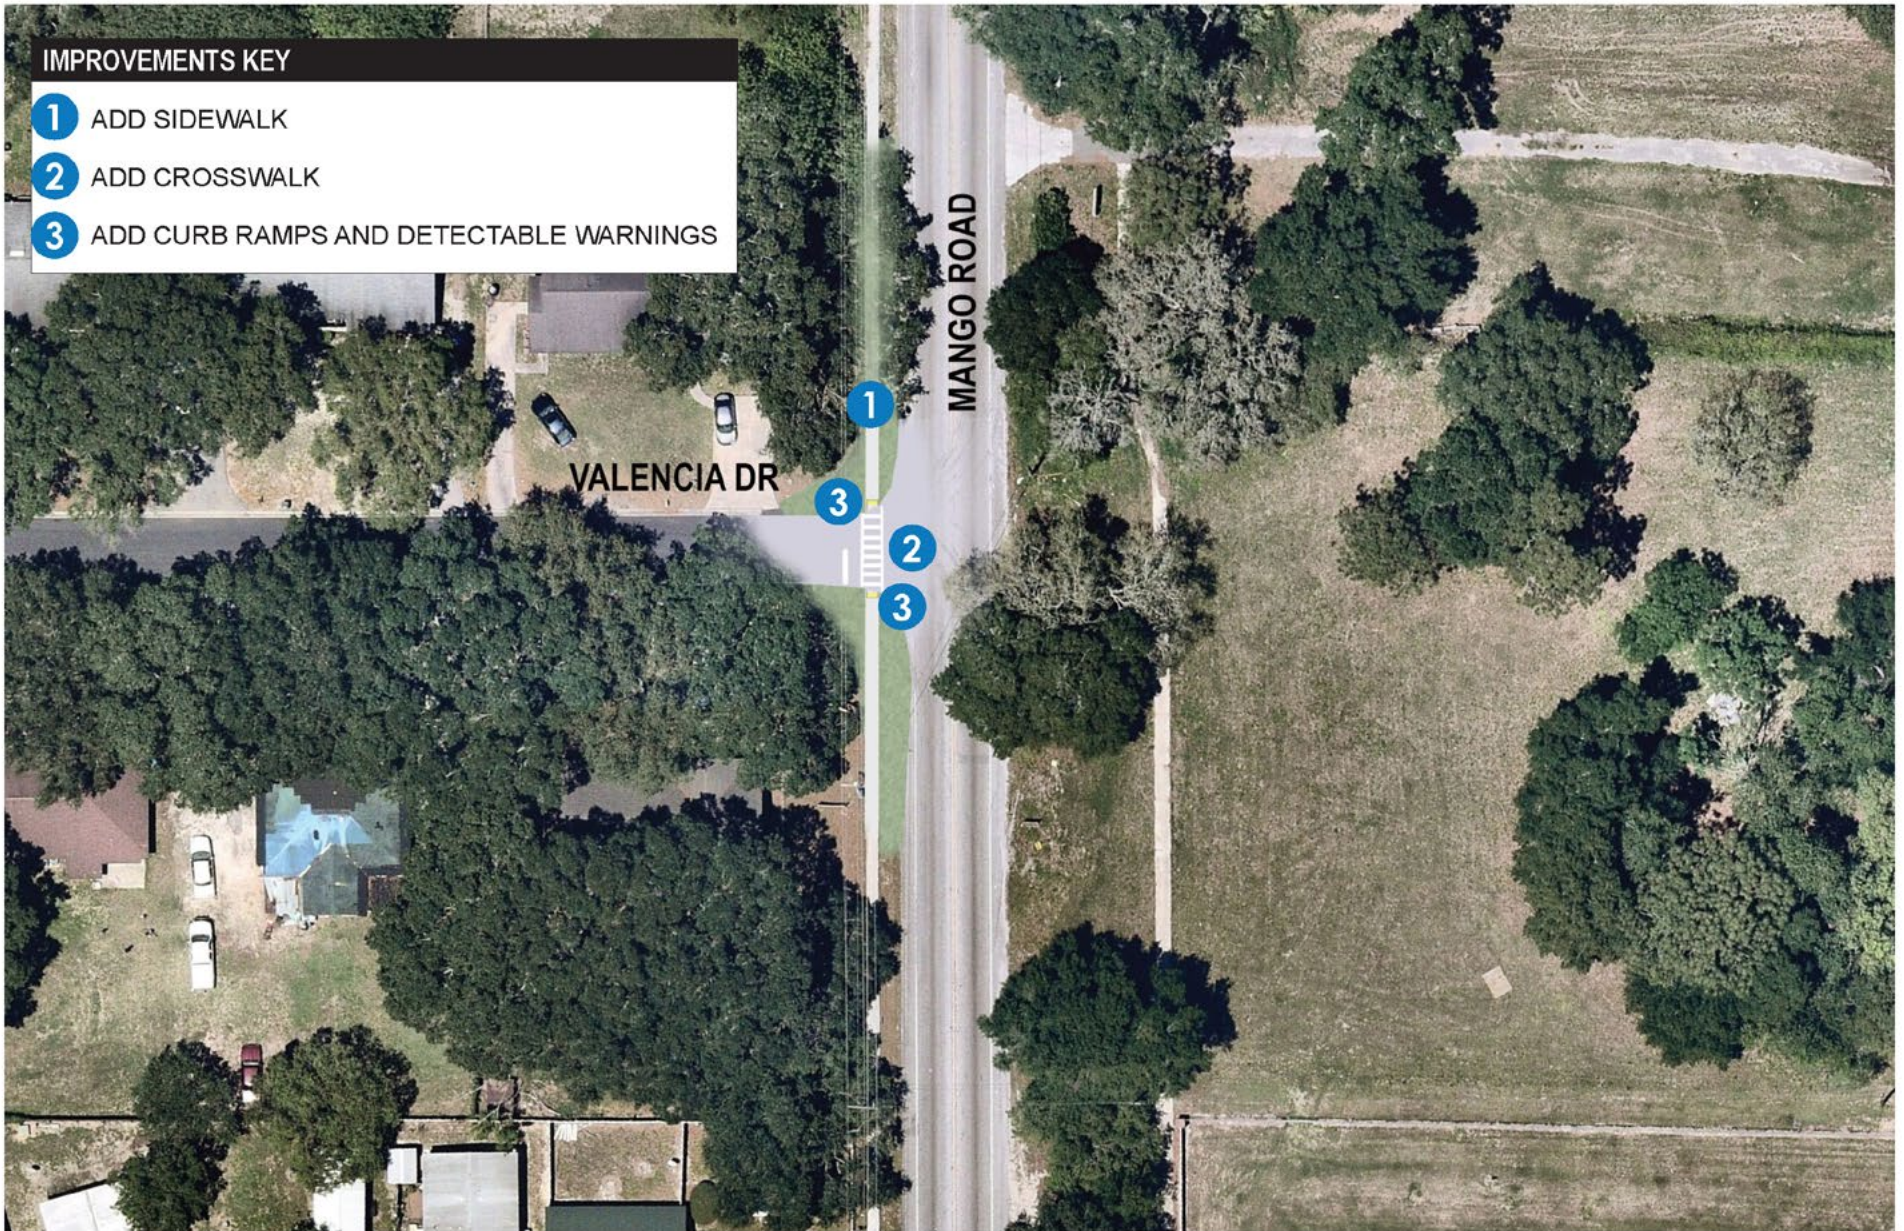
Figure 29 - Mango Road and Valencia Drive

Valencia Drive is a local residential road located north of Canterbury Drive. Between 2014 and 2018, nine crashes were reported near Valencia Drive, one crash was a serious injury rear end crash and another crash involved a pedestrian.

The recommended safety improvements at Valencia Drive consist of adding a crosswalk and detectable warning across Valencia Drive and adding sidewalk to connect the existing sidewalk to the crosswalk from the north and south of the intersection. The existing sidewalk was covered by pavement which should be removed. The crosswalk and detectable warning will provide a safer crossing for pedestrians and provide a visual warning for drivers that pedestrians are present in the area **(Figure 29)**.
