Hillsborough MPO | Hillsborough County

Lynn/Turner Road Vision Zero Corridor Study Corridor Summary

This report focuses on the approximately 1.5 miles of Lynn/Turner Road between Ehrlich Road and Gunn Highway and the collaborative effort between Hillsborough County and the Hillsborough County MPO to identify changes to bring the number of fatalities and serious injuries on the corridor to **ZERO**.

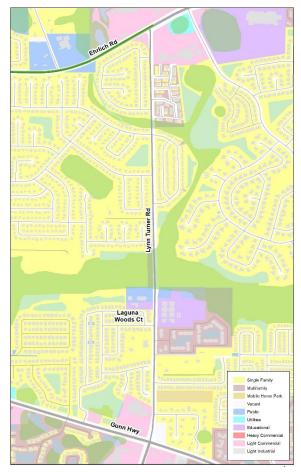
Existing Land Use

Land uses along the corridor consist primarily of single-family residential. More intense commercial retail uses exist near the intersections of Ehrlich Road and Gunn Highway, and a collection of educational and multi-family residential uses exist towards the center of the corridor near Laguna Woods Court.

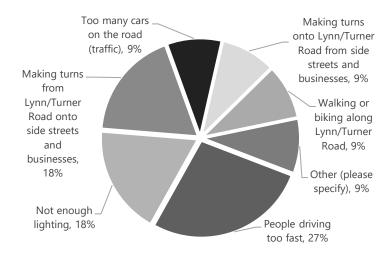
A large portion of respondents cited high traffic speeds (27%), making turns off or onto the corridor (27%), and insufficient lighting (18%) as the primary elements that reduce their feeling of safety along the corridor. Some respondents remarked on the narrowness of the road, a lack of safe places to turn, and a high posted speed limit contributing to negative feelings of safety.

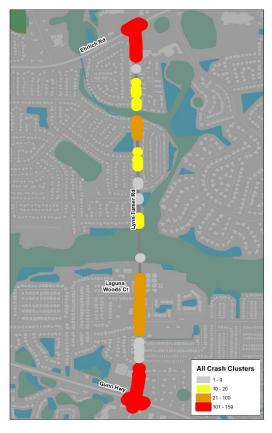
Severe Injury Crash Clusters

clusters, Ehrlich Road, Gunn Highway, and Laguna Woods Court emerge as the highest crash locations for both all crash types and severe injury crash types. A smaller cluster of two severe crashes occurred at the intersection of the corridor with Village View Drive/Headland Hills Drive.

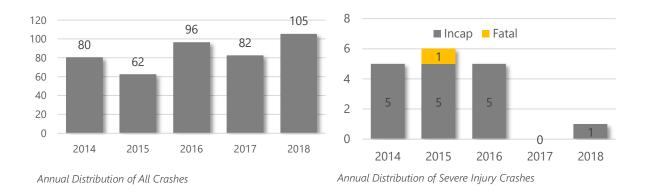
When reviewing crashes on an annual basis, a slight upward trend is observed for total crashes, while severe crashes were generally level prior to a significant drop to zero in 2017.

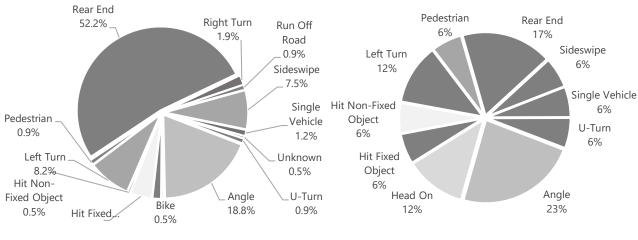
When comparing trends in crash types between all crashes and severe crashes, one finds that Angle, Left Turn, and Head On crash types more often result in a severe injury when compared to total crashes along the corridor. This indicates that potential countermeasures specifically addressing turning movements and physically separating travel lanes should be considered.

Crash Types of All Crashes

Crash Types of Severe Injury Crashes

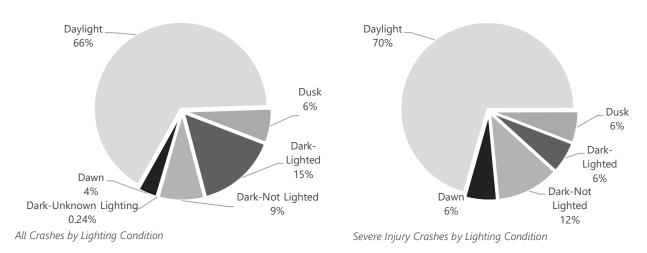
Another indicator of potential countermeasures is the lighting conditions under which crashes occurred. Although the share of severe injury crashes occurring in low light conditions was lower than total crashes, the share of severe crashes occuring under "Dark, Not Lighted" circumstances were slightly higher than that of total crashes. Additional opportunities to enhance lighting along the corridor should be reviewed.

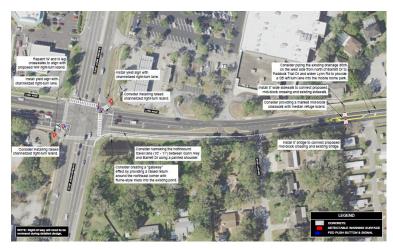
Suggested Countermeasures near Gunn Highway

- Gateway feature effect north of Gunn Highway
- New pedestrian crossing (north of Barrett Drive)
- Enhanced intersection and roadway lighting near Essrig Elementary School
- Left turn lanes to enhance access to local side streets
- Evaluate roundabout opportunities as a longer-term countermeasure
- Enhanced pedestrian crossings at signalized intersections
