Vision Zero Corridor Study

78th Street

DRAFT TECHNICAL MEMORANDUM

Fall 2020

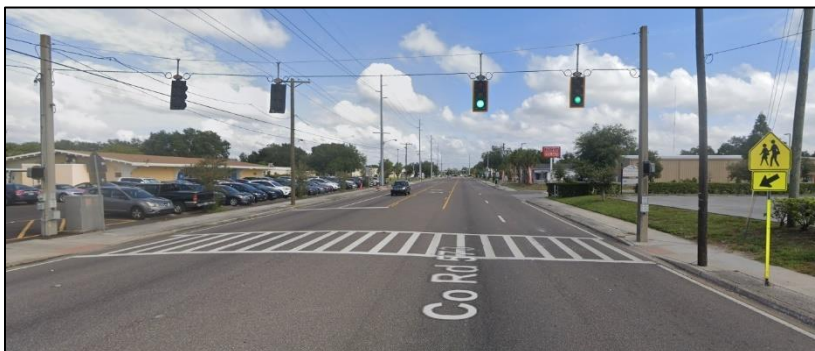
78th Street Midblock Crossing. Source: Google Street View, September 2019.

There are three marked and signalized pedestrian crossings along the corridor located at 78th Street and Palm River Road, 78th Street and Causeway Boulevard, and a midblock crossing in front of Clair Mel Elementary School and the Palm River Medical Center just north of Eau Claire Circle. The midblock crossing is approximately 0.25 miles south of Palm River Road and 1 mile north of Causeway Boulevard.

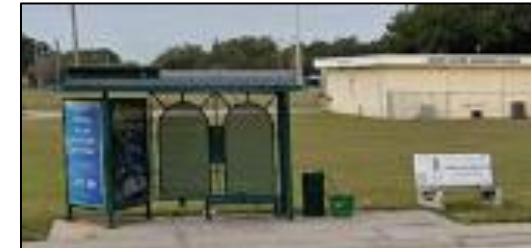
The transit stop for the community library is located north of Destin Drive and includes a shelter, benches, and a trash can.

Library transit stop.

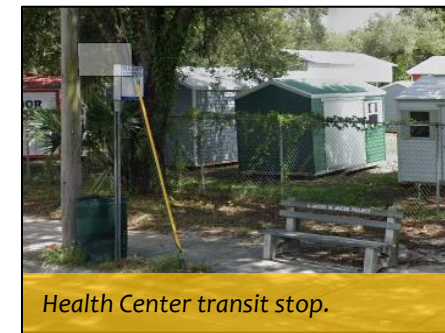
The transit stop for the Tampa Family Health Center is located just north of Causeway Boulevard and is equipped with a bench and a trash can.

Health Center transit stop.

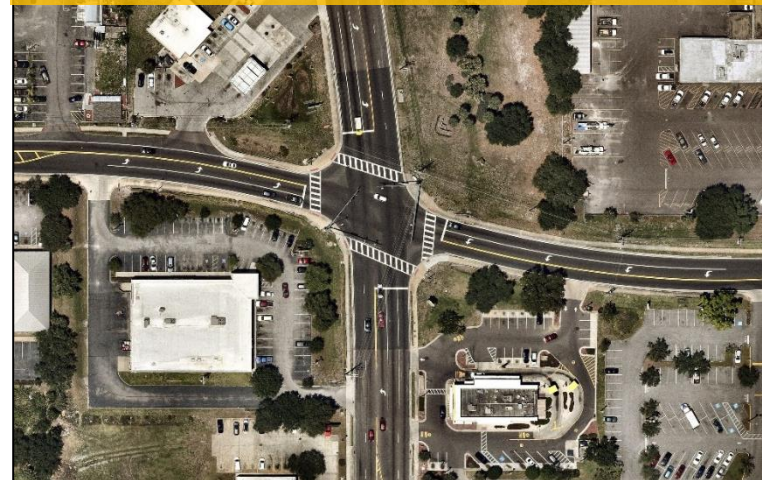
78th Street/Palm River Road intersection. Source: Google Maps.

The intersection of 78th Street/Palm River Road had the following crash statistics:

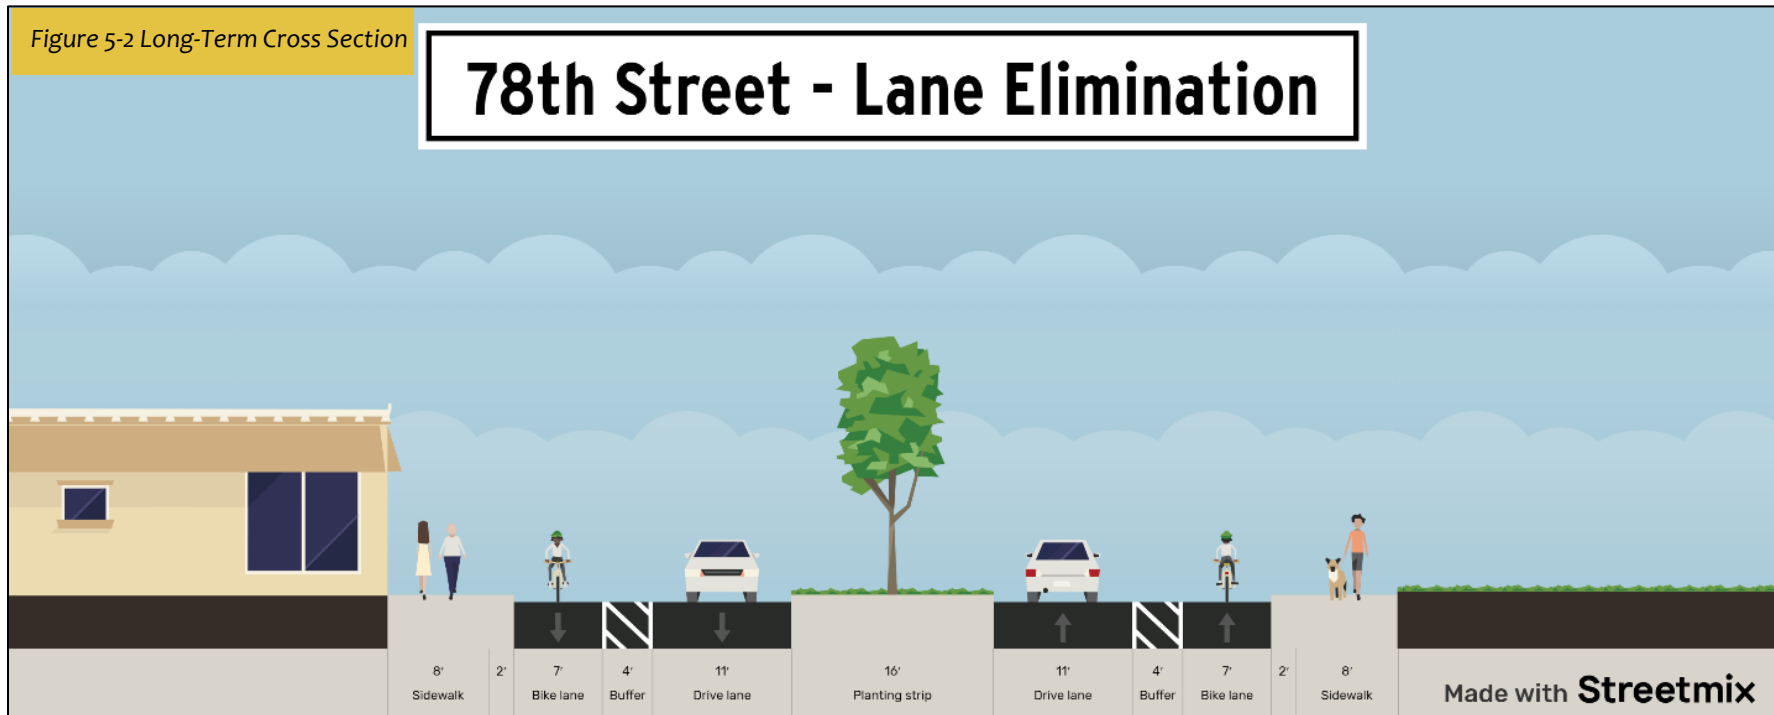
ALTERNATIVE 2 CROSS SECTION

As an alternative to incrementally improving the pedestrian and bike environment, and based on the review of traffic data and consulting with agency partners, **a lane elimination along 78th Street may be a viable option to enhancing safety for all road users**, including pedestrians, bicyclists, and motorists.

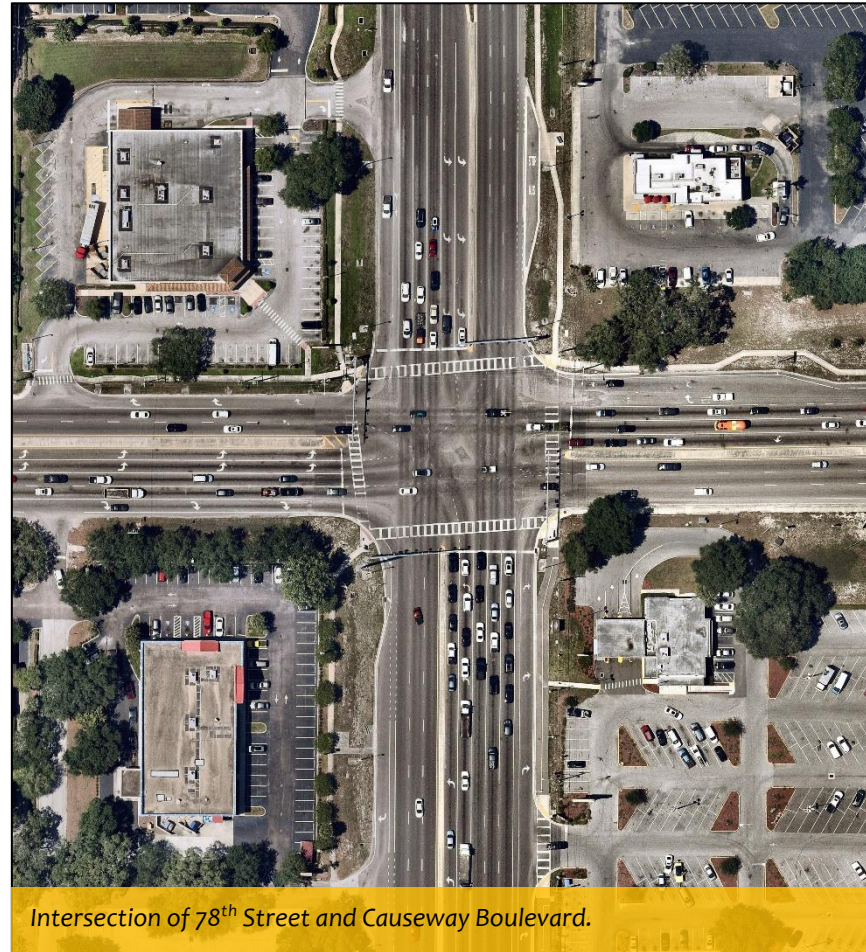
The intersection consists of two through lanes in each direction along Causeway Boulevard, and one lane in each direction along 78th Street. There are dedicated left turn lanes at all approaches of the intersection. There are also dedicated right turn lanes at the northern, eastern and southern legs of the intersection. East-west bike lanes exist along Causeway Boulevard.

Intersection of 78th Street and Causeway Boulevard.

Out of the total 417 crashes that occurred along the 78th Street corridor over the last five years, over 37% (156) occurred at the intersection with Causeway Boulevard. About 38% of these crashes were rear-end collisions, 30% were related to speeding and aggressive driving, and 29% were related to left-turning movements. The crashes at this intersection resulted in one fatality and six severe injuries.

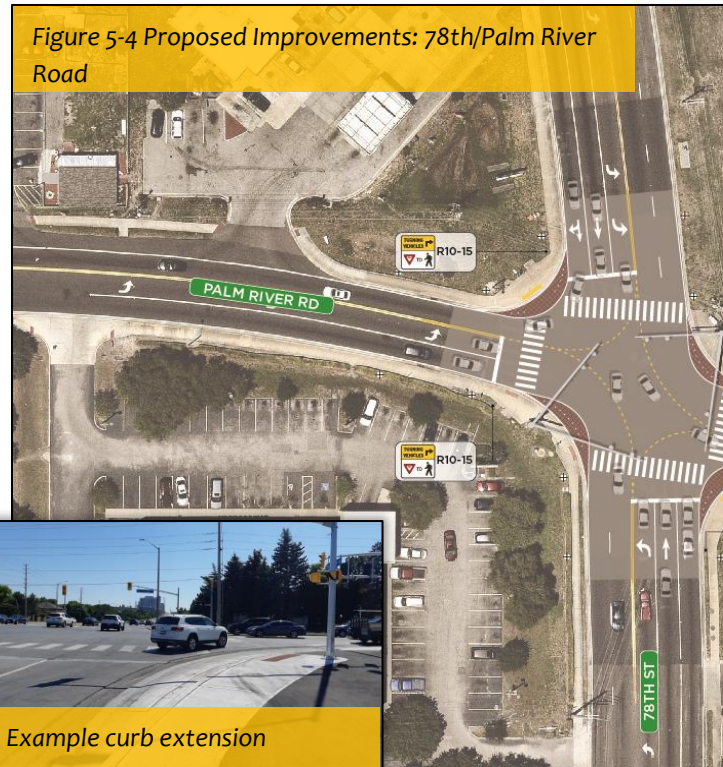
- ◆ **Skip pavement marking extensions:** Adding skip markings to this intersection is especially needed given its skewed geometry.
- ◆ **Curb extensions:** Curb extensions should be installed at all corners of this intersection to alleviate the offsets created by the skewed geometry. With the proposed configurations, pedestrians are expected to wait at the existing curb ramps, with the curb extensions and bollards serving as additional buffer from turning vehicles. Existing curb ramp conditions should be further evaluated for ADA compliance.

- ◆ **Signage:** Installing the MUTCD sign R10-15 all four corners of the intersection would help increase right turning vehicle yielding rate to pedestrians.
- ◆ **Lighting:** a significant number of crashes (18%) occurred during nighttime; therefore, it is important to evaluate and enhance street lighting. Adequate street lighting should be evaluated for appropriate street light type installation.

A total of 137 crashes occurred at the intersection of 78th Street and Palm River Road over the last five years. About 39% of these crashes were related to left turning movements, 23% were rear-end collisions, and 18% occurred during dark and unlit conditions. The crashes at this intersection resulted in a fatality and six severe injuries. The intersection of 78th Street at Palm River Road is geometrically skewed, which may be presenting some offset and visibility challenges. In developing safety countermeasures, there are low-cost, high-impact treatments that can be implemented to alleviate this. Given this challenge, it is also important to implement treatments that enhance pedestrian and bike safety.

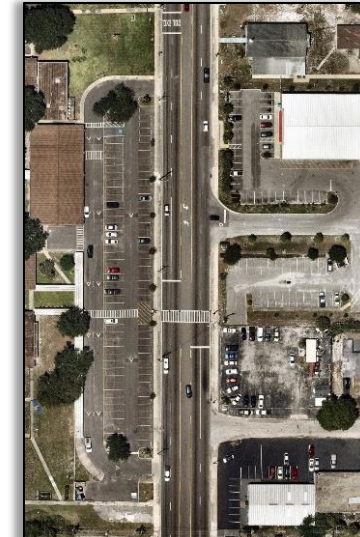
In spite of being equipped with a traffic signal and high-emphasis crosswalk, **44 crashes took place at this location**, out of which involved a pedestrian, and one caused a bicyclist fatality. Three crashes occurred at night, and about 60% were related to speeding and aggressive driving.

Current 78th Street midblock crossing.

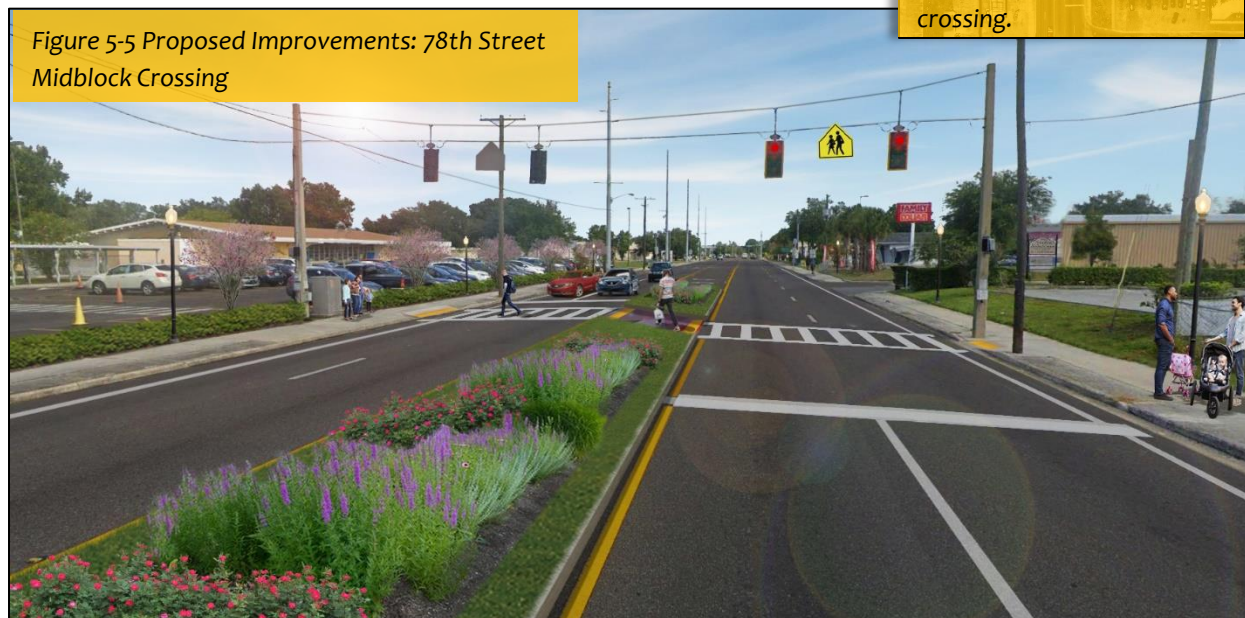
Concrete median: The current five-lane undivided section of 78th Street is not conducive to a safe pedestrian crossing environment. While the turn lane is needed to facilitate turning onto side streets, designated pedestrian crossings along 78th Street would benefit from a raised concrete or landscaped median.

- ◆ **Pedestrian refuge area:** In conjunction with the median island, a pedestrian refuge area should be installed across the median. To facilitate visibility and eye contact between motorists and pedestrians, the pedestrian refuge area can be diagonal.
- ◆ **Lighting:** While only 12% of all crashes occurred during dark conditions, it is recommended that street lighting is installed at this intersection to further enhance safety conditions.

Figure 5-5 Proposed Improvements: 78th Street Midblock Crossing 29

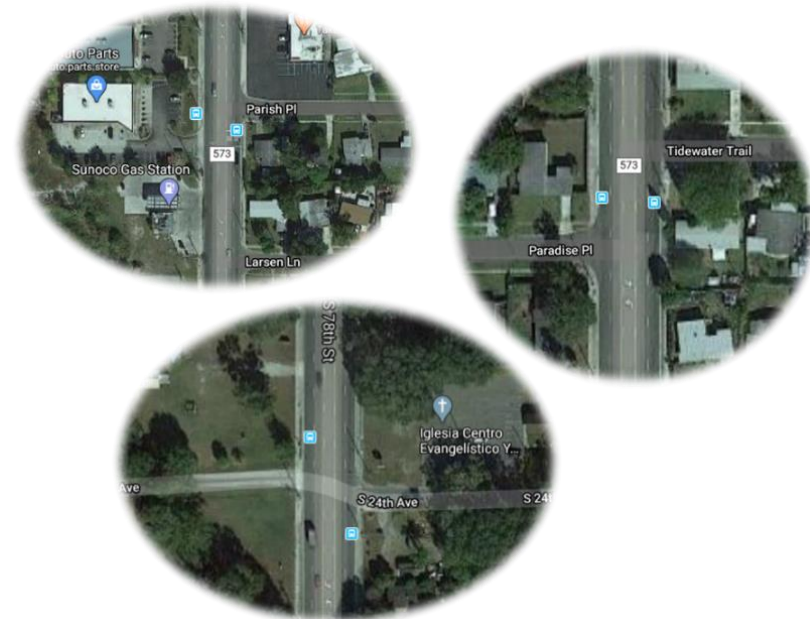
Transit stops along 78th Street

- ◆ It provides a refuge area across the five-lane roadway section.
- ◆ It can also serve as an aesthetic treatment with low-hedge landscaping that provides more neighborhood context to the corridor.
- ◆ **Collaboration with transit agencies:** In conversation with agency partners, there is an opportunity to discuss consolidating and aligning bus stops along the corridor with the Hillsborough Area Regional Transit Authority. Consolidating, designating, and enhancing transit stops would be beneficial to all road users.
