Hillsborough MPO | Hillsborough County

Fletcher Avenue Vision Zero Corridor Study Corridor Summary

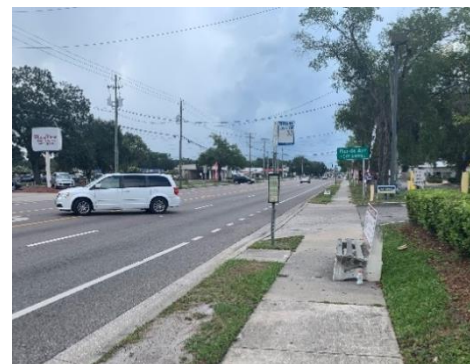
Location	Direction	Average Speed	Free Flow Speed
E. of Rome Ave	EB	33.5 mph	39.9 mph
E. of Rome Ave	WB	36.5 mph	41.1 mph
W. of Central Ave	EB	12.2 mph	28.0 mph
W. of Central Ave	WB	17.5 mph	25.1 mph
W. of Nebraska Ave	EB	17.8 mph	25.4 mph
W. of Nebraska Ave	WB	16.0 mph	25.0 mph

ClearGuide Travel Speed Data – Collected 2/19/20, 12:00 PM

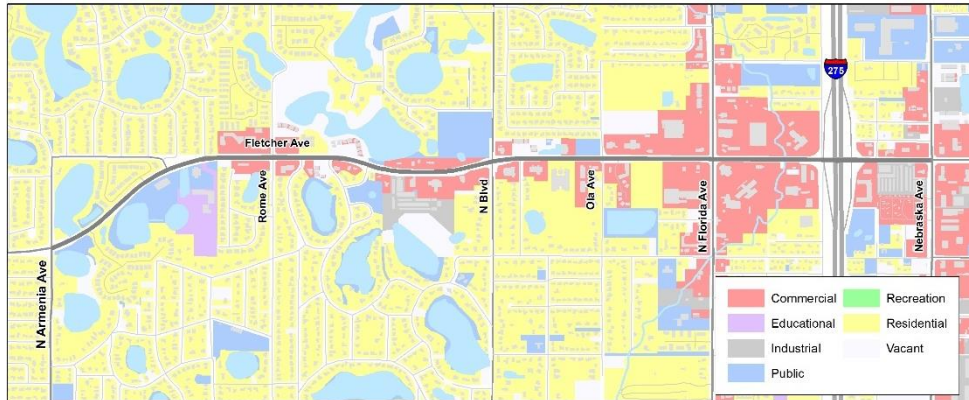
Generalized Existing Land Use Categories

Land uses on the western end of the corridor consist of residential, office, and educational uses. To the east, uses become more intensely

commercial with a significant number of driveway curb cuts.

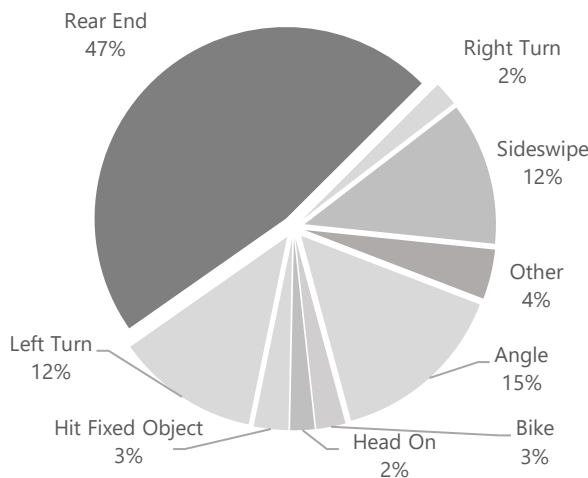
Crash Types of All Crashes

When comparing trends in crash types between all crashes and severe injury crashes, one finds that Left Turn and Pedestrian crash types more likely to result in a severe injury crash. This indicates that potential countermeasures specifically addressing turning movements and pedestrian facilities, such as improved crosswalks or sidewalks, are needed.

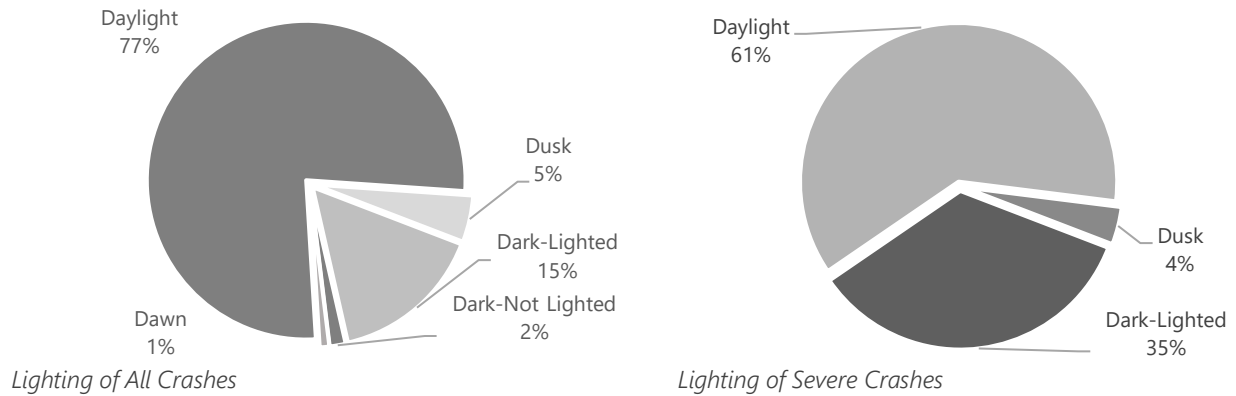
Another indicator of potential countermeasures is the lighting conditions under which crashes occurred. According to the data, more severe injury crashes occurred outside of daylight hours, indicating that lighting along the corridor may be deficient and contributing to death and serious injury.

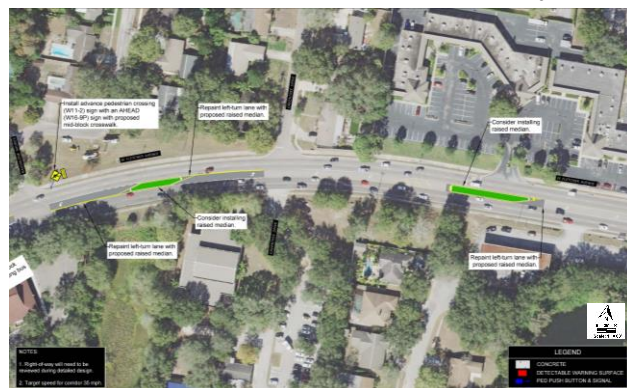
Suggested improvements along Fletcher Ave west of Rome Ave

A comprehensive set of site-specific suggestions were identified to address specific crash trends and related issues throughout the corridor. Generally, these suggestions include raised median islands, channelized turn lanes, enhanced crossings, and an additionally traffic signal. The accompanying technical memorandum includes a detailed list of these suggestions along with conceptual drawings to help visualize the improvements. Many of the site-specific suggestions are intended to support the proposed 35 MPH target speed for Fletcher Avenue and to help address the number of left turn and angle crashes that have accounted for over 46% of the fatal and serious injury crashes along the corridor.
